SERVICE BULLETIN

Classification: AT15-014c	Reference: NTB15-085c	Date: April 18, 2017
------------------------------	--------------------------	-------------------------

2013-2015 ALTIMA; CVT DELAYED ENGAGEMENT WHEN SHIFTING INTO DRIVE OR REVERSE

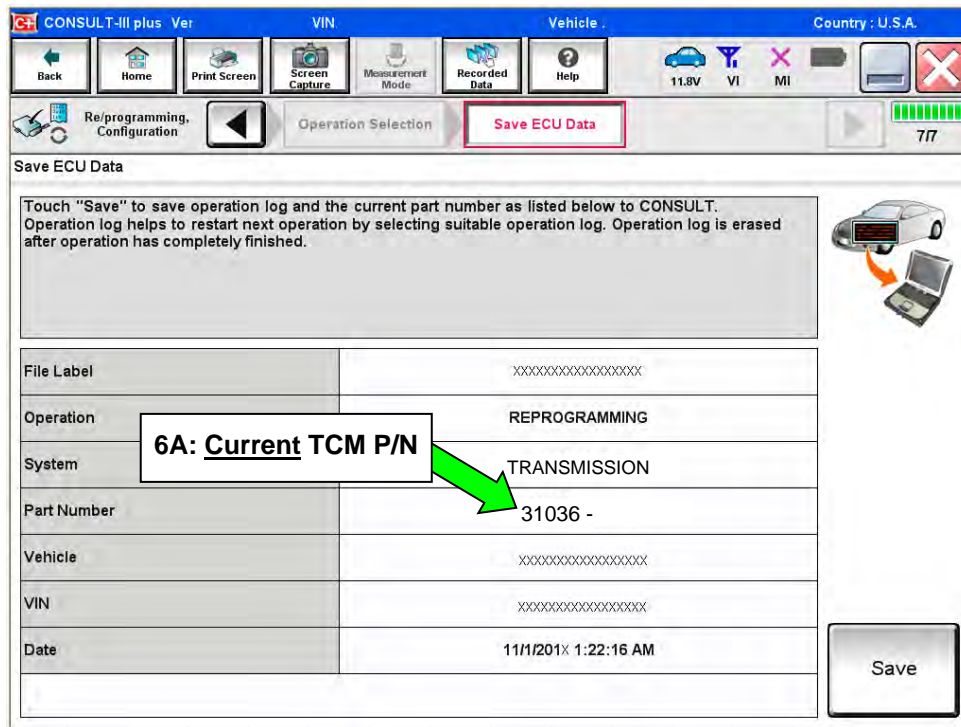
6. When you get to the screen shown in Figure 2, confirm this bulletin applies as follows.

A. Find the TCM **Part Number** and write it on the repair order.

NOTE: This is the current TCM Part Number (P/N).

5. Follow the on-screen instructions and navigate the C-III plus to the screen shown in Figure 2 on the next page.

B. Compare the P/N you wrote down to the numbers in the **Current TCM Part Number** column in **Table A** below.

- If there is a match, continue with the reprogramming procedure.
- If there is not a match, go to page 11, **Control Valve (Valve Body) Removal and CVT Belt Inspection**.

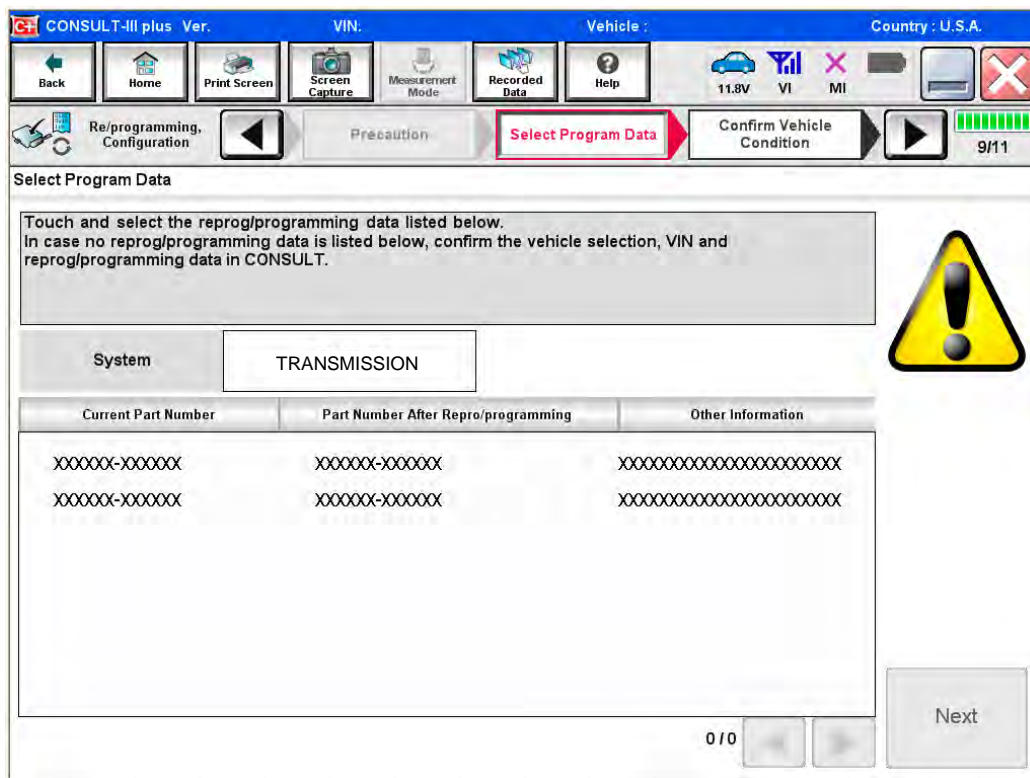
- In some cases, more than one new P/N for reprogramming is available.
 - If more than one new P/N is available, the screen in Figure 3 displays.
 - Select and use the reprogramming option that **does not** have the message “Caution! Use ONLY with NTBXX-XXX”.
- If you get this screen and it is blank (no reprogramming listed), it means there is no reprogramming available for this vehicle. Close C-III plus, and then go to page 11, **Control Valve (Valve Body) Removal and CVT Belt Inspection**.

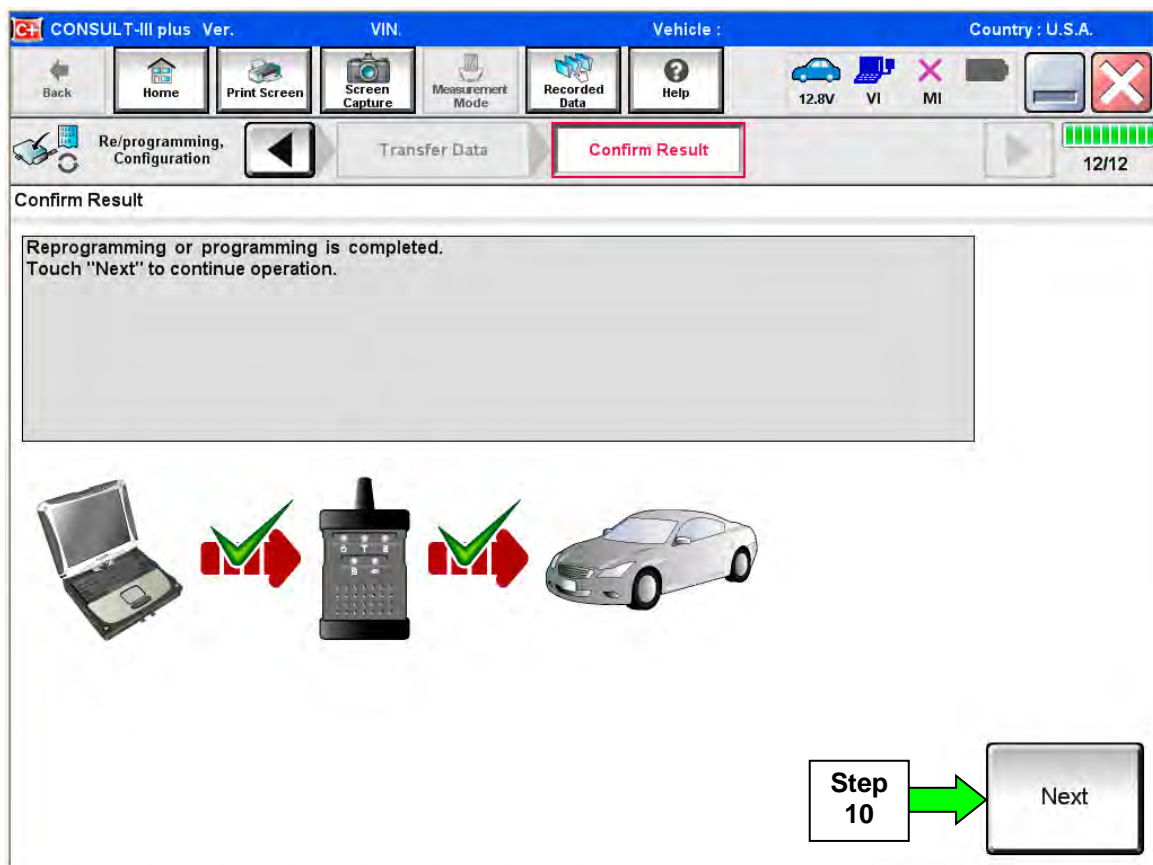
8. When the screen in Figure 4 displays, reprogramming is complete.

NOTE: If the screen in Figure 4 does not display (indicating that reprogramming did not complete), refer to the information on the next page.

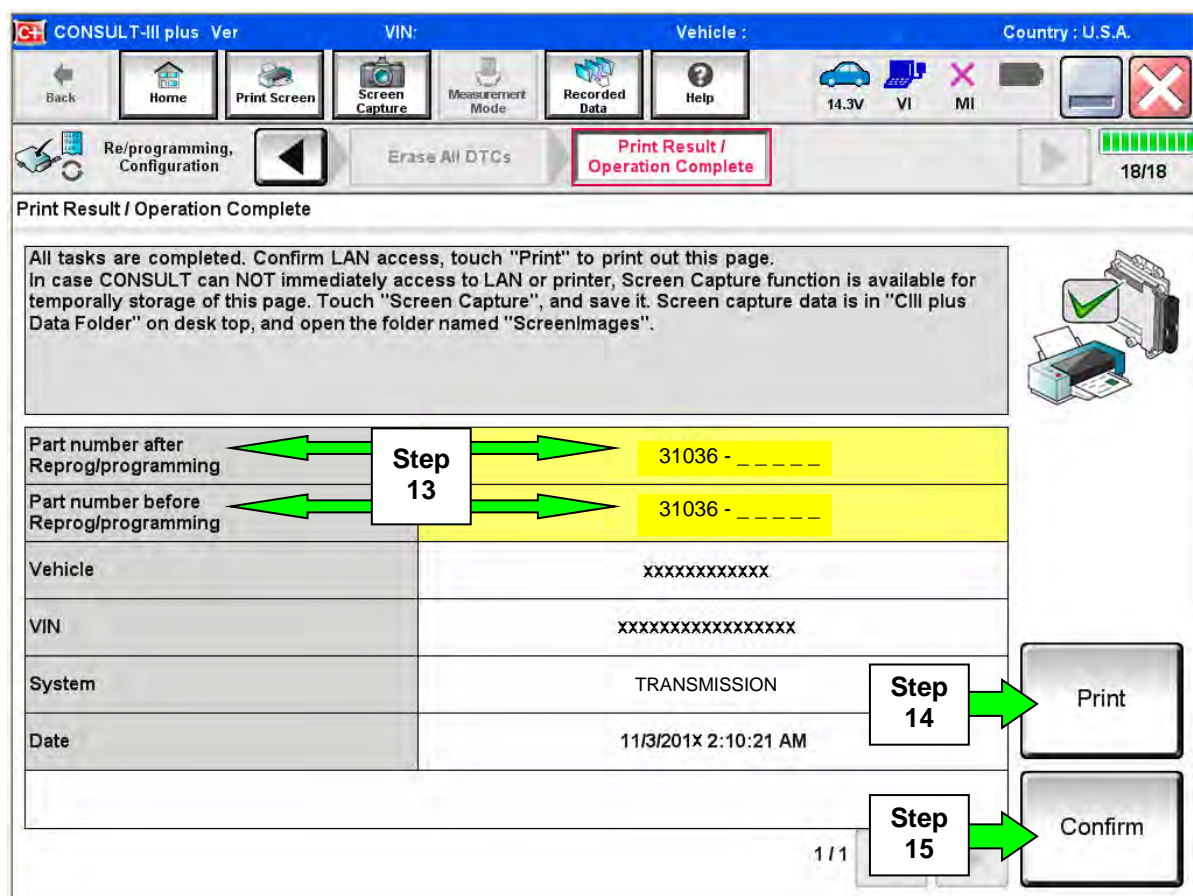
11. Follow the on-screen instructions to **Erase All DTCs**.
12. When the entire reprogramming process is complete, the screen in Figure 7 will display.
13. Verify the before and after part numbers are different.
14. Print a copy of this screen (Figure 7) and attach it to the repair order for warranty documentation.
15. Select **Confirm**.

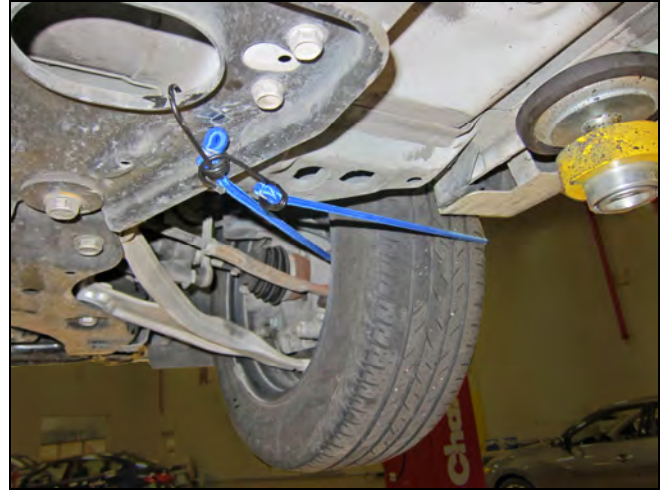
Figure 9

2. Secure the front right tire with a suitable strap.
 - This will assist in making the belt turn.
3. Mark the front left tire with a suitable marking.
 - This will assure all 360° of the belt is inspected.

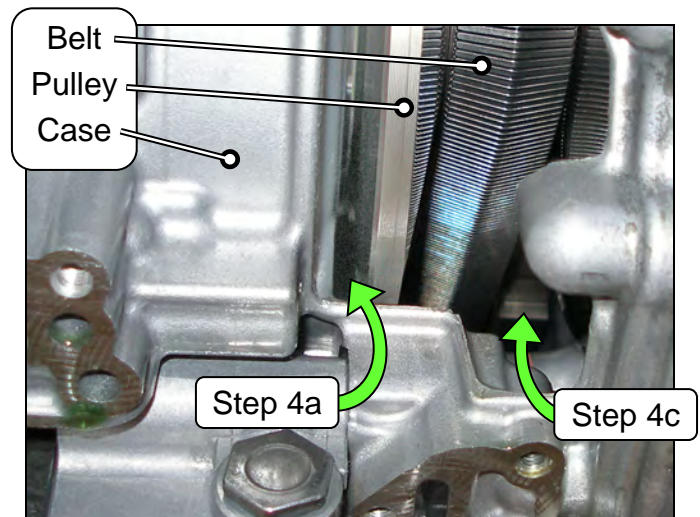
Figure 10

- a. Insert the camera lens between the CVT case and pulley where shown in Figures 10 and 11.
 - Insert the lens approximately seven (7) inches, and then view the side of the belt that contacts the pulley.

- Insert the camera lens in the second location where shown in Figures 10 and 13, and then perform step 4b again.

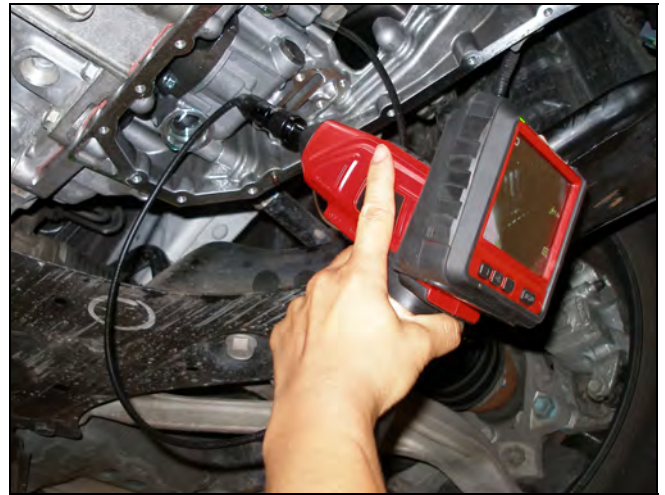
Figure 12

- b. Slowly and carefully turn the front left tire one full turn in the forward rotation to view all of the belt.

- Holding the borescope with one hand allows for turning the tire with the other hand (see Figure 12).

CAUTION: If the tire is rotated in the rearward rotation, the camera lens may get caught between the belt and pulley.

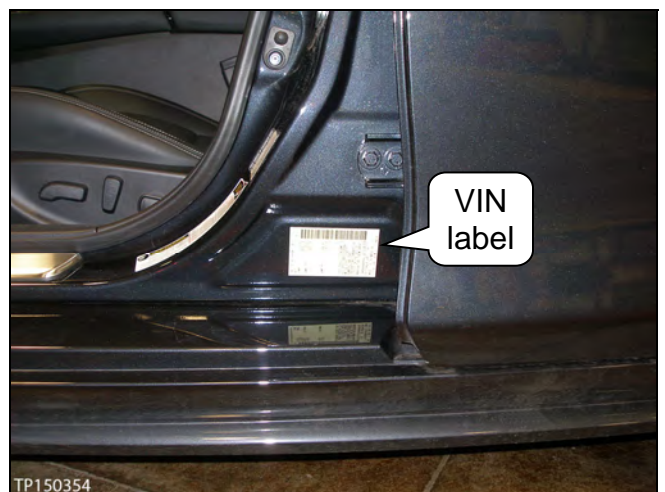
Figure 14

- e. Once CVT replacement is determined as required, use borescope J-51951 to record a 15 second or less continuous video of the most severe evidence of belt slip and the VIN on the F.M.V.S.S. certification label (VIN label). See Figure 14.

NOTE: This required video must be attached to the Powertrain Call Center CVT Preauthorization Form (in ASIST) prior to calling for authorization. Failure to submit a continuous video will cause immediate denial of request for replacement.

- Before starting to record, make sure the camera handle's AA batteries are fresh and the LCD monitor's battery is charged.
 - The whole video will show as backward, or reversed mirror image. This is okay.

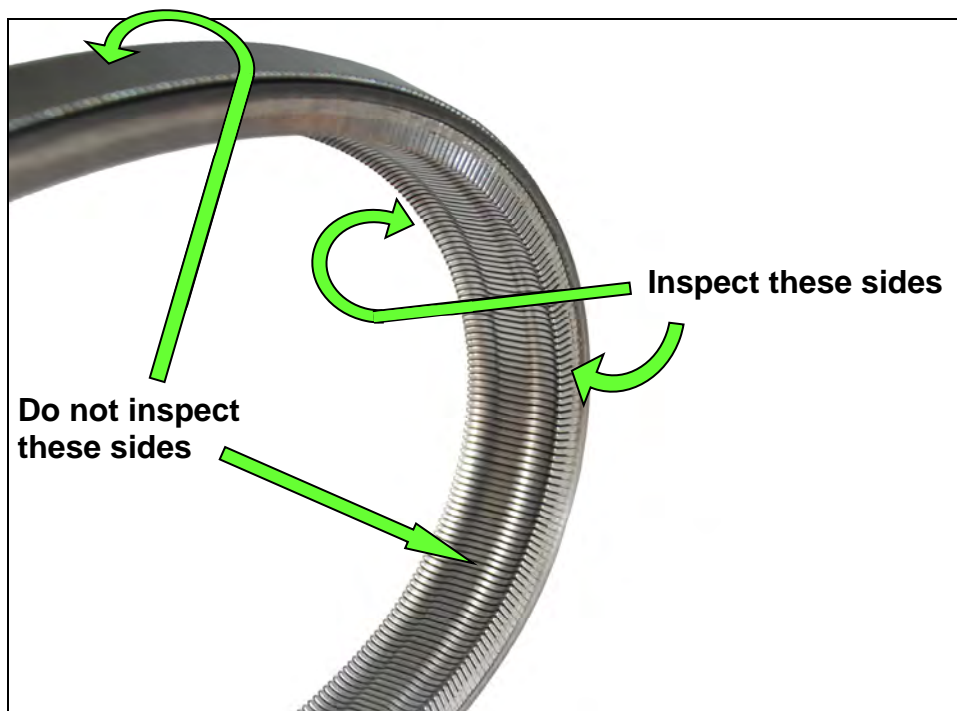
Figure 15

4. Using borescope J-51951 with mirror attachment, inspect the entirety of the two sides of the belt that come in contact with the pulleys (see page 14, Figure 15). Reference the pictures on pages 14-18 for comparison.

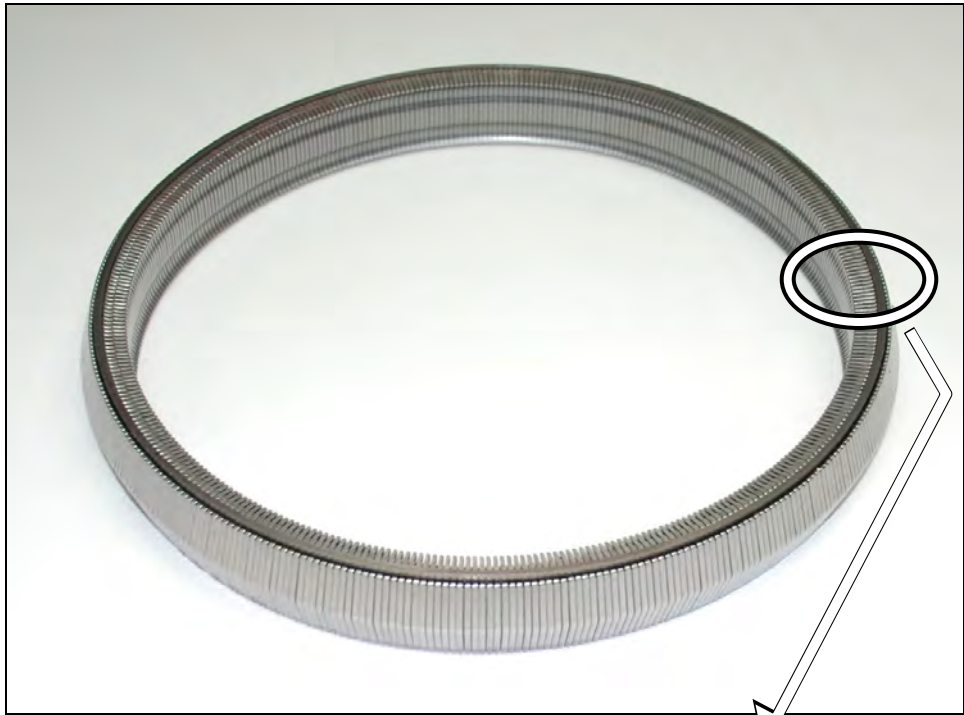
Figure 16: New belt

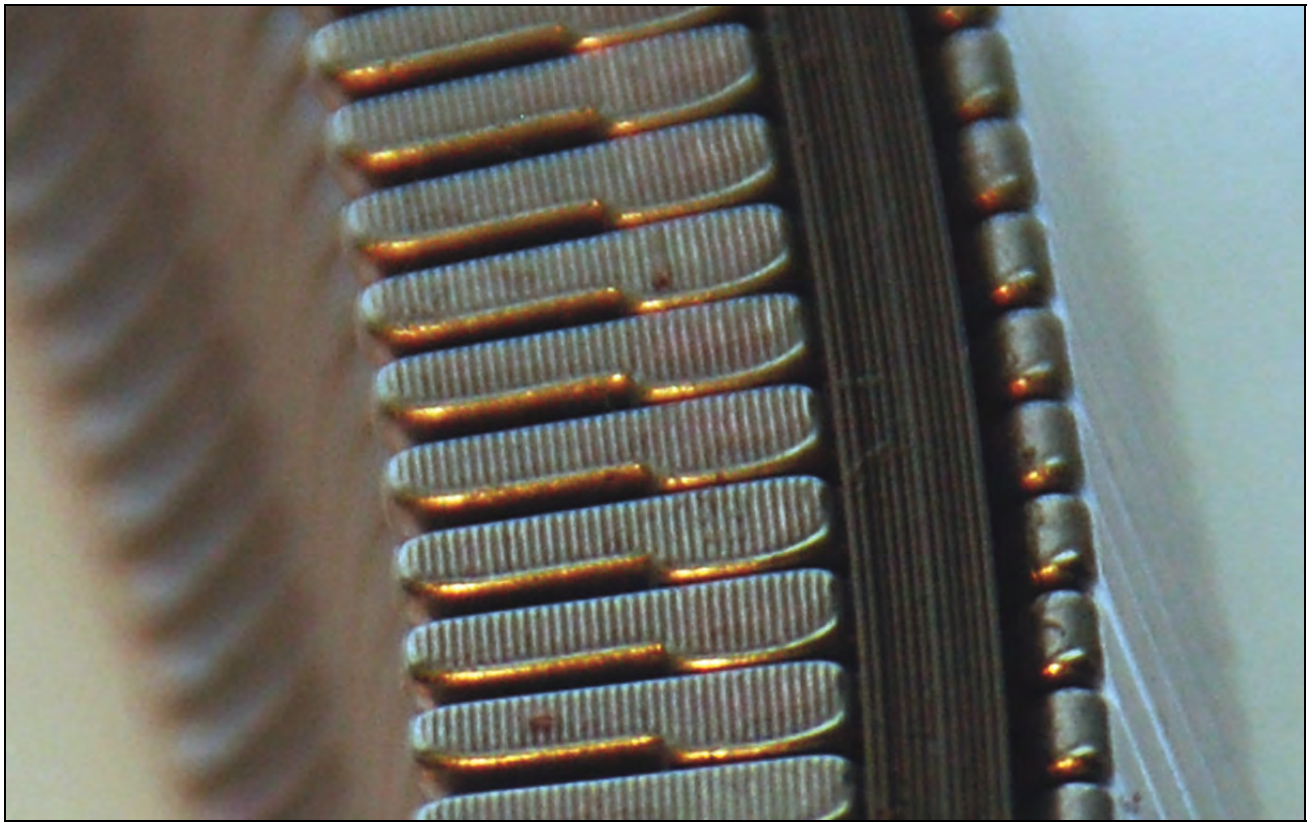
Figure 17: Close-up of section to be inspected

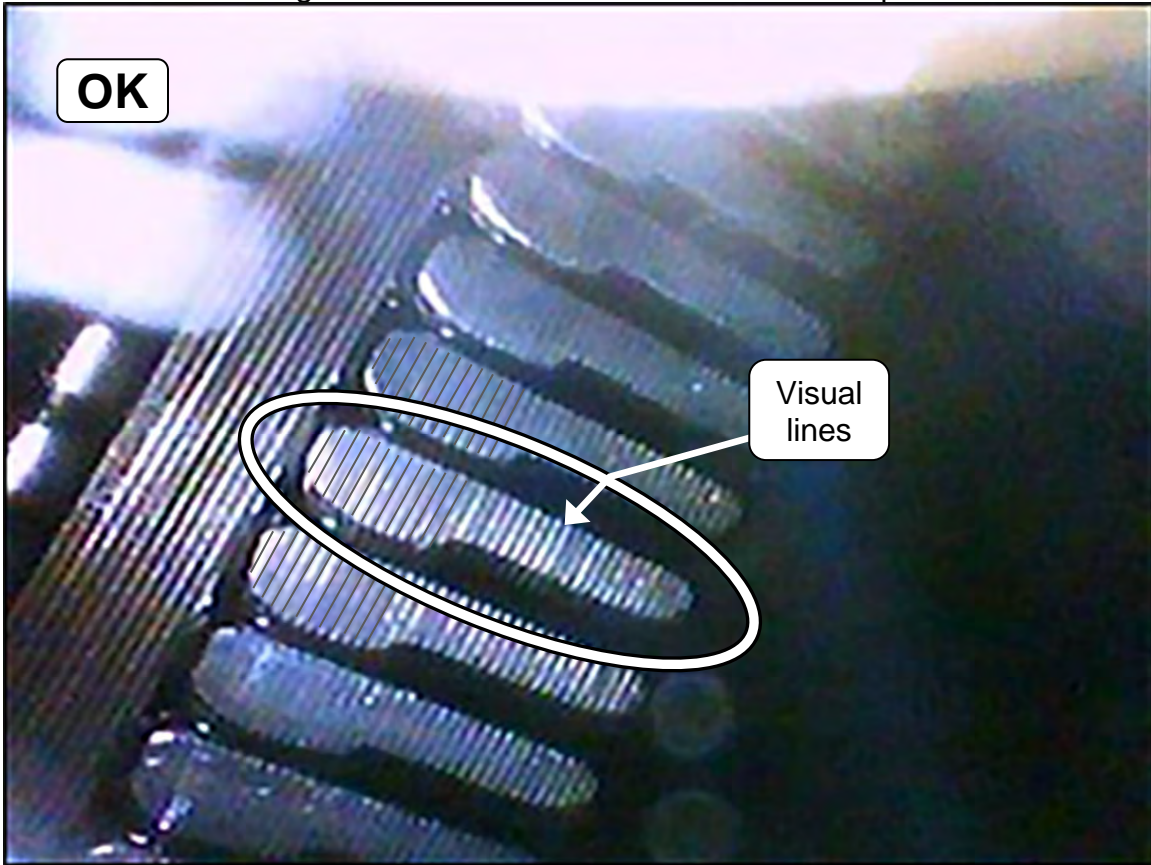
Pictures in Figures 18 and 19 were taken with borescope J-51951.

Figure 18: Belt is OK

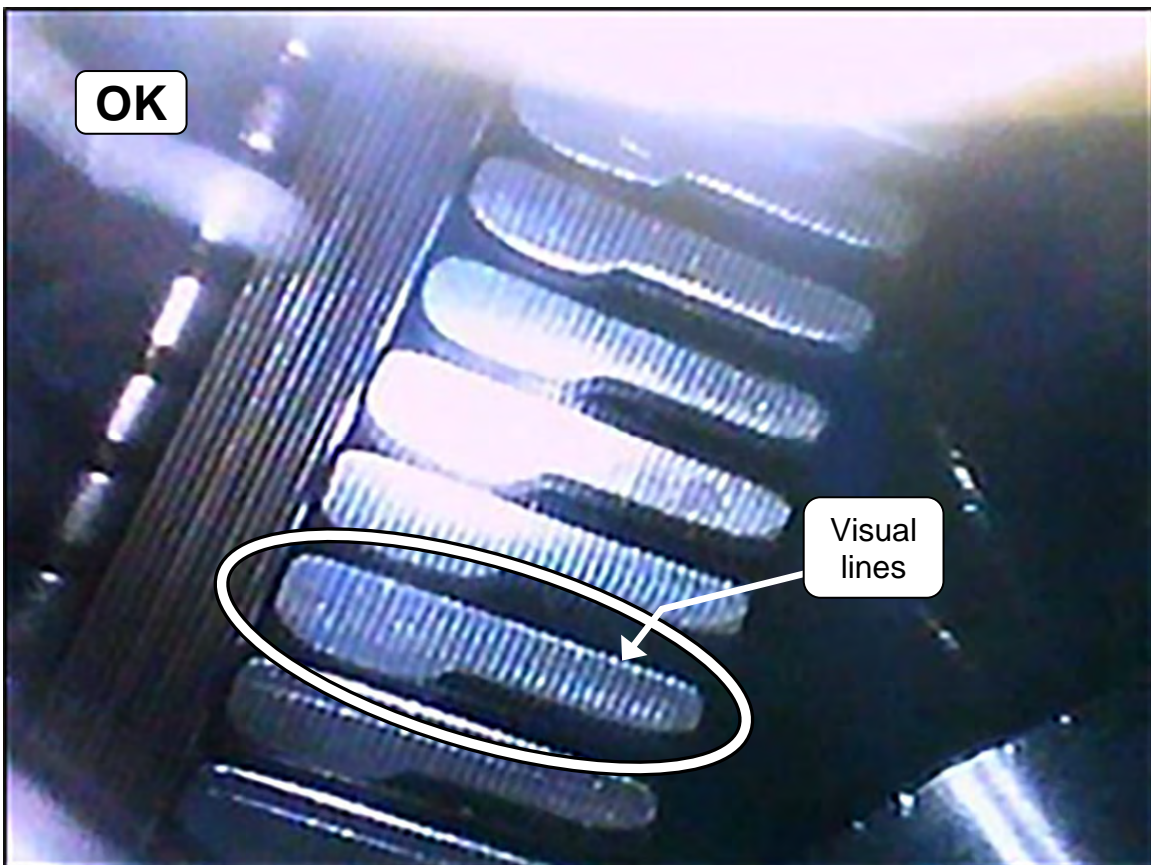
Figure 19: Belt is OK

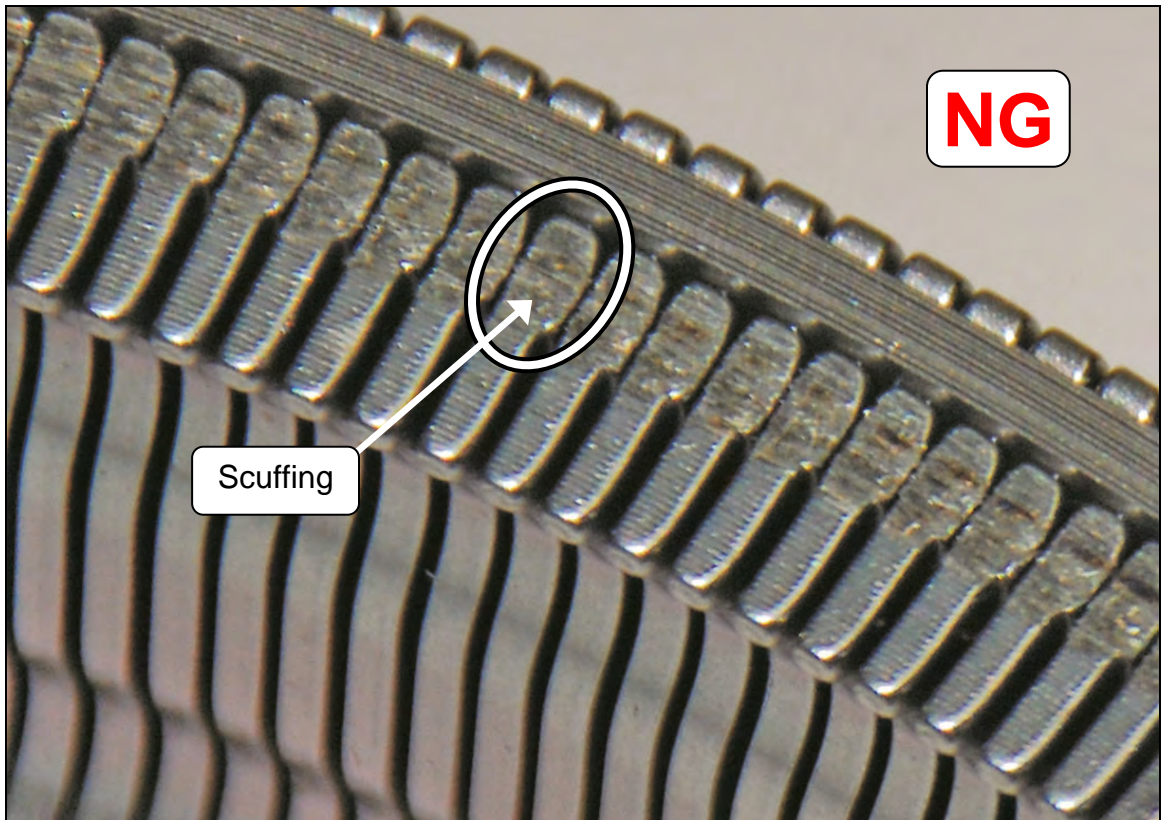
Figure 20: Example of NG belt

6. If the belt inspection result is NG, replace the CVT assembly.
- Get authorization to replace the CVT assembly (see page 26).
 - Make sure to perform step 4e on page 13.

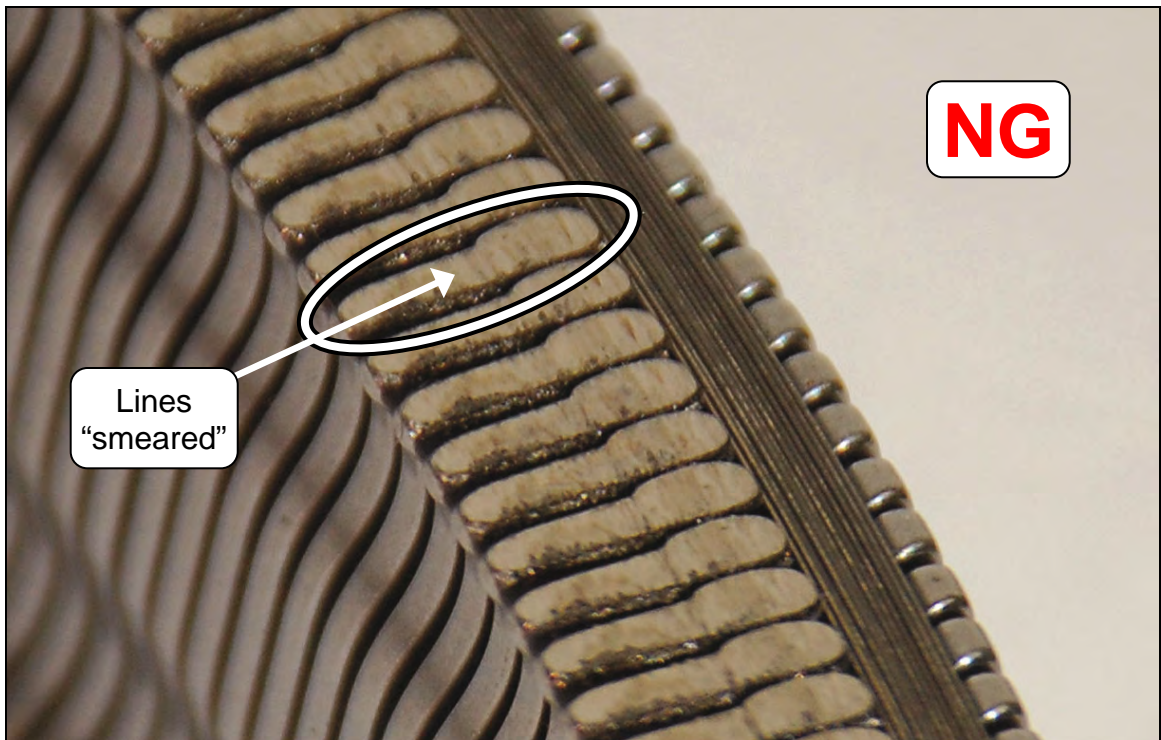
Figure 21: Example of NG belt

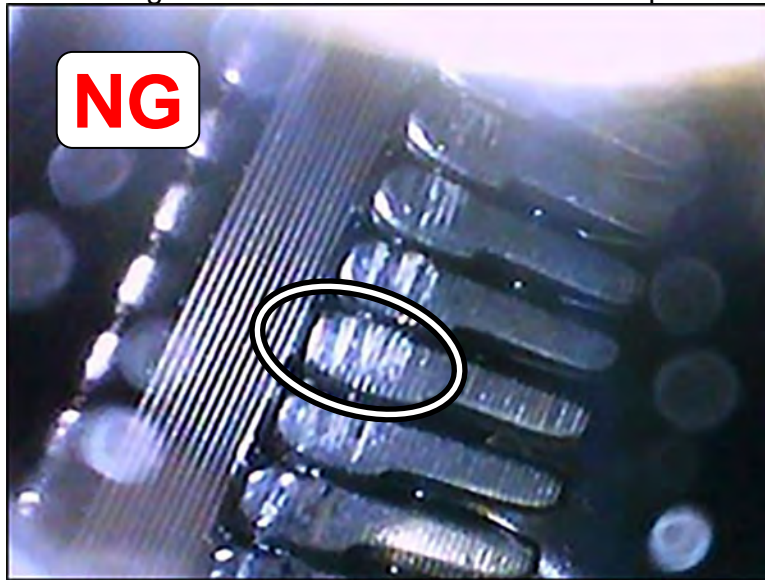
Pictures in Figures 22-24 were taken with borescope J-51951.

Figure 22: Example of NG belt

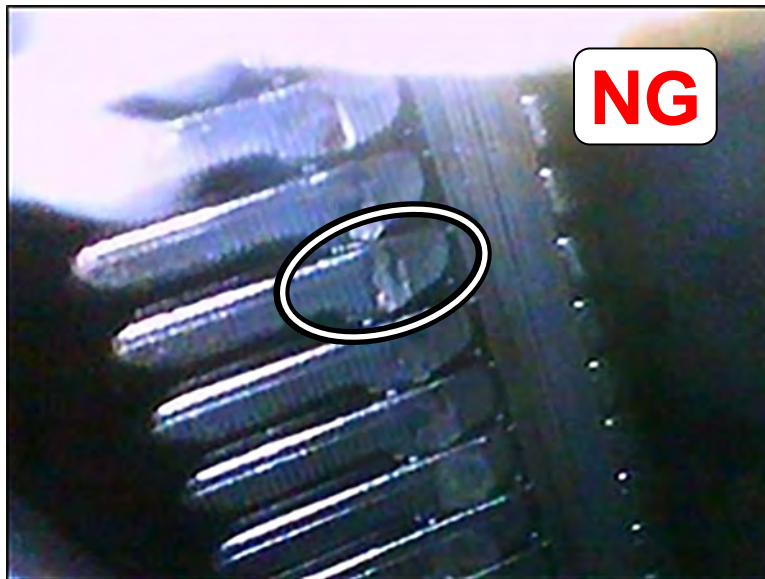
Figure 23: Example of NG belt

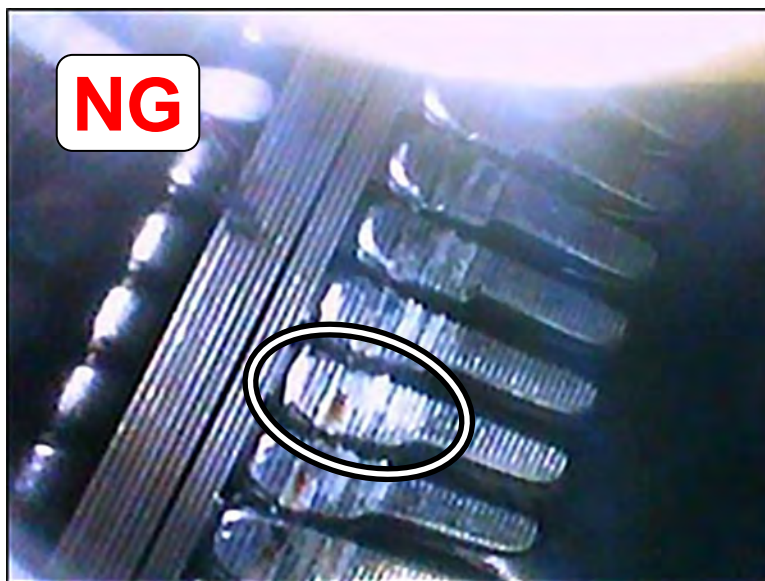
Figure 24: Example of NG belt

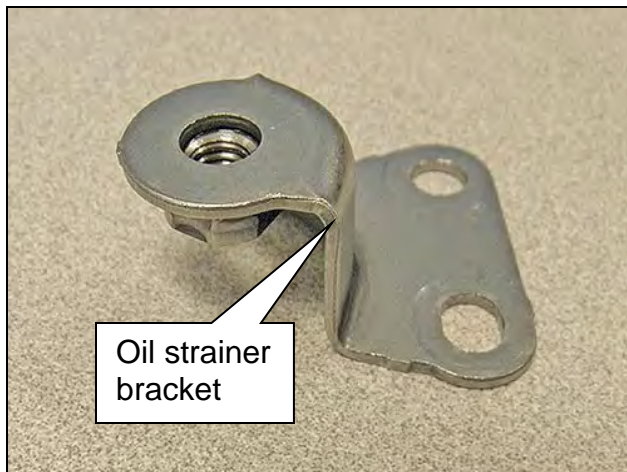
Figure 25

1. Discard the oil strainer bracket (Figure 25).
2. Install a new lip seal. Do NOT reuse the old lip seal (Figure 26).

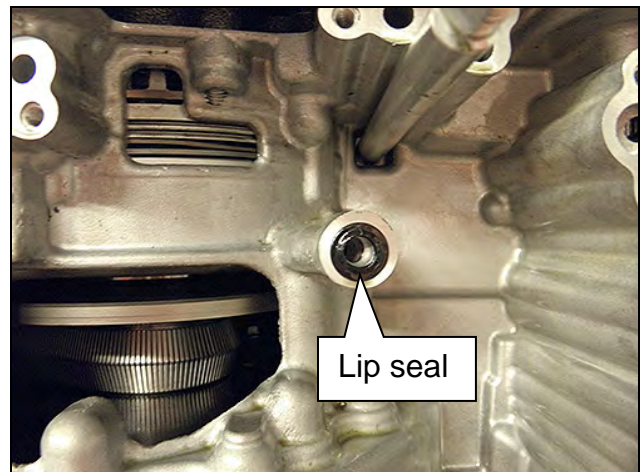
Figure 26

NOTE: Apply a small amount of petroleum jelly to the lip seal to keep it in place on the CVT.

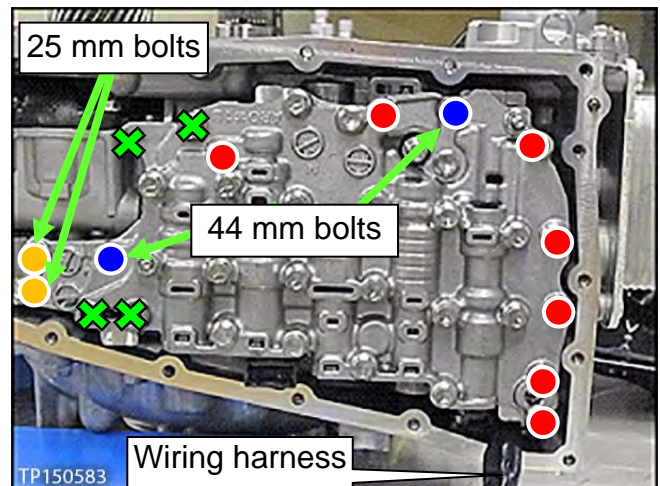
Figure 27

3. Install the Control Valve with nine (9) mounting bolts (Figure 27).

IMPORTANT: Leave Four (4) ✘ bolt holes blank at this step.

CAUTION: Make sure the wiring harness is not in the way / does not get pinched.

- 54 mm long bolt ● – 7 pieces
- 44 mm long bolt ● – 2 piece
- 25 mm long bolt ● – 2 piece

CAUTION: These two bolts are installed WITHOUT the strainer bracket.

- Bolt torque: 8.0 N•m (0.81 kg-m, 70.8 in-lb.)

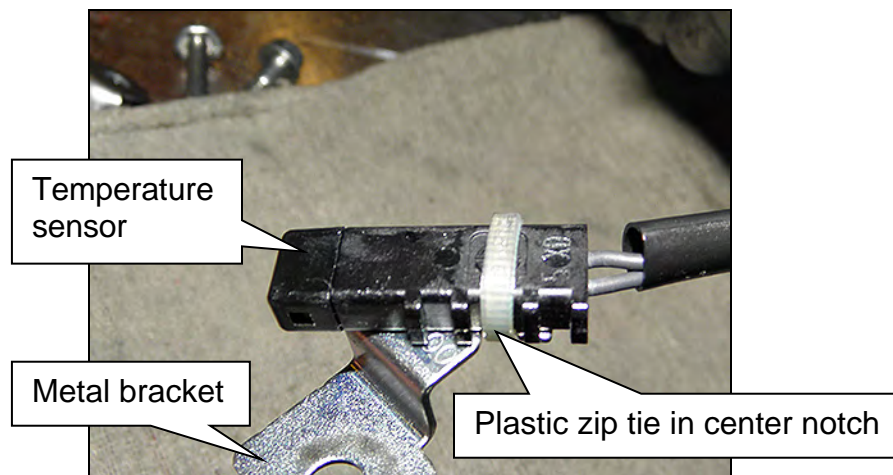
Figure 28

- a. Cut the plastic zip tie with an appropriate tool to remove the temperature sensor bracket from the terminal harness assembly. (Figure 28).

CAUTION: Cut the plastic zip tie over the metal bracket to avoid damage to the temperature sensor.

- b. Discard the removed bracket and plastic zip tie.
- c. Use the plastic zip tie from **PARTS INFORMATION** to attach the new temperature sensor bracket to the temperature sensor of the terminal connector harness.

IMPORTANT: Locate the plastic zip tie at the center notch of three notches on the temperature sensor.

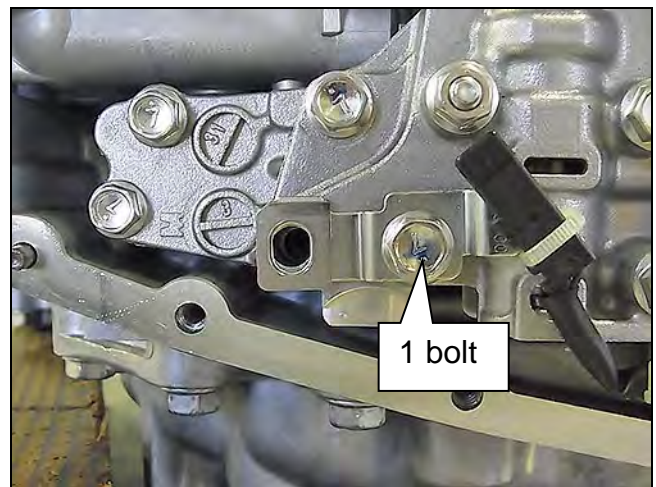
Figure 30

6. Install the CVT fluid temperature sensor bracket to the valve body with one (1) bolt (Figure 30).

NOTE: Leave one (1) bolt hole blank as it will be used to secure the oil strainer at a later step.

- Bolt torque: 8.0 N•m (0.81 kg-m, **70.8 in-lb.**)
- Bolt length: 54 mm

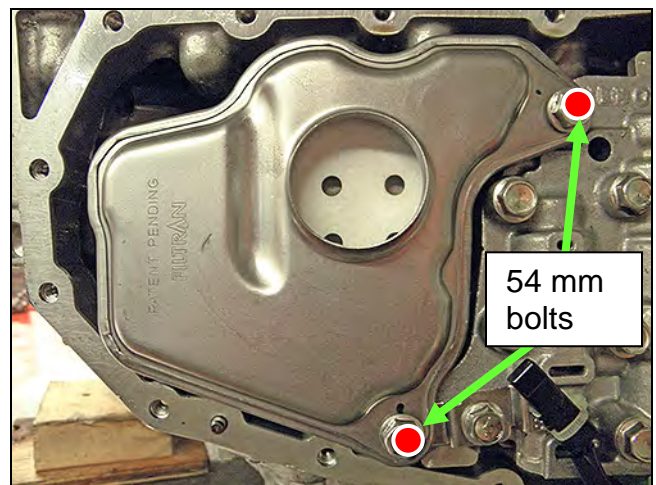
Figure 31

7. Install the new oil strainer with its new O-ring seal with two (2) bolts (Figure 31).

NOTE: replacement strainer maybe a different shape.

- Bolt torque: 8.0 N•m (0.81 kg-m, **70.8 in-lb.**)
- 54 mm long bolt

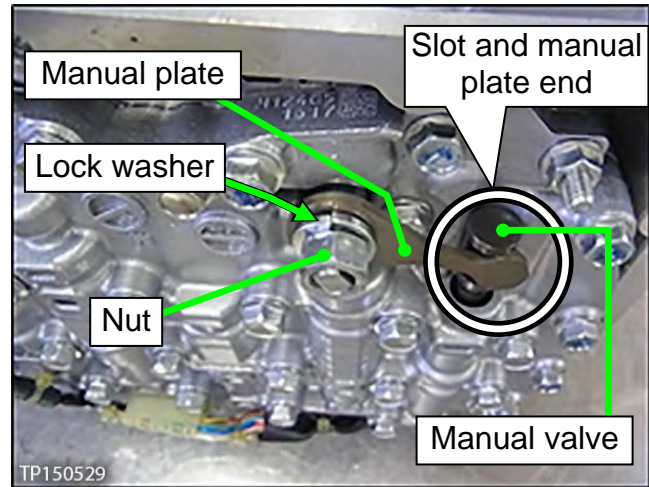
Figure 32

8. Install the manual plate, lock washer, and nut (Figure 32).

NOTE: Make sure the manual plate fits into the slot of the manual valve before applying torque to the nut.

- Reuse the existing manual plate, lock washer, and nut.
- Nut torque: 22.5 N•m (2.29 Kg-m, **16.6 ft-lb.**)

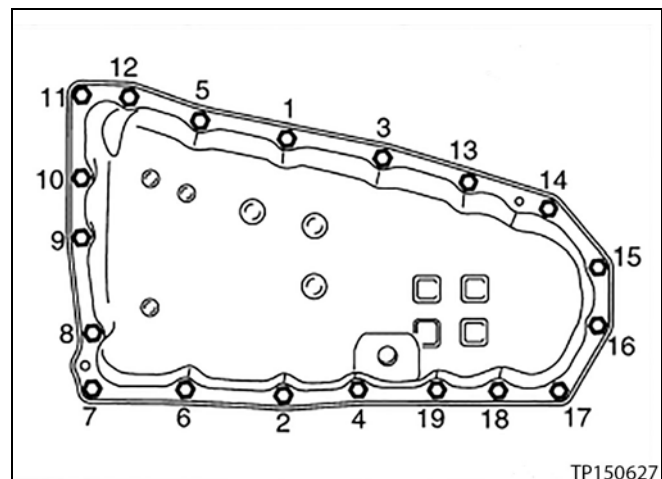
Figure 33

12. Install the oil pan bolts (see Figure 33).

- Reuse the existing pan bolts.
- Oil pan bolts torque: 8.0 N•m, (0.81 Kg-m, **70.8 in-lb.**)

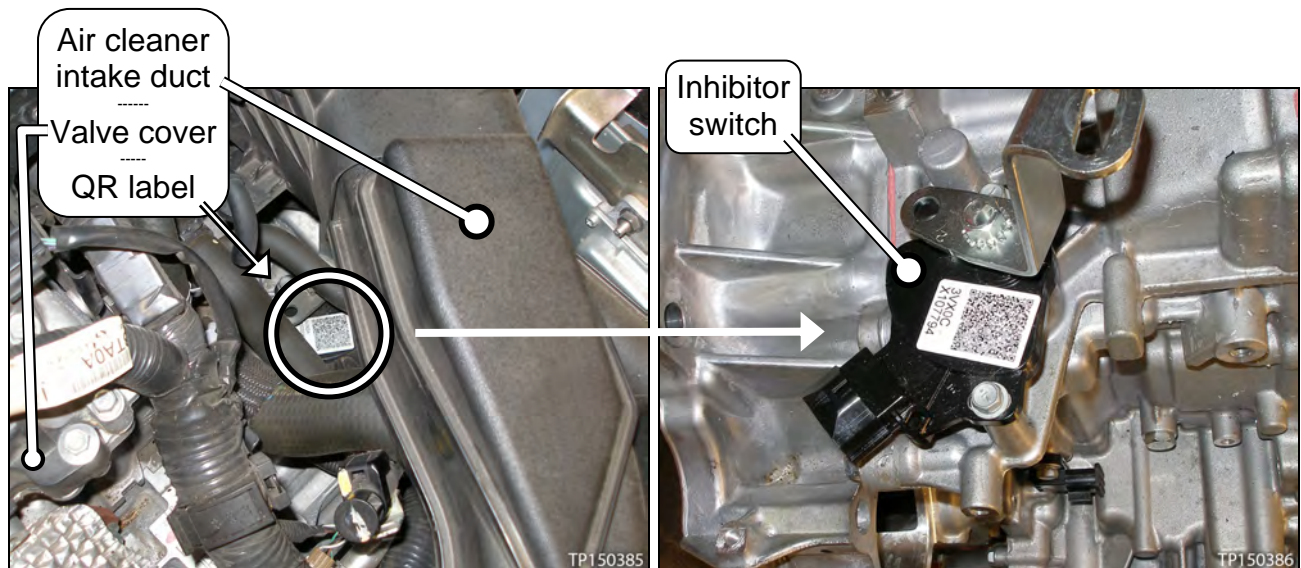
- Refer to **TM – Transaxle & Transmission / RE0F10D / BASIC INSPECTION**, and perform **ADDITIONAL SERVICE WHEN REPLACING CONTROL VALVE**.
 - Check for fluid leakage.
 - Attach the QR label with the new calibration data onto the transmission range switch (inhibitor switch).
 - See Figure 34 and 35 below.
 - A QR Label and CD-R are included with the replacement valve body.
