SERVICE BULLETIN

Classification: AT15-015g	Reference: NTB15-086g	Date: April 18, 2017
------------------------------	--------------------------	-------------------------

2013-2014 ALTIMA AND 2014-2016 ROGUE; MIL ON WITH DTC P0776, P1715 MAY HAVE HESITATION AND/OR LACK OF POWER

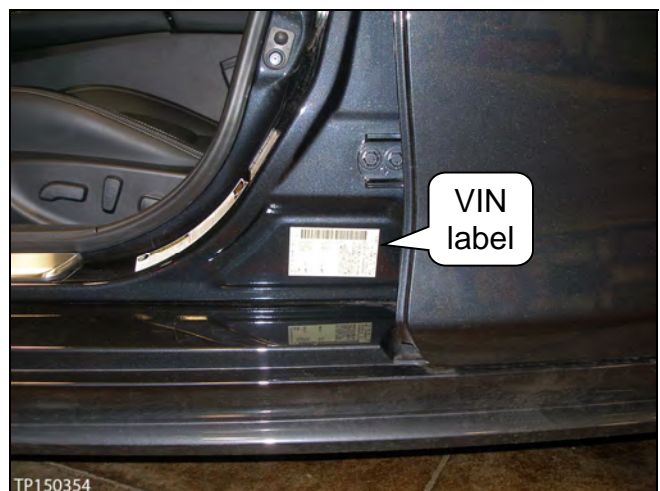
Figure 7

- e. Once CVT replacement is determined as required, use borescope J-51951 to record a 15 second or less continuous video of the most severe evidence of belt slip and the VIN on the F.M.V.S.S. certification label (VIN label). See Figure 7.

- Before starting to record, make sure the camera handle's AA batteries are fresh and the LCD monitor's battery is charged.
 - The whole video will show as backward, or reversed mirror image. This is okay.
 - The required video must show clear evidence of belt slippage and be 15 seconds or less.
5. If the belt inspection result is OK, replace the valve body.
 - There is no need for pictures or video showing "OK" belt surfaces.
 - For valve body replacement, go to page 12, **Control Valve (Valve Body) Installation**.
 6. If the belt inspection result is NG, replace the CVT assembly.
 - Get authorization to replace the CVT assembly (see page 28).
 - Make sure to perform step 4e on page 6.
 - For CVT assembly replacement, refer to the appropriate ESM, section **TM – Transaxle & Transmission / RE0F10D**.

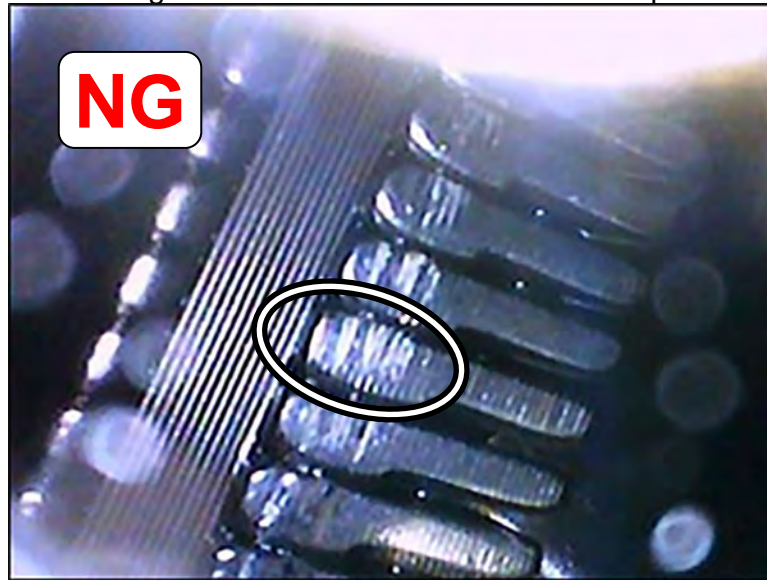
Pictures in Figures 15-17 were taken with borescope J-51951.

Figure 15: Example of NG belt

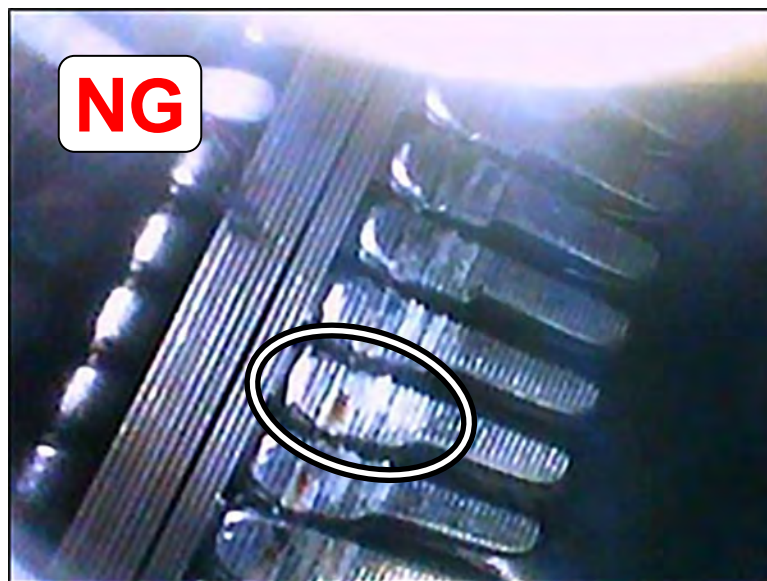
Figure 17: Example of NG belt

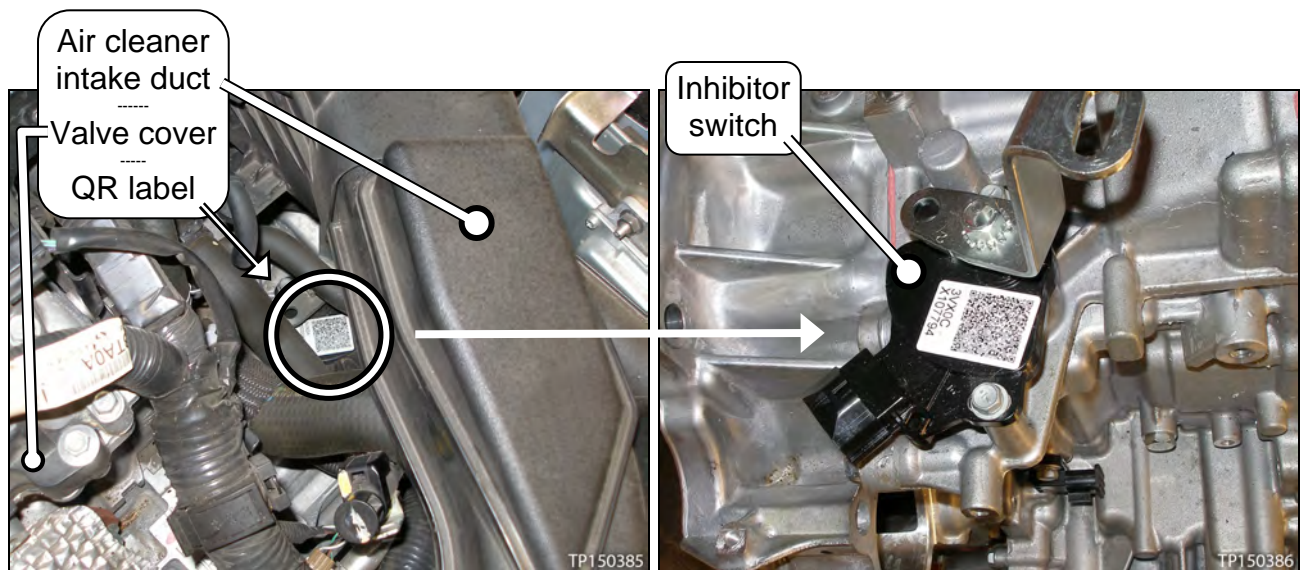
Figure 13A

- Refer to **TM – Transaxle & Transmission / BASIC INSPECTION**, and perform **ADDITIONAL SERVICE WHEN REPLACING CONTROL VALVE**.
 - Check for fluid leaks.
 - Attach the QR label with the new calibration data onto the transmission range switch (inhibitor switch).
 - See Figures 13A and 14A below.
 - A QR Label and CD-R are included with the replacement valve body.
