SERVICE BULLETIN

Classification: EL17-003a	Reference: NTB17-015a	Date: April 19, 2017
------------------------------	--------------------------	-------------------------

CUSTOMER SATISFACTION INITIATIVE 2G TELEMATICS HARDWARE REPLACEMENT

APPLIED VEHICLE: 2011-2015 LEAF (ZE0) **With navigation only**

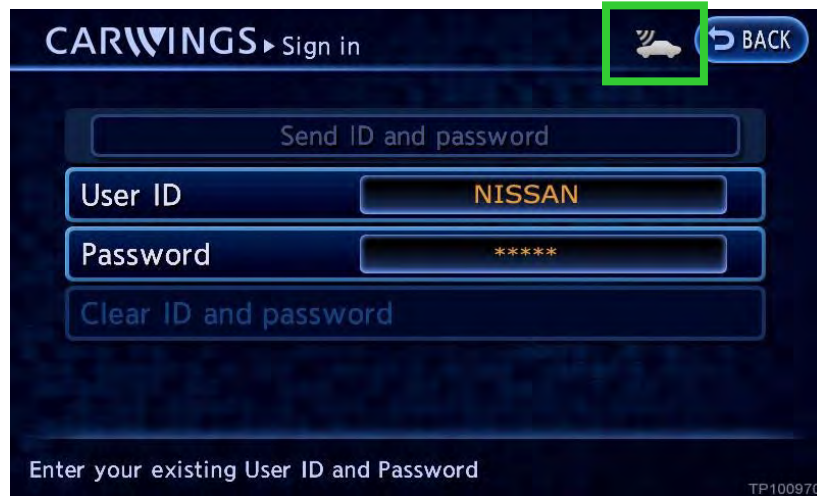
Figure 22

IMPORTANT Leave the vehicle ignition ON until the Telematics icon turns white and is not crossed out as shown in Figure 22.

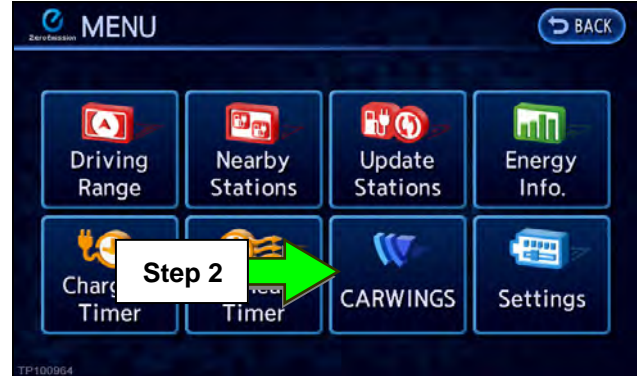
Figure 27

2. Select **CARWINGS**) and then **CARWINGS Settings**.
