GROUP BOD	MODEL 2015~2016MY Sedona (YP)
	NUMBER 116 (Rev 1, 3/24/2017)	DATE November 2015
TECHNICAL SERVICE BULLETIN		
SUBJECT: SERVICE ACTION: POWER SLIDING DOOR (PSD) INSPECTION AND/OR REPAIR (SA 210)

This bulletin provides the procedure to inspect and/or repair the power sliding doors (PSD) of some 2015~2016MY Sedona (YP) vehicles, produced from January 6, 2015 through July 6, 2015, which may exhibit an inoperative power sliding door(s). To correct and/or prevent this condition, Kia is requesting the completion of this Service Action on all affected vehicles, including dealer stock, prior to delivery. Before conducting the procedure, verify the vehicle is included in the list of affected VINs.

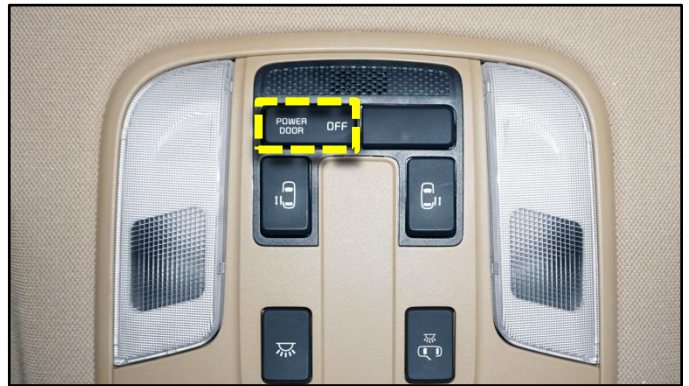
1. Press the Power Sliding Door (PSD) button to turn the PSD system OFF.

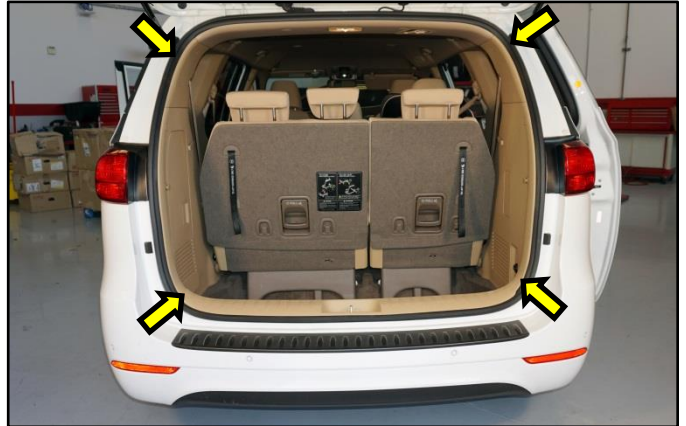
1. Open the tailgate and remove the weather strip from the trunk compartment opening.

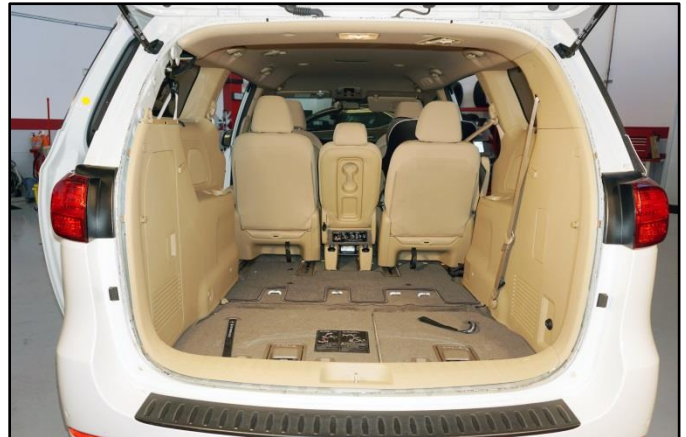
2. Fold and stow the third row seats, as shown.

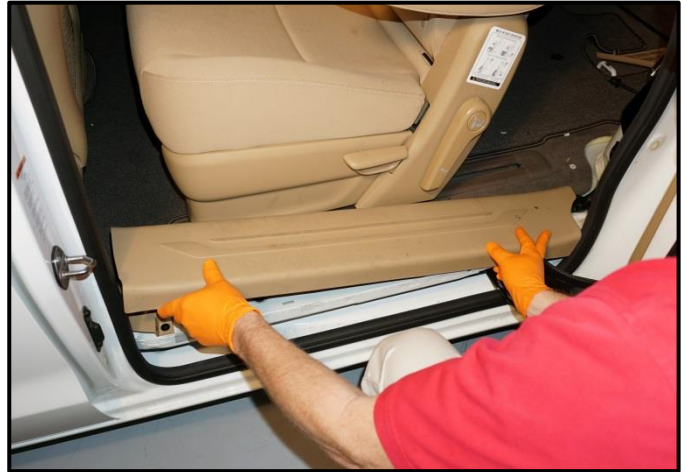
4. Remove the sliding door threshold trim piece, as shown. **NOTE: replace any broken clip(s) with new ones.**

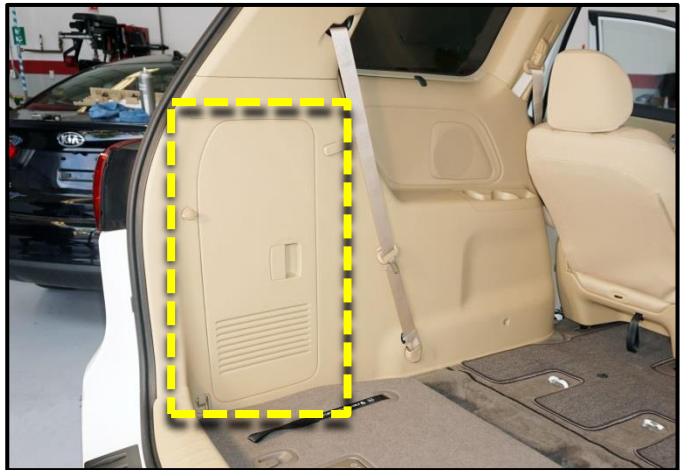
5. Remove the scissor jack storage compartment access door.

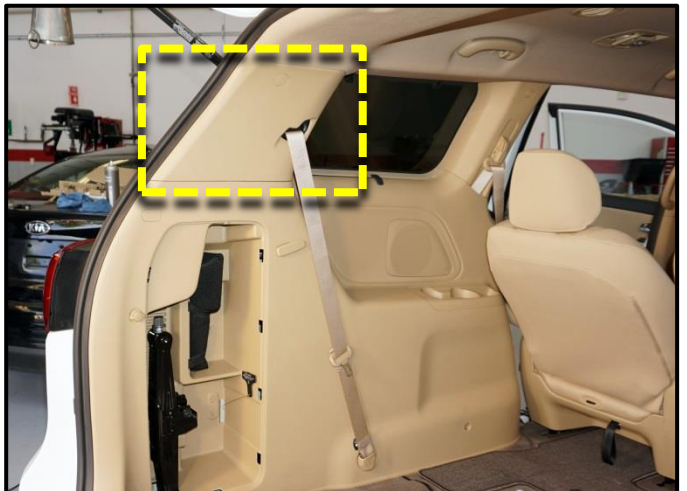
6. Remove the upper seat belt trim panel. **NOTE: replace any broken clip(s) with new ones.**

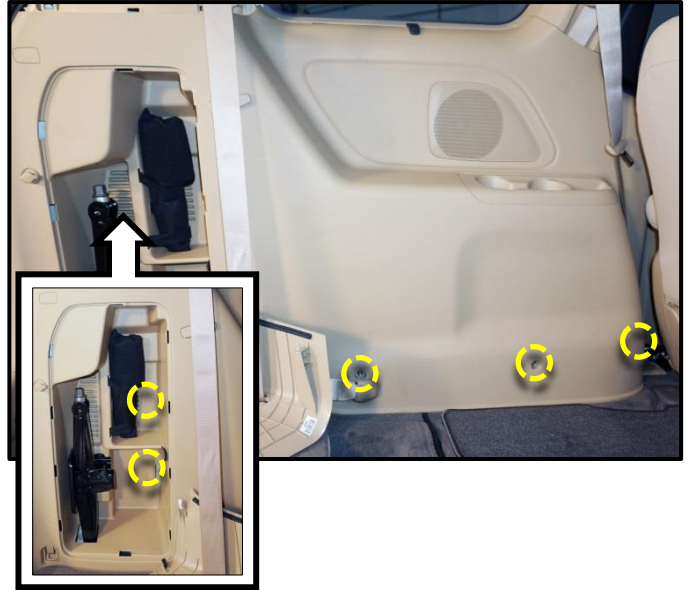
7. Remove multiple bolts from the side trim panel, as shown, prior to removing the panel. **Note: replace any broken clip(s) with new clips.**

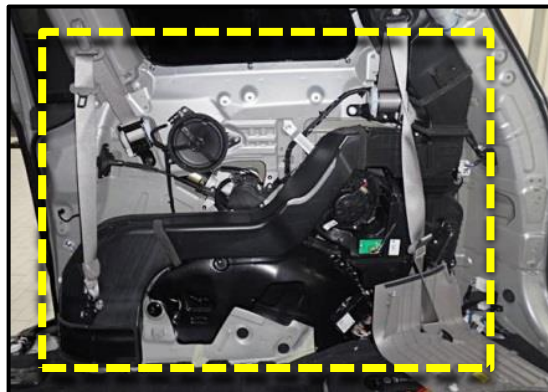
On the right hand side of the vehicle, remove the heater ducting to access the PSD motor.

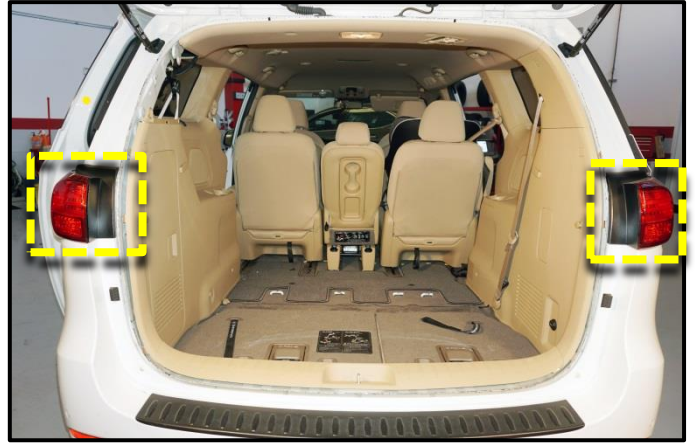
1. Open the tailgate and remove the LH/RH rear combination tail lamps.

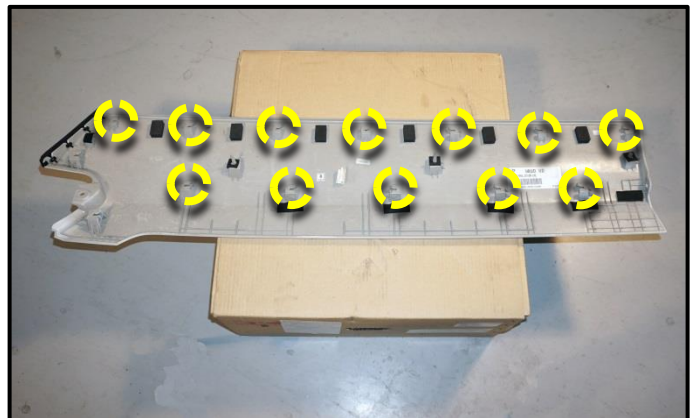
11. Install the replacement clips onto the LH and RH PSD exterior trim panels.
