GROUP <b>BOD</b>	MODEL <b>2016MY Sorento (UMa)</b>
	NUMBER <b>166</b>	DATE <b>April 2017</b>
<b>TECHNICAL SERVICE BULLETIN</b>		
<b>SUBJECT: SERVICE ACTION: FRONT DOOR OUTSIDE HANDLE REPLACEMENT (SA283)</b>

This bulletin provides the procedure to replace the left and right front outside door handle assemblies on some 2016MY Sorento (UMa) vehicles, produced from November 17, 2014 to January 25, 2016, which may experience a high effort / sticking feeling to open the front doors. Follow the procedure outlined in this bulletin to replace both front outside door handle assemblies. Before conducting the procedure, verify that the vehicle is included in the list of affected VINs.

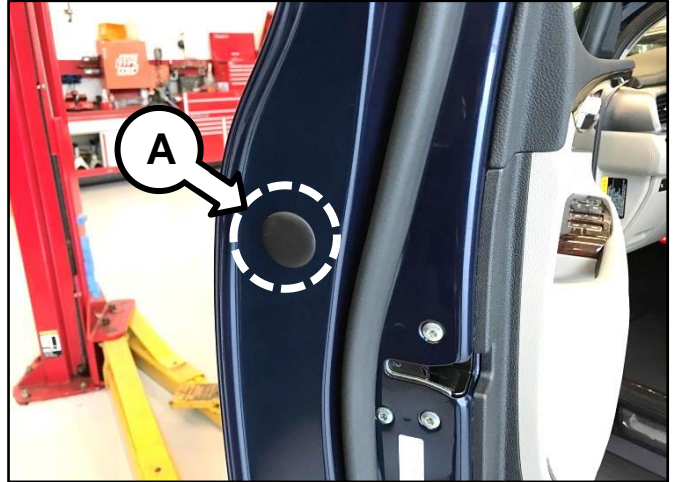
1. Using a non-marring trim removal tool, remove the door handle mounting bolt cover (A).

Use a non-marring trim removal tool (such as Snap-on® Part Number PBN5 or equivalent) to avoid damaging trim pieces.

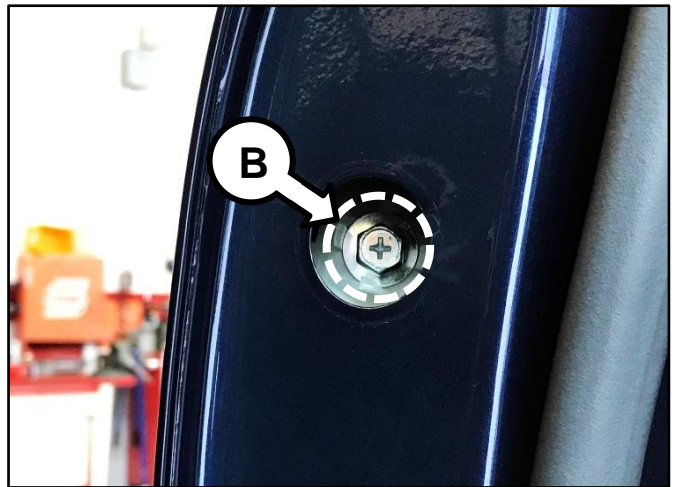
2. Loosen the mounting bolt (B).

34.8 – 51.6 lb.in (3.4 – 5.7 Nm, 0.4 – 0.6 kgf.m)

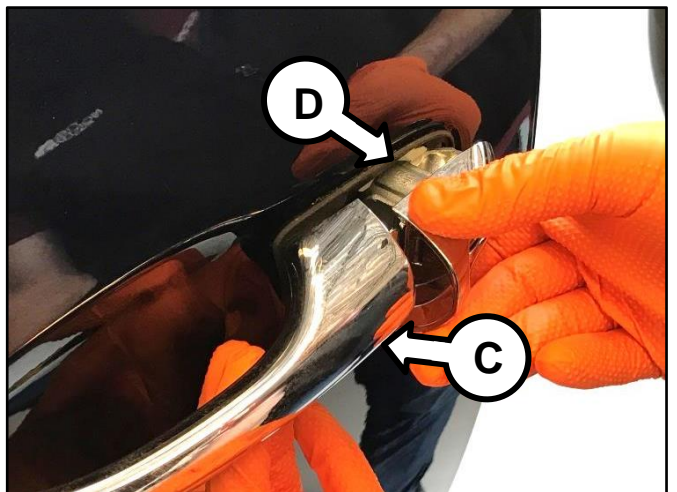
3. Slightly pull the door outside handle (C) and remove the door outside handle cap (D).

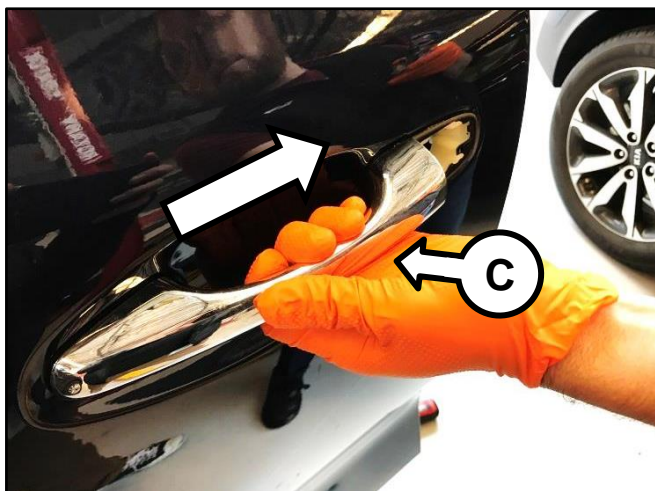
- Slide the door outside handle (C) towards the rear of the vehicle.

Use caution not to damage the door paint when removing the door outside handle.

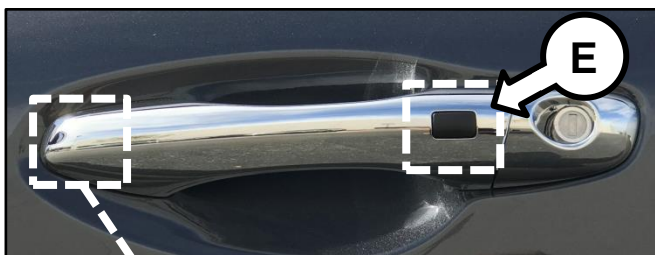
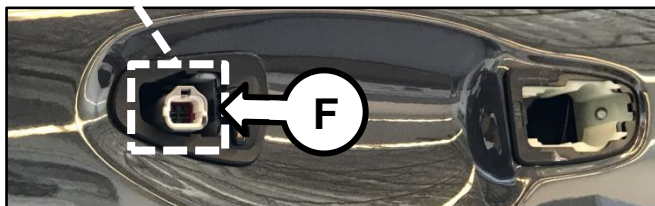
- If equipped with Push Button Start (E), disconnect the front door outside handle connector (F).

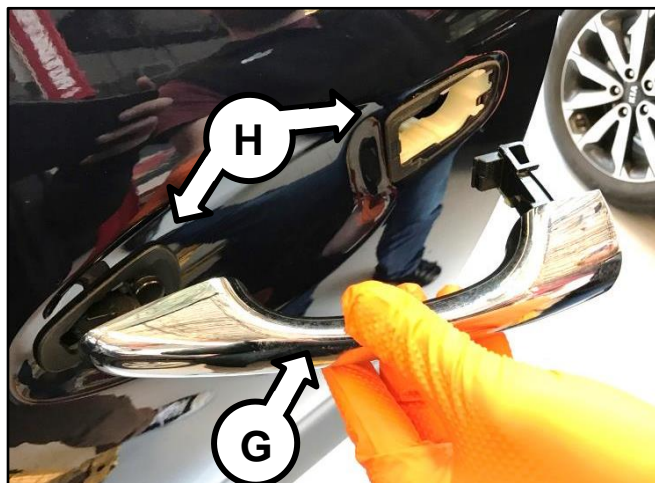
- Connect the front door outside handle connector to the new handle (G) and install the new handle.

Ensure the connector is completely inserted and locked. When installing the new handle, ensure the handle seals (H) are seated properly.
