GROUP BOD	MODEL 2014-2015MY Optima (QF) Sorento (XMa)
	NUMBER 167	DATE April 2017
TECHNICAL SERVICE BULLETIN		
SUBJECT: EXTERIOR EMBLEM REPLACEMENT

EXTERIOR EMBLEM REPLACEMENT

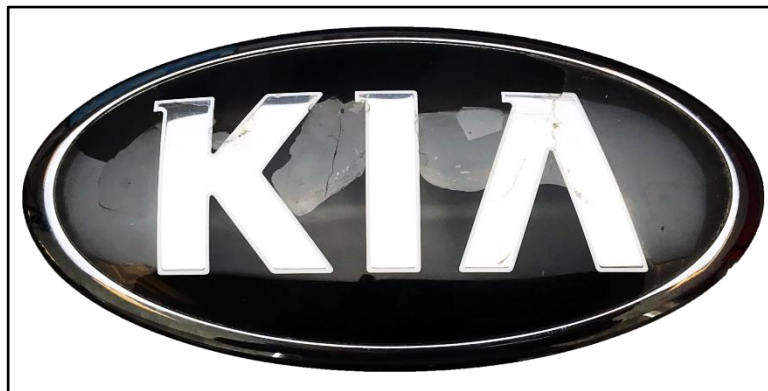
This bulletin provides the procedure to replace the front and rear Kia emblems on some 2014-2015MY Optima (QF) and replace the front and if necessary, the rear emblems on some 2014-2015MY Sorento (XMa) vehicles, which may exhibit peeling or delamination of the emblem coating. Follow the procedures outlined in this bulletin to correct the concern of peeling or delaminating emblems.

Delaminated Emblem

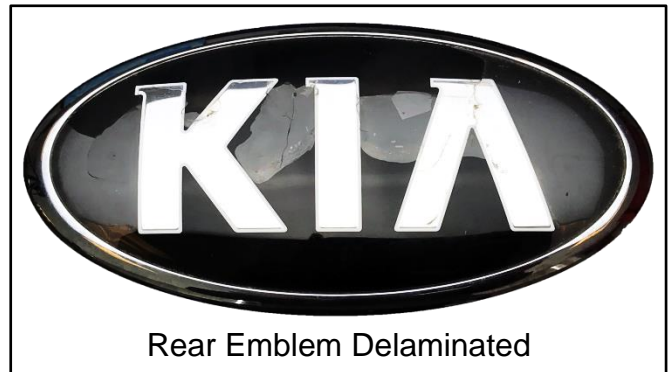
8. Inspect the rear emblem for peeling or delamination.

Rear Emblem Delaminated

If peeling or delamination IS evident, proceed to the next step.

If peeling or delamination is NOT evident, no further action is required.
