Service Campaign 67-05

AFFECTED: 2017 Winnebago View and Itasca Navion 524G

SUBJECT: Water Heater Bypass Valve Installation

Water Heater Bypass Valve Installation

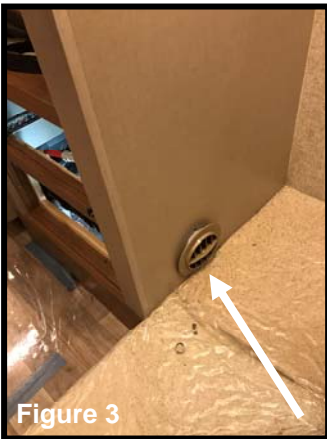
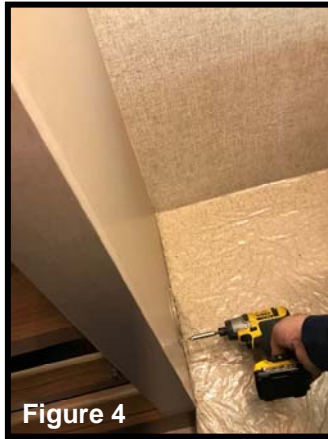
2. Remove register from wardrobe (Figures 3 & 4). Shift duct to allow access to water heater bypass valve (Figures 5 & 6). **Figure 7 is an illustrated drawing indicating the valve that needs to be reinstalled.**

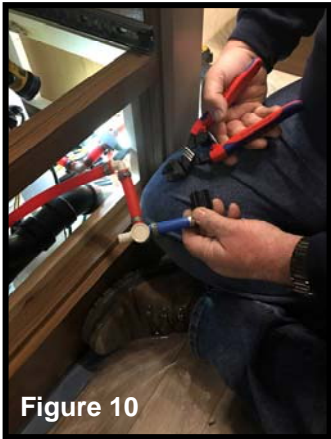
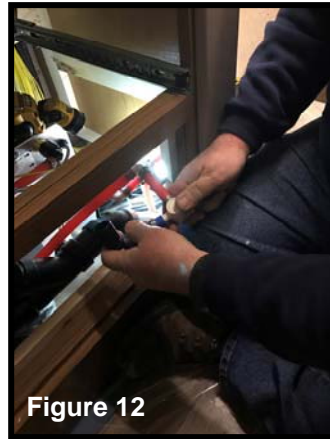
4. Pull line out of wardrobe for better access and rotate valve 180°, handle will now face passenger sidewall when reinstalled (Figure 10). Snip remaining hose clamp on bypass valve (Figure 11). Remove line and insert line onto opposite side of bypass valve (Figure 12). Secure with new clamp (Figure 13).
