**Subject:** ISV5.0 Fan Hub ATC for Tiffin Allegro RV

**Number:** Atc1885

## FAN, CLUTCH & ADAPTER ASSEMBLY FOR CUMMINS ISV

WI-315

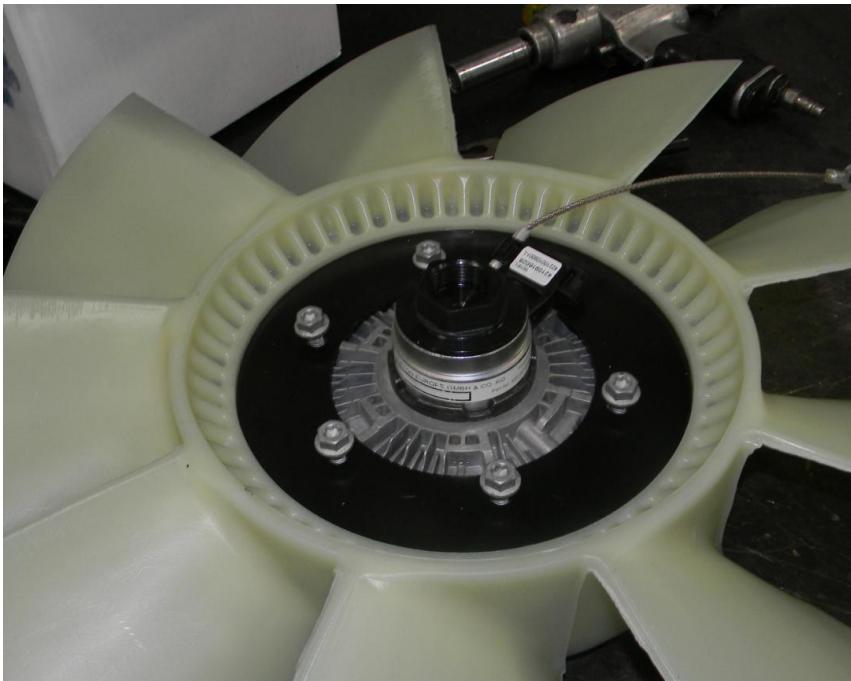
1. Remove factory screws from rear of Horton Clutch.
2. Place fan onto rear of clutch with flow of fan toward the front of the clutch.
3. Align Fan bolt holes with bolt holes in clutch & reinstall factory screws.

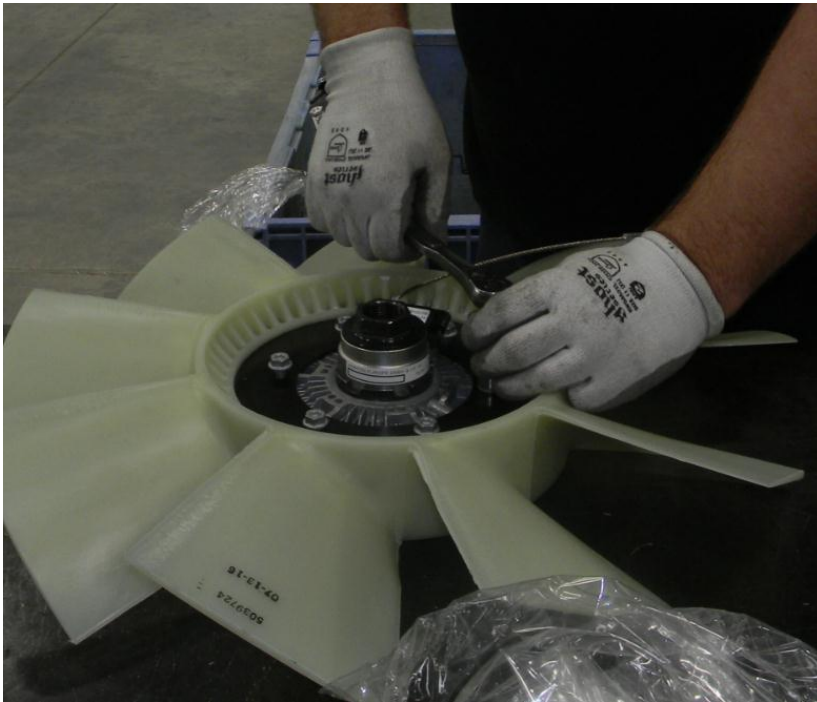
4. Run factory screws up using a  $\frac{1}{4}$ " drive hand ratchet and a  $\frac{1}{2}$ " socket.

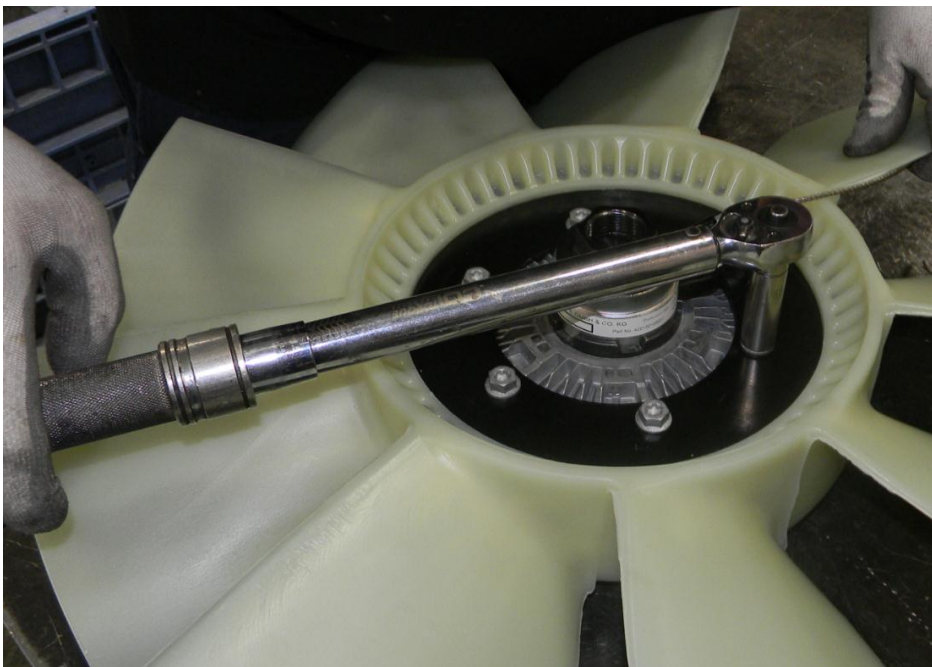
5. Torque screws to 21 Nm.

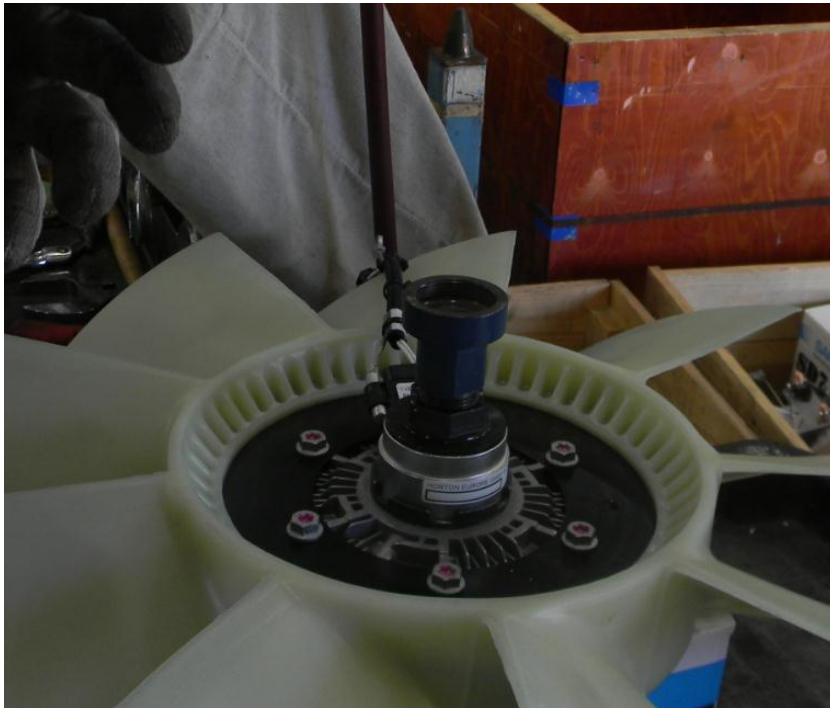
6. Install Adapter to Fan/Clutch Assembly and hand tighten.

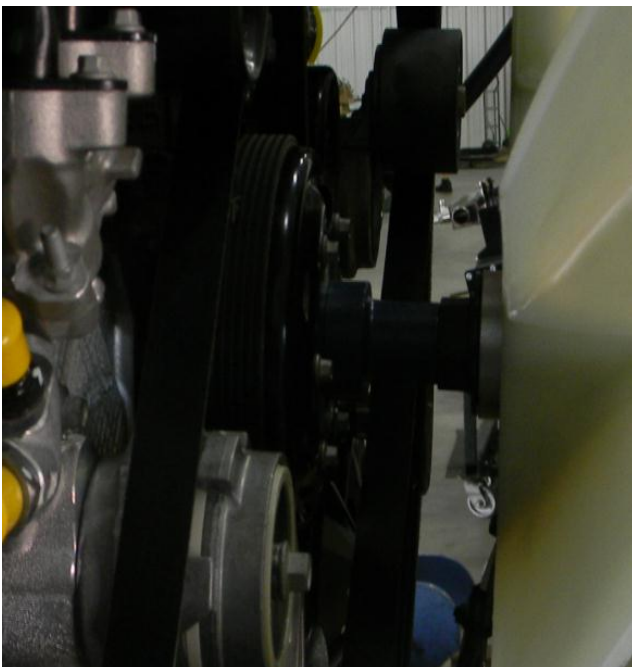
7. Start Adapter onto Engine Shaft by turning in a Clockwise direction when facing the engine.

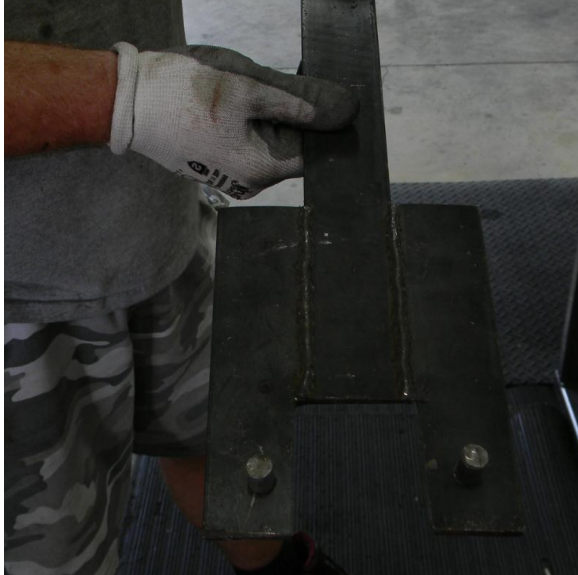
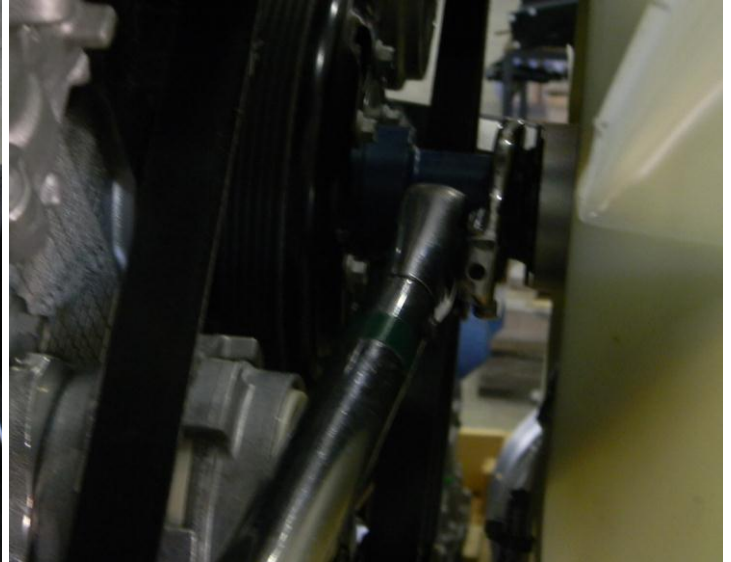
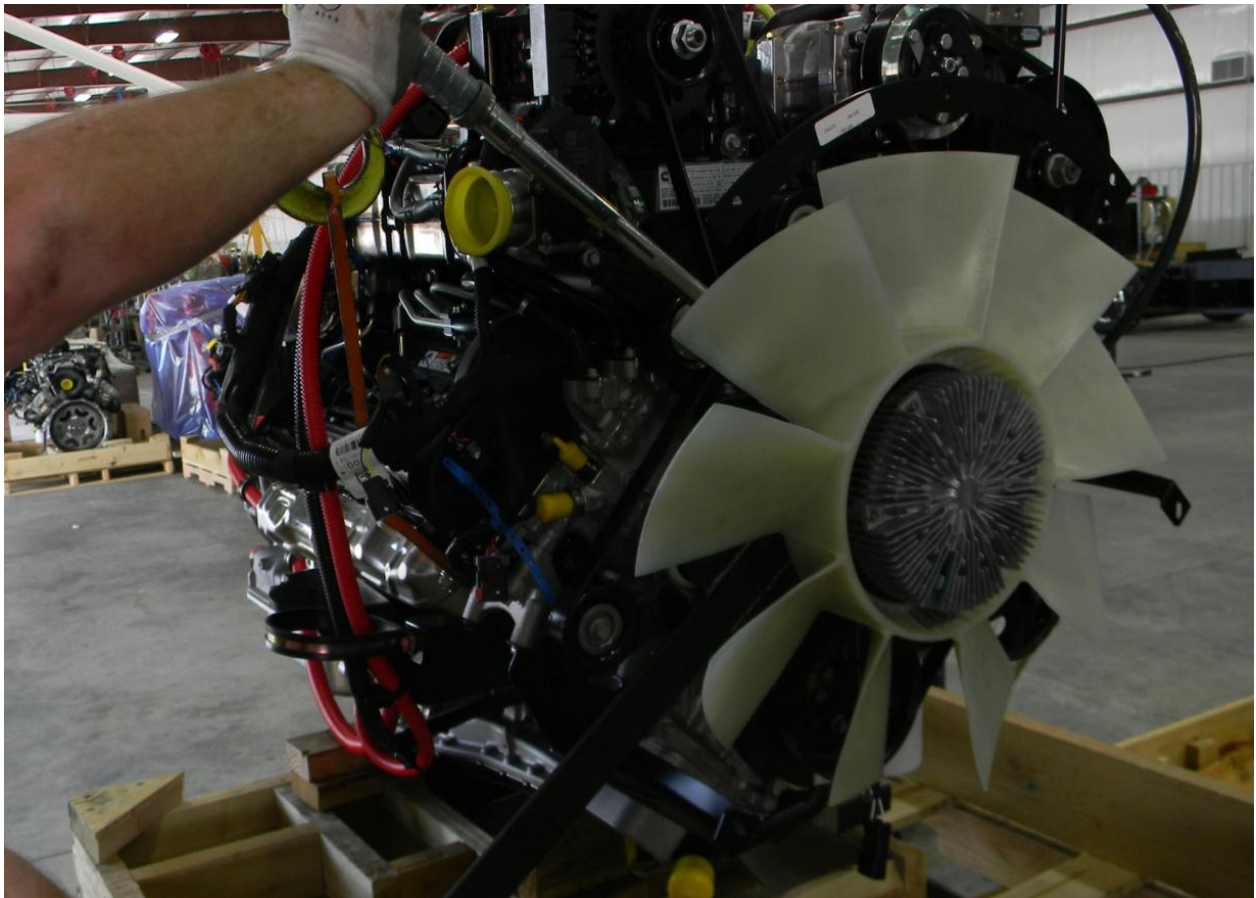
8. While using the Fan Pulley Wrench to hold the fan Pulley and a Torque Wrench on the Clutch nut, Torque the Assembly to 100 ft-lbs..

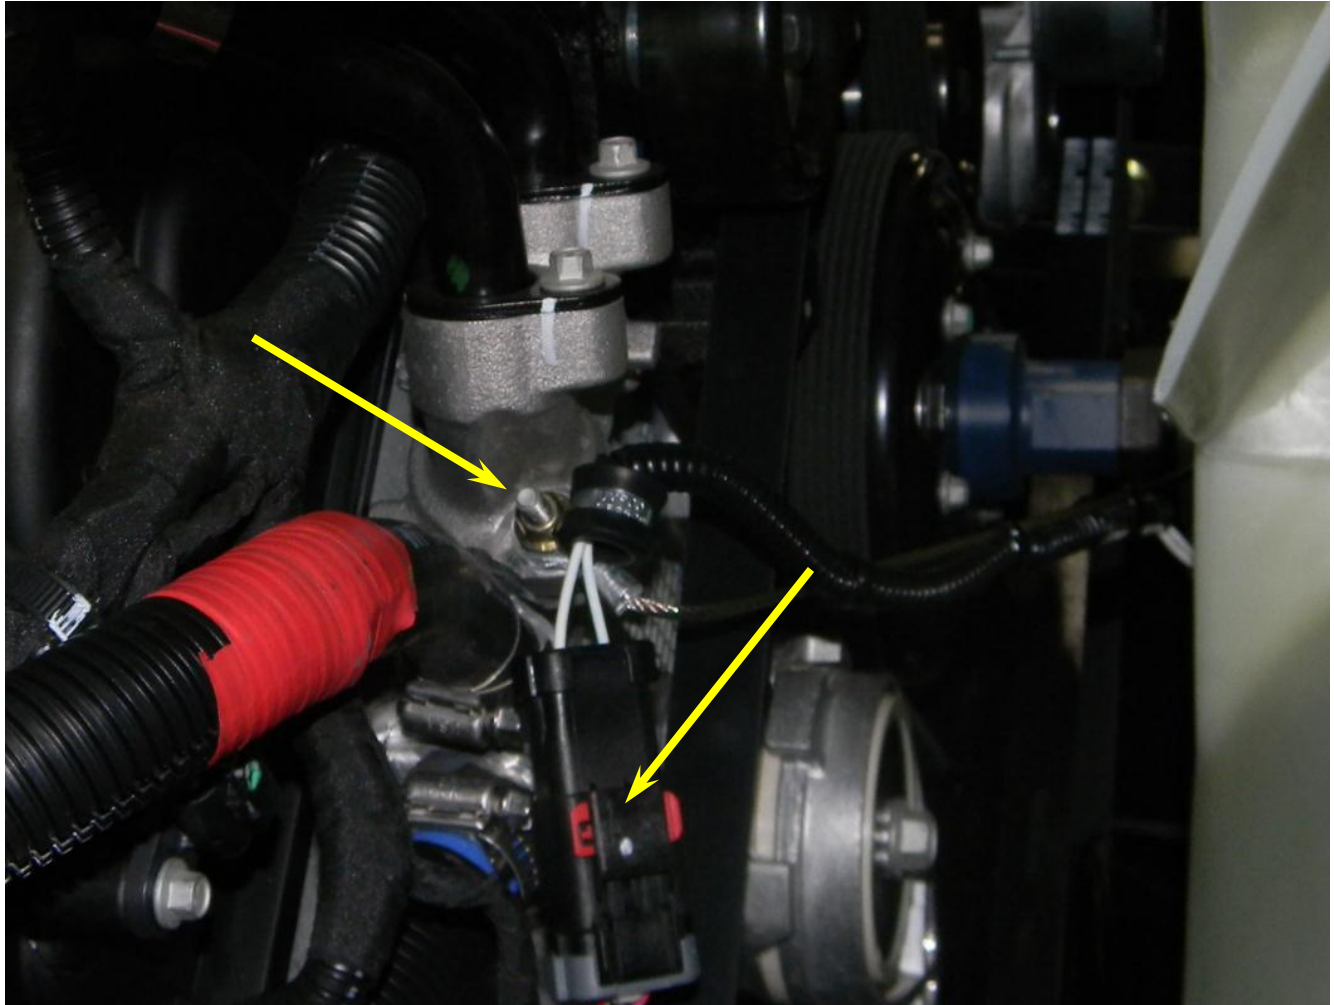
9. After torquing the clutch nut, attach the clutch retaining cable and the clutch wiring harness clamp to the stud provided on the engine block on the driver side just above the drive belt. Torque the nut to 8 ft.-lbs.
10. Plug the clutch harness into the mating engine harness plug located at the retaining strap stud on the engine.
