# TECHNICAL SERVICE BULLETIN

Technical Service Bulletin: 67-02082017-0323

# Inspection and Repair of Suburban SF-30 Furnace Air Intake Tube

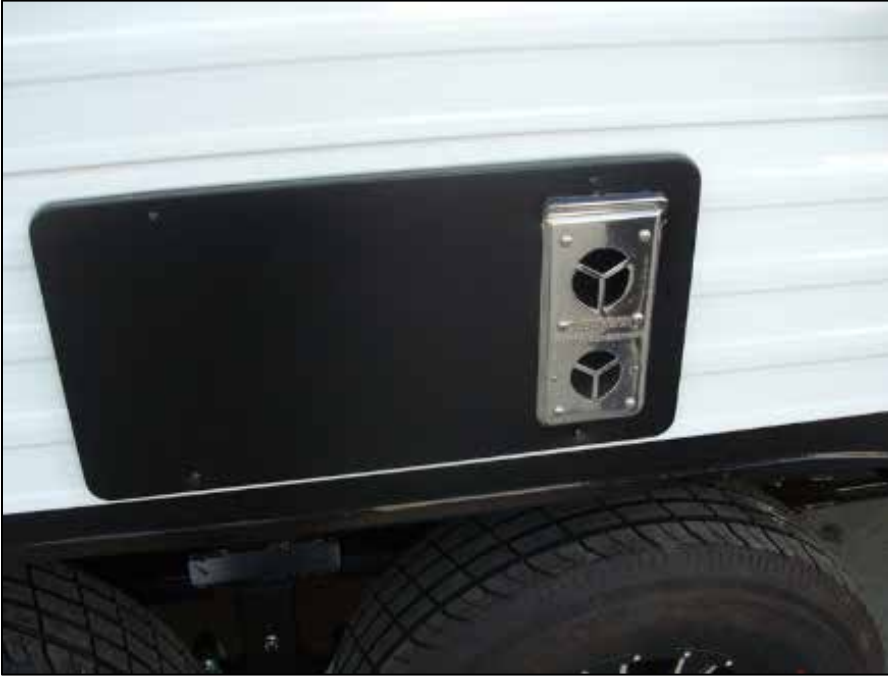
Illustration - 1

- Locate the exterior furnace vent/access door on the side wall of the subject travel trailer. (See *Illustration No# 1*)
- Use a tape measure to measure inside Intake Vent Tube – (Top Vent).
  - o Notice that the outer tube overlaps the inner tube. The measure point is the inner tube joints to the outside vent housing.
- This measurement will need to be 2" or less. (See *Illustration No# 2*)
- If the measurement is greater than 2" proceed to Repair Instructions below.
