INSTRUCTION TO SERVICE

ITS: 6522	
SECTION:	410 Tapping Plates
WRITTEN BY:	Jeff Kosheluk
SUBJECT:	Part A: Inspect support brackets on air accessory tank. Part B: Add support brackets by the existing mounting bracket on the air accessory tank (CS forward tank only). This is only completed when support brackets are broken.

ITS6522

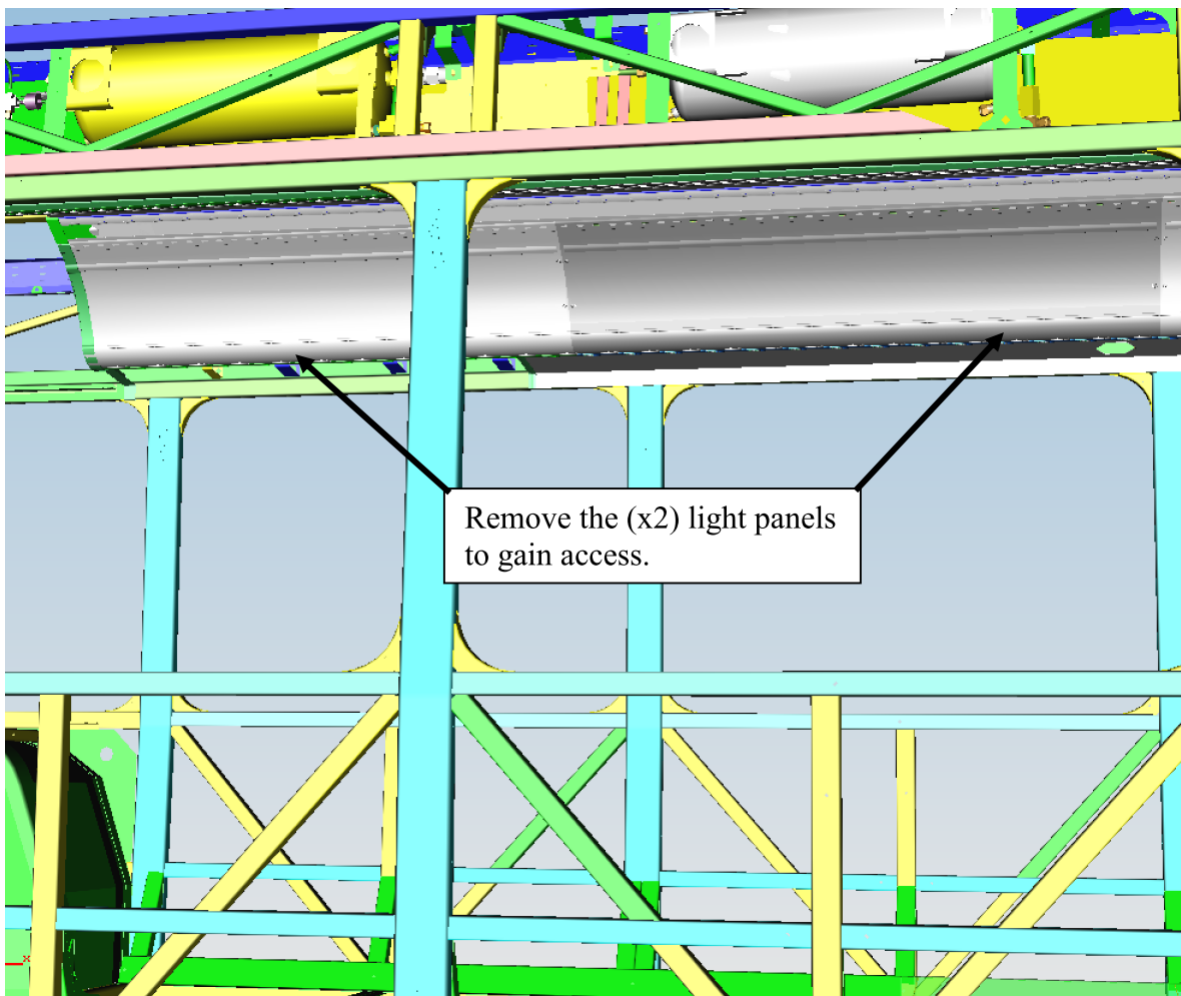
FIGURE 1: SHOWN LOCATION ON CURBSIDE TO REMOVE

1. Turn the main battery disconnect switch to the “OFF” position.
2. On the interior of the bus, locate the first 2 light banks on the curbside front of the bus, directly behind the curbside luggage rack. Remove the first (x2) light banks to gain access to the air accessory tank. **Note:** If the light panel has hardware on the bottom side, remove and set aside to re-install later. **Refer to Figure 1.**
3. Disconnect the electrical on light panel before removal. Set aside panels to avoid damage and re-install later.

4. LIGHT PANELS (X2)

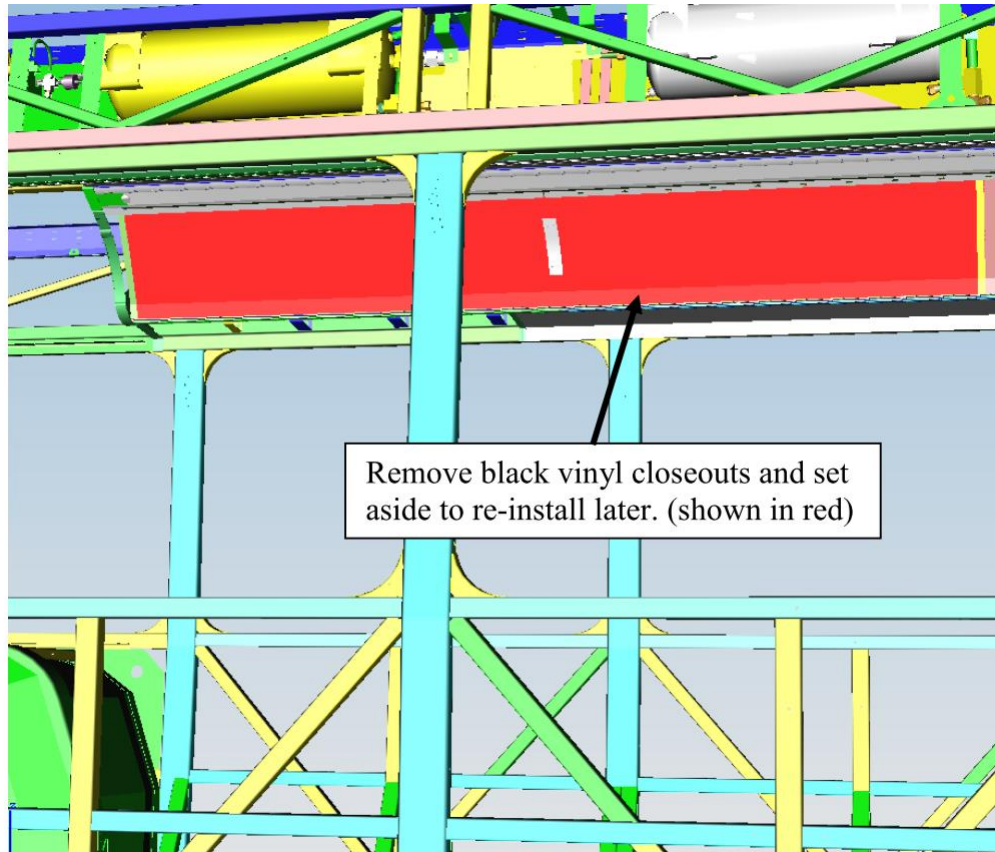
FIGURE 2: REMOVE BLACK VINYL CLOSEOUTS TO GAIN ACCESS

4. Remove the black vinyl closeouts to gain access to the air accessory tank. Set aside to re-install later. **Refer to Figure 2.**

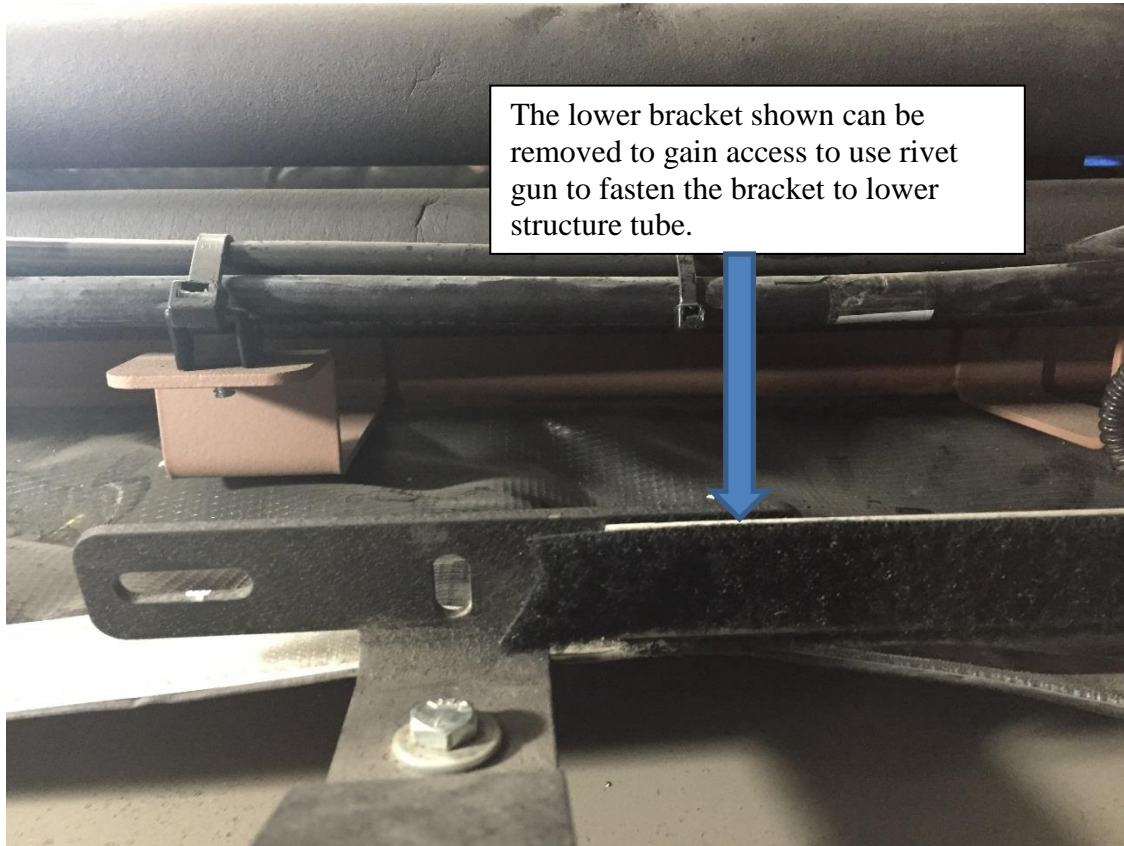
7. Drain the air on all the tanks, locate the drains on the outside of the bus (refer to Service Manual for locations). Open the valve, once all the air is out, close the valve.
8. Label the airlines so that the airlines get connected into the correct valves on the air tank when re-connecting. Disconnect the airlines.
9. Loosen off the mounting hardware on the accessory air tank, carefully remove the air tank and set off to the side.
10. Start with the forward most bracket at the air accessory tank. For steps 12 - 18, refer to **Figure 3 & 4**.
11. Remove the lower bracket that secures Velcro in place above the speaker panel. This allows to gain access when applying the bottom rivets for the new brackets.

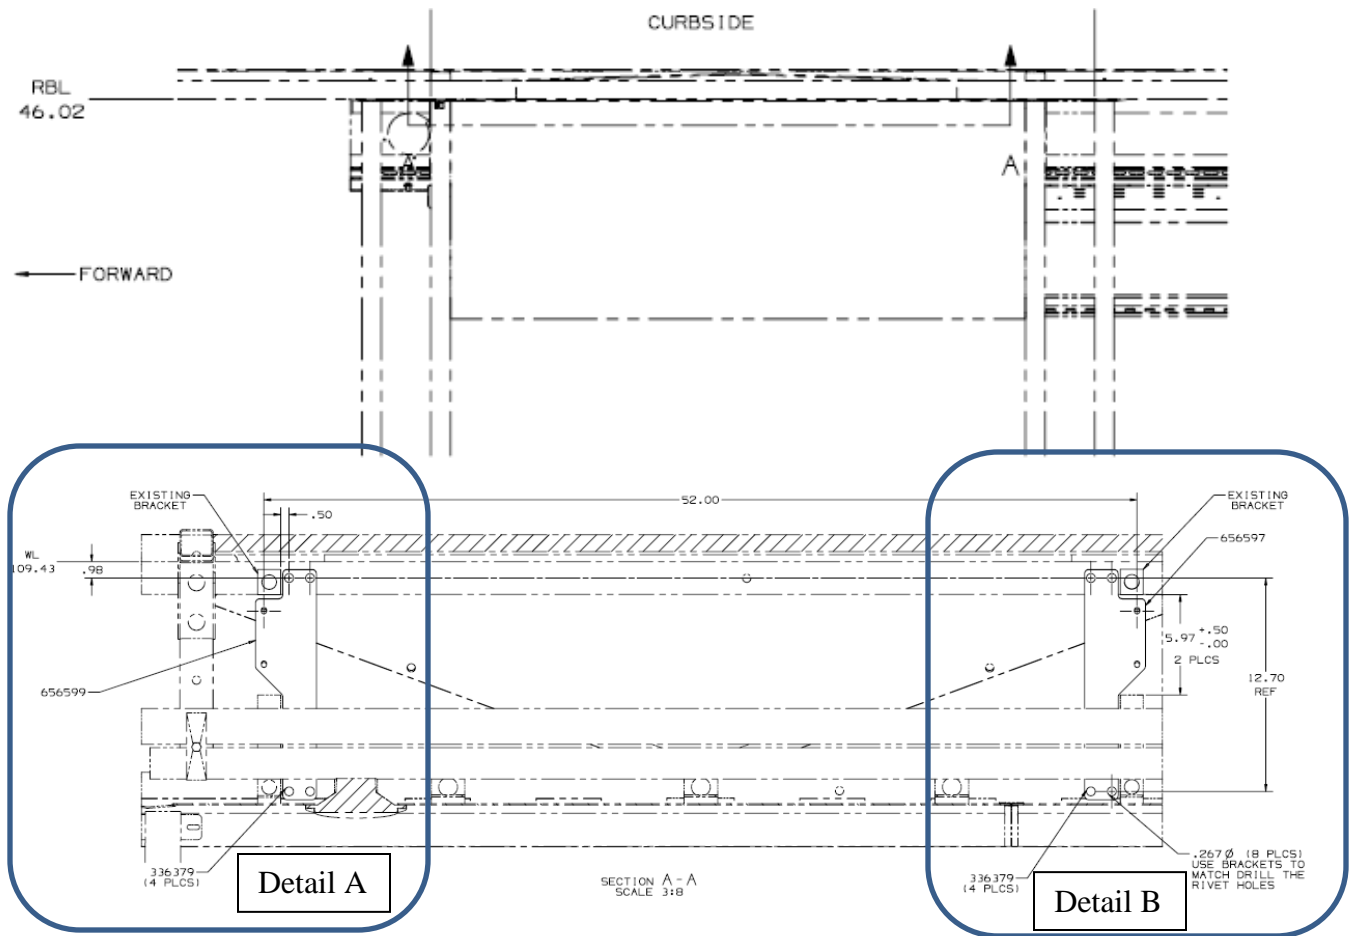
FIGURE 3: SHOWN VIEW TO CUT OFF SECTION OF THE ORIGINAL BRACKET TO INSTALL NEW BRACKET. DETAIL A & B WILL PROVIDE MORE DETAILS.

6. Inspect the forward and rearward air tank support mounting plate to see if the support plate is cracked.
YES/NO & cracked/broken (circle). Refer to Figure 3. If no cracks found, proceed to step 20.
Forward Bracket- Cracked or Broken: YES/NO
Rearward Bracket – Cracked or Broken: YES/NO

12. Cut off the section of the original support plate to allow the new support plate (**PN: 656599**) to be installed.
13. Install Assy. – LG Tank SPRT (**PN: 656599**) into the position shown as per the dimensions. Drill the (x4) holes (0.267" diameter) using the holes in the bracket as a template. Install rivets (**PN: 336379**) and crimp in place.
14. Repeat step 12 & 13 to install bracket (**PN: 656597**) at the rear location.

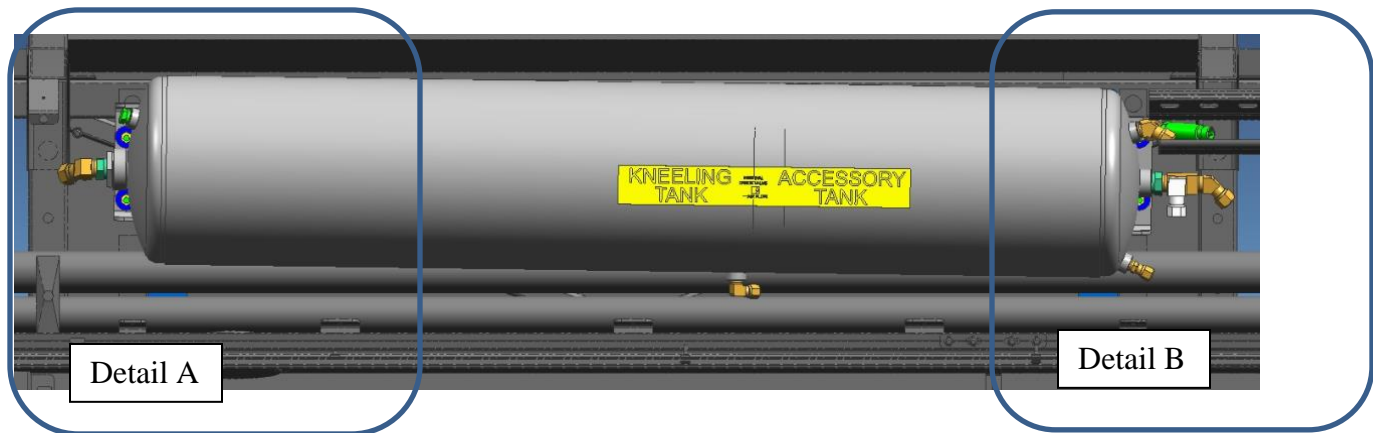
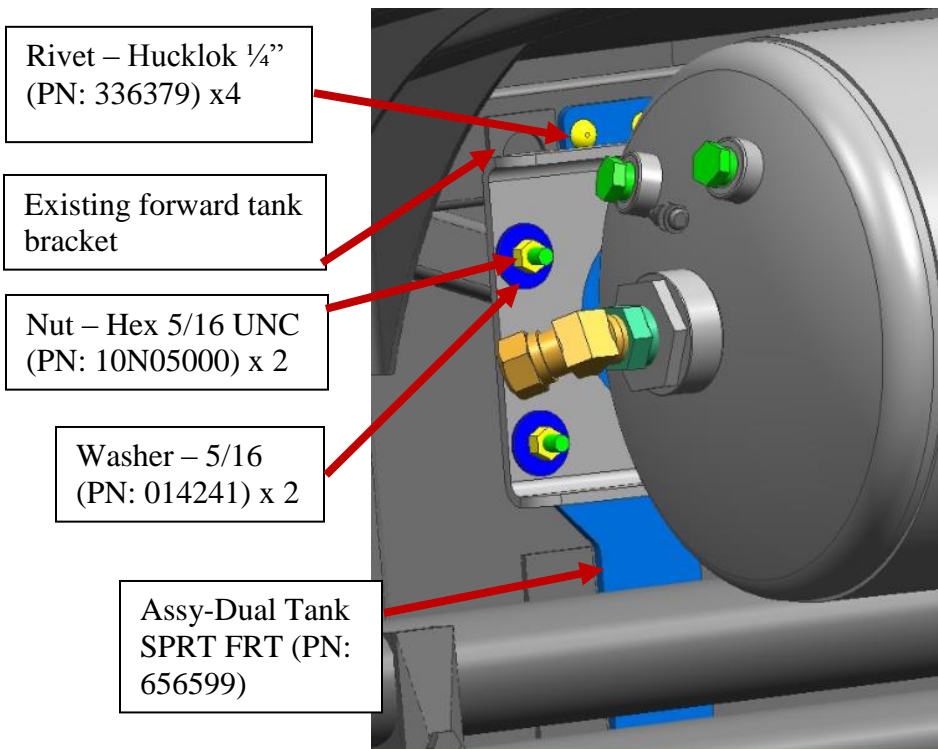
DETAIL A VIEW.

15. Carefully re-install the air tank in place. Apply Loctite 243 (PN: 081034) on the bolt threads first. Loosely install new hex nut (PN: 10N05000) and flat washer (PN: 014241) on both sides.
16. Re-connect the airlines onto the air tank. Tighten fittings in place. Be careful not to pinch or damage the line.
17. Once air tank in place and secured into position, tighten hardware and torque to **10 FT/LBS** at 2 places.
Note: Apply torque strips on all hardware and bracket.
