| DOC # | PROCESS NAME | PAGE | REVISION | STATION | BY | DATE |
|---|---|---|---|---|---|---|
| <b>AR835</b> | <b>Upper Shock Mount Crack Repair</b> | <b>1 OF 2</b> | | <b>SER-V</b> | <b>C.WARD</b> | <b>2/22/2017</b> |

**Complaint:** Cracks at Shock Mount Bracket on Frame

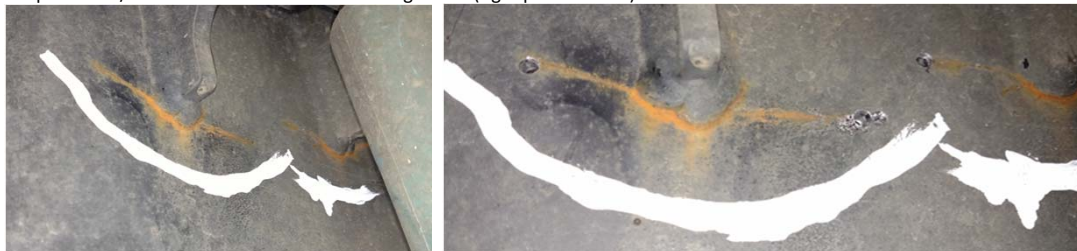
Step 4: Drill 1/8" hole at the ends of the existing cracks (right photo below)

**Correction:** Drill 1/8" Stop Holes into Frame at the end of cracks and weld Fish Plates over the affected cracked areas

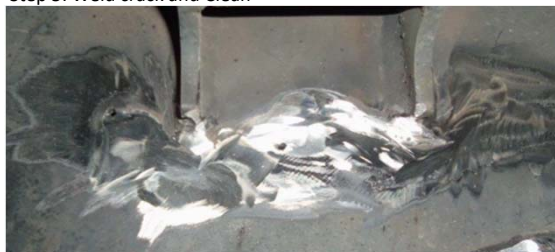
Step 5: Weld crack and Clean

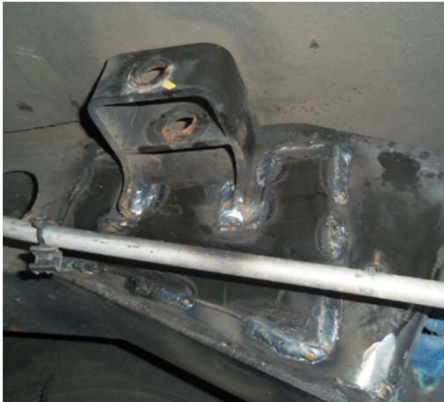
Step 6: Add plate and stitch weld
