<b>HYUNDAI</b>   NEW THINKING. NEW POSSIBILITIES.  <b>Technical Service Bulletin</b>	<b>GROUP</b> <b>HVAC</b>	<b>NUMBER</b> <b>17-HA-001</b>
	<b>DATE</b> <b>MARCH 2017</b>	<b>MODEL(S)</b> <b>SONATA (YF)</b>
<b>SUBJECT: HVAC HEATER BOX SEPARATOR REPLACEMENT PROCEDURE</b>

***This TSB supersedes TSB 16-HA-001 to clarify how to determine the applicable part number.***

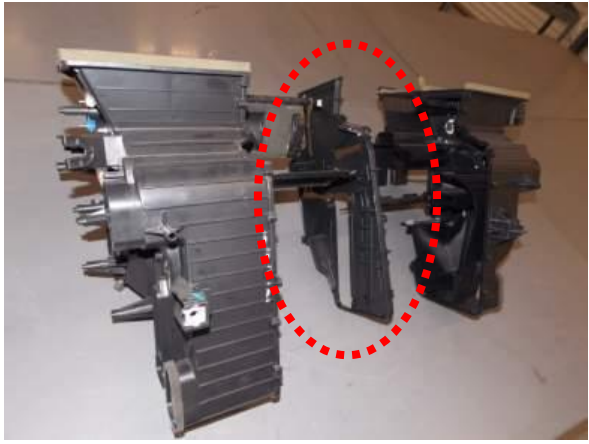
Part Name	Part Number	Note
Heater Box Separator

<b>97203-3S000</b> <b>97206-3S000</b>	Use Full VIN to determine correct replacement part number from the catalog.
Foam Seals

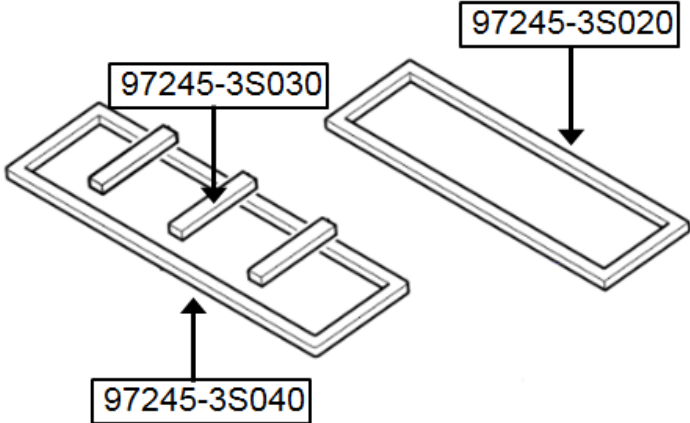
<ul style="list-style-type: none"> <li>Foam seal parts applicable to all model years and HVAC types.</li> <li>Not required to perform this repair.</li> </ul> <p><b>(Only replace if damaged.)</b></p>

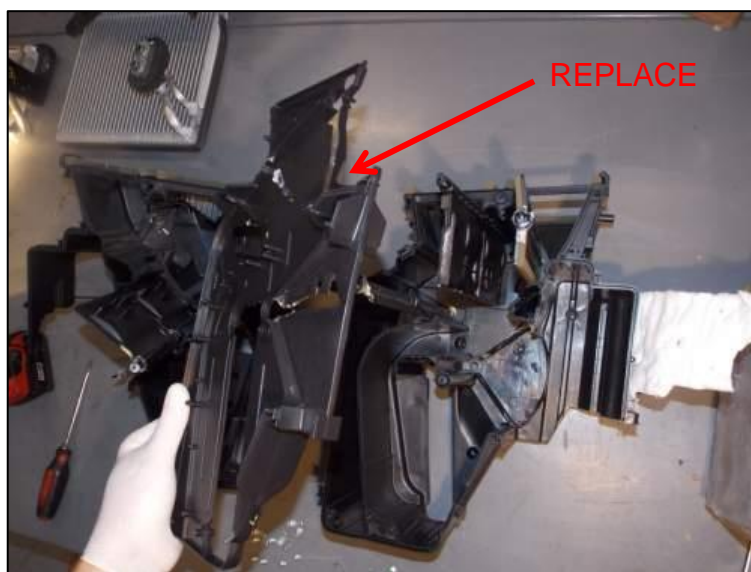
**Description:** Some Sonata (YF) vehicles may develop a condition with the separator plate in the middle of the heater box (Heater & Evaporator Assembly) becoming warped and may cause interference against one or more of the internal flaps that control air flow to the vents.

10. Remove the Heater Box Separator and replace it with a new part.
