Technical Service Bulletin

GROUP CAMPAIGN	NUMBER 17-01-005-1
DATE FEBRUARY 2017	MODEL(S) SANTA FE (CM)

SUBJECT: SANTA FE (CM) UNDERBODY CORROSION PREVENTATIVE SERVICE
(SERVICE CAMPAIGN 947)

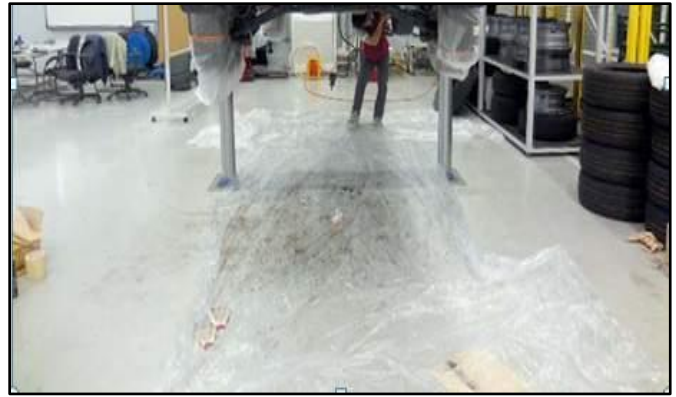
1. When applying the cavity wax, the floor might be contaminated. It is recommended to put a plastic vinyl sheet on the floor before applying wax.

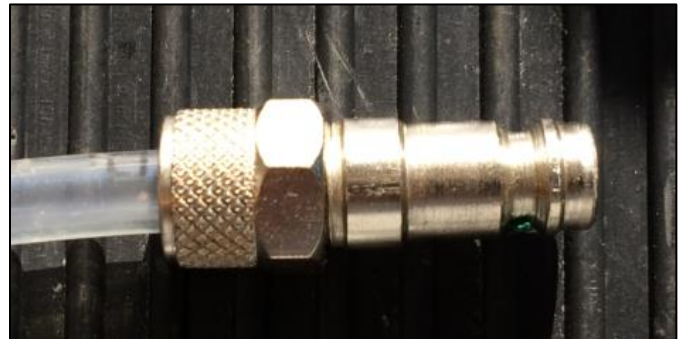
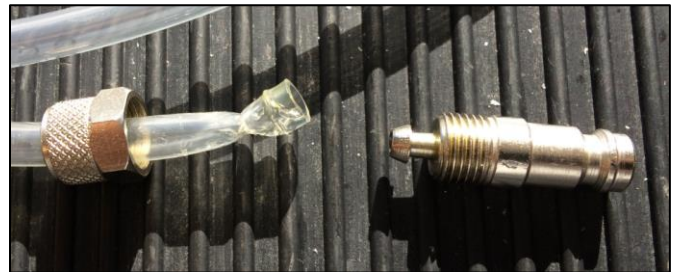
- 2a. Remove the compression fitting from the nozzle assembly that originally comes with the wax gun by unscrewing the nut, then removing the fitting from the tube.

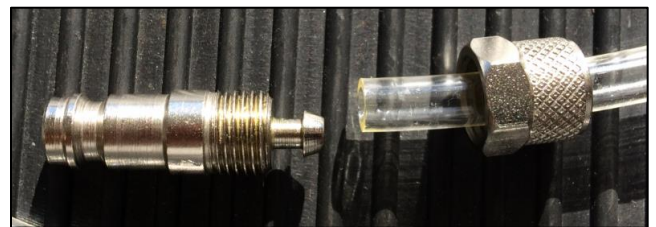
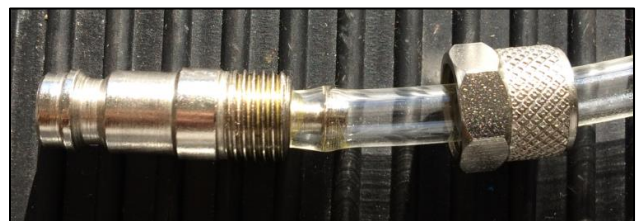
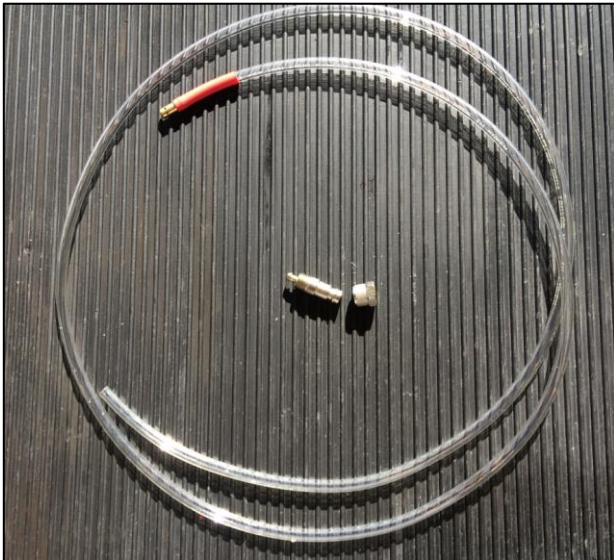
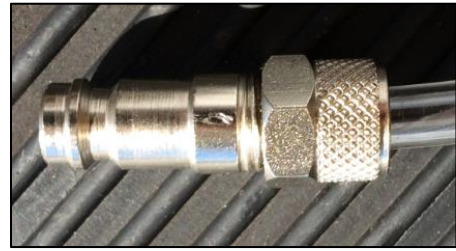
- 2b. Attach the compression fitting to the tubing on the new nozzle assembly.

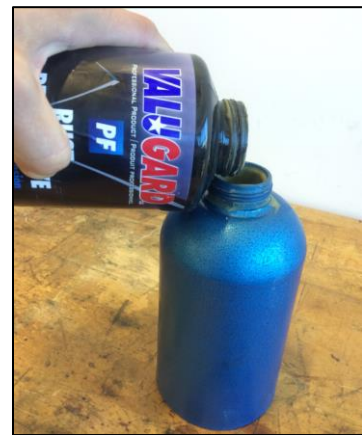
2c. Fill wax gun reservoir with cavity wax.

Prime the wax gun by spraying into a trash bag (or similar) until a light mist is visibly coming out of the nozzle.

Air supply pressure must be set to 70 psi.

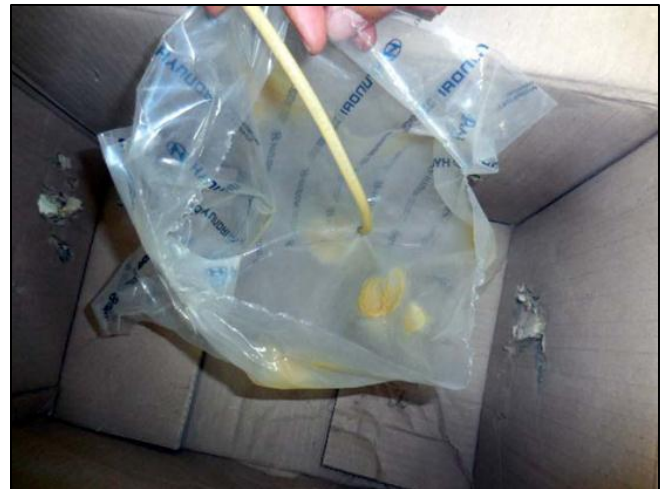
If volume of wax coming out of the nozzle slows significantly (so that a light mist is no longer visible), prime the gun again.

It may speed the priming process to block the nozzle with a rag while spraying the gun until the flow of wax increases.

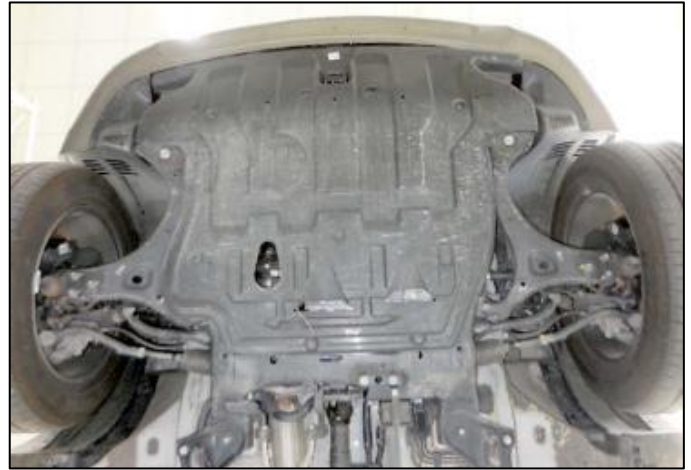
1. Remove the engine undercover (if equipped).

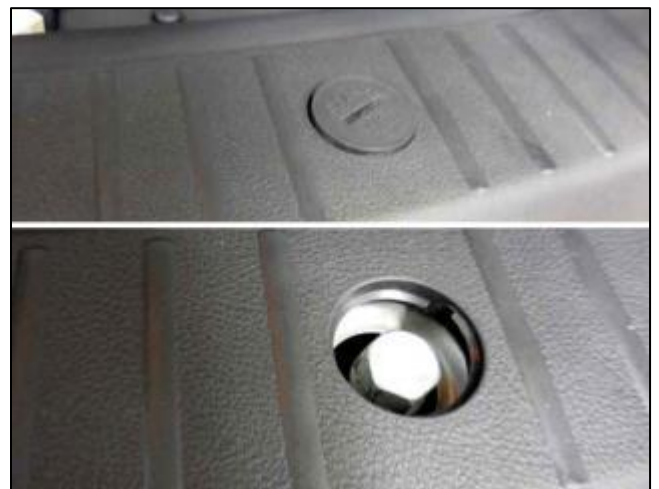
2. Open the vehicle's tail gate, remove the cover for the bolt to lower the spare wheel/tire assembly, and loosen the bolt to lower the spare.

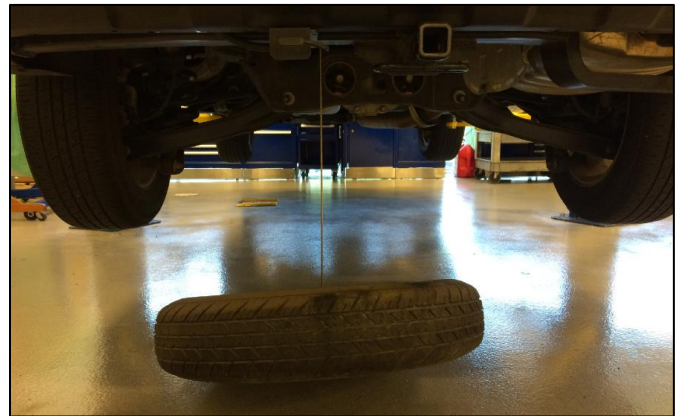
3. Remove the spare wheel/tire assembly.

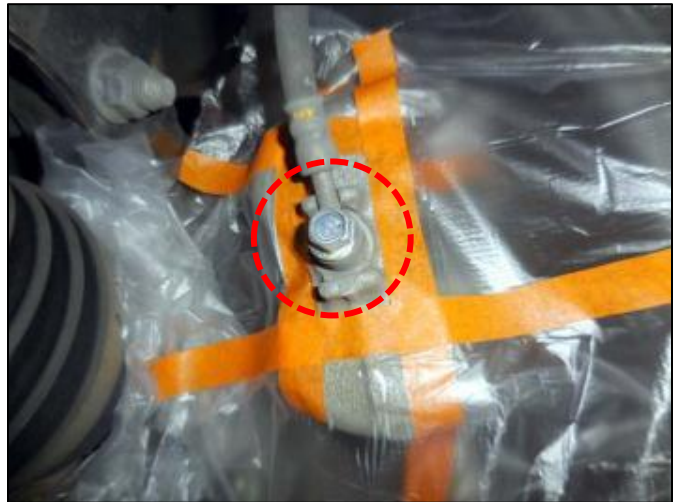
5. Clean the brake banjo bolt surfaces at all 4 calipers using a wire brush. Then wrap the brake assemblies with plastic bags to protect them from overspray. Use tape to secure the plastic in place. Leave the banjo fitting area exposed, as shown.

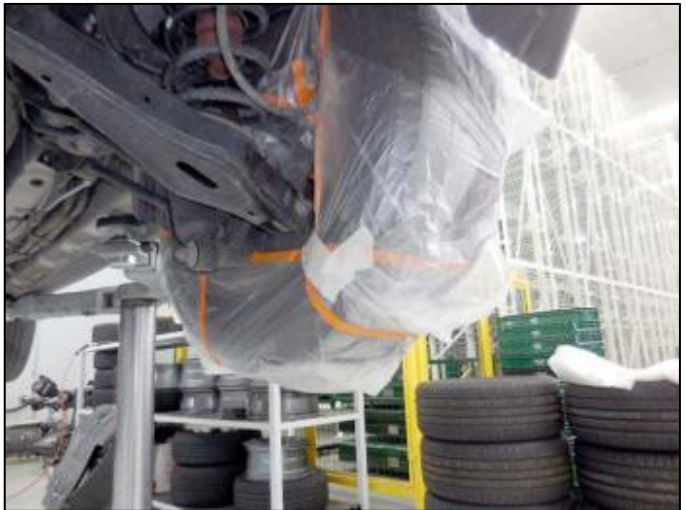
6. Wrap large plastic bags around the wheel/tire/brake assemblies to protect them from overspray. Use tape to secure the plastic in place.

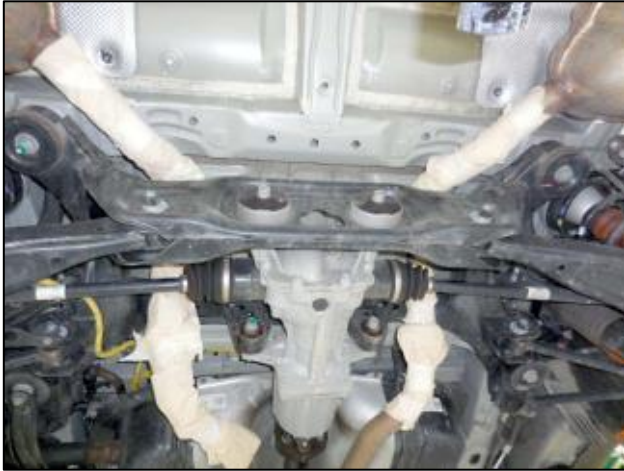
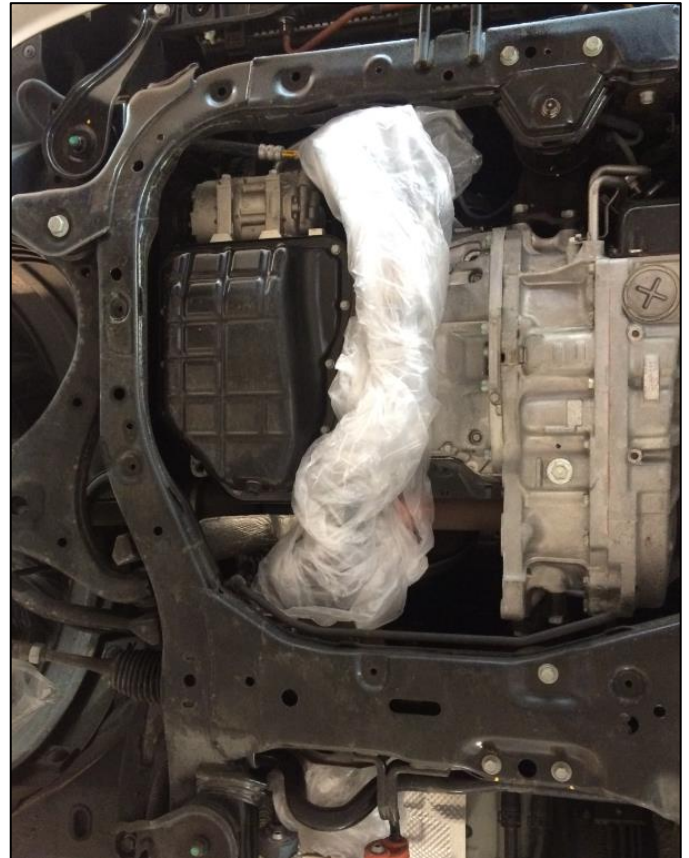
7. Wrap the exhaust areas adjacent to the front and rear cross members with plastic bags to protect them from overspray. Use tape to secure the plastic in place.

The exhaust must be sufficiently cooled before it is wrapped.

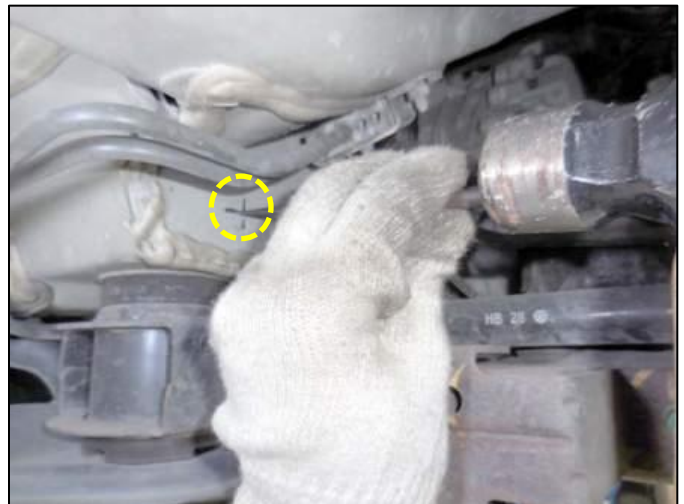
11. Center punch at positions A and B, as previously measured and marked.

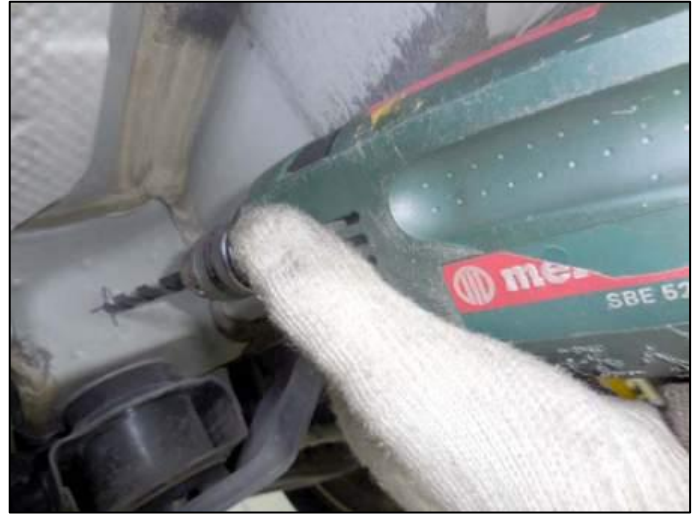
12. Drill 12mm holes at positions A and B.
Deburr holes after drilling.

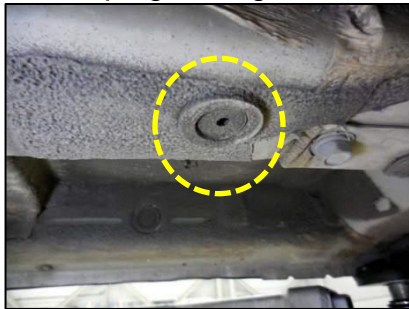
13. Remove the 6 plugs along the frame rails

and the 6 plugs along the sills.

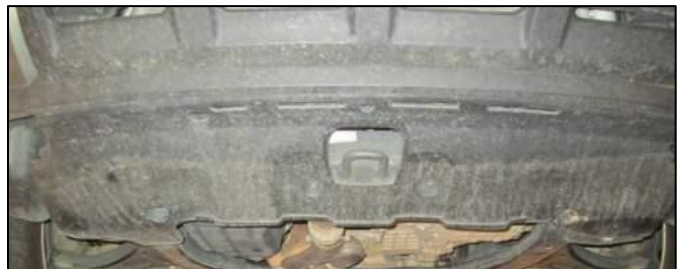
1. Lift the vehicle on a hoist and remove the undercover.

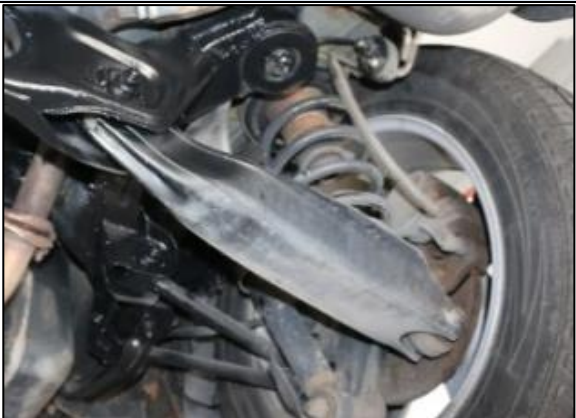
STEEL	ALUMINUM

- Rear lower control arms

If the vehicle has rear lower control arms made of aluminum, no preventative maintenance procedures are required on the rear lower control arms.

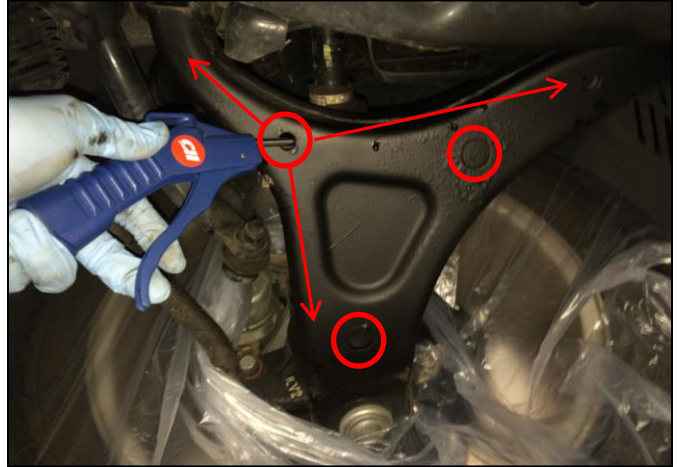
3. Remove the remaining debris by inserting an air nozzle into the locations shown, then blowing air in multiple directions.

- Front lower control arms

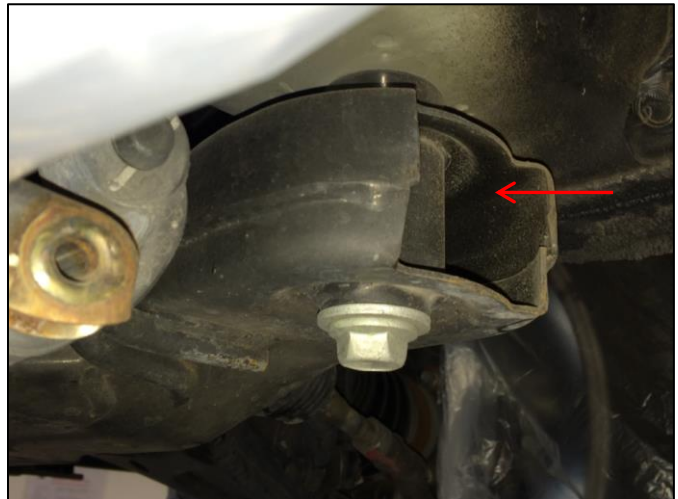
- Front cross member (rear side of cross member, blowing air towards the front of the vehicle)

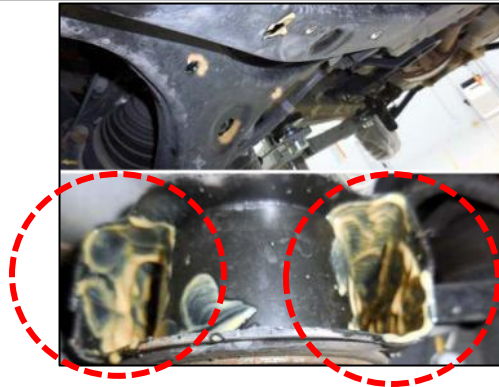
Generally for coating interior surfaces, insert the “inside” nozzle as deeply as possible at each point of entry. Spray the cavity wax while simultaneously rotating the nozzle, and slowly pulling the nozzle out. Continue this rotating/pulling motion until the pink tubing is seen coming out of the hole. The pink tubing indicates there is about 50mm of tubing left until the end of the nozzle. Stop spraying when the pink tubing is seen.

1. Front cross member – Interior surfaces (using **“inside”** nozzle)

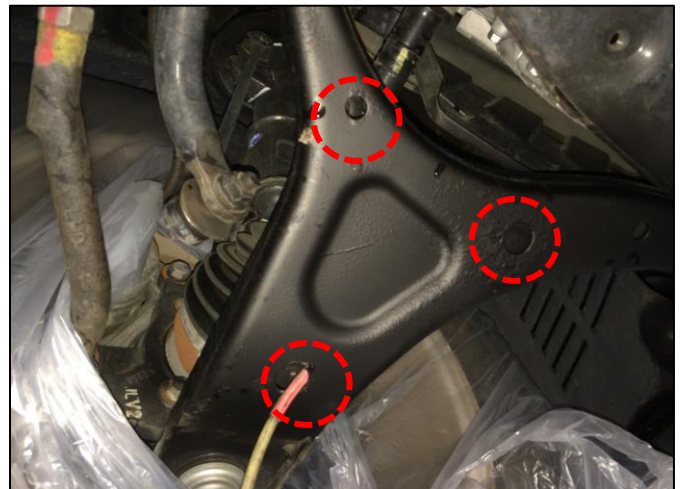
2. Front lower control arms – Interior surfaces (using **“inside”** nozzle)

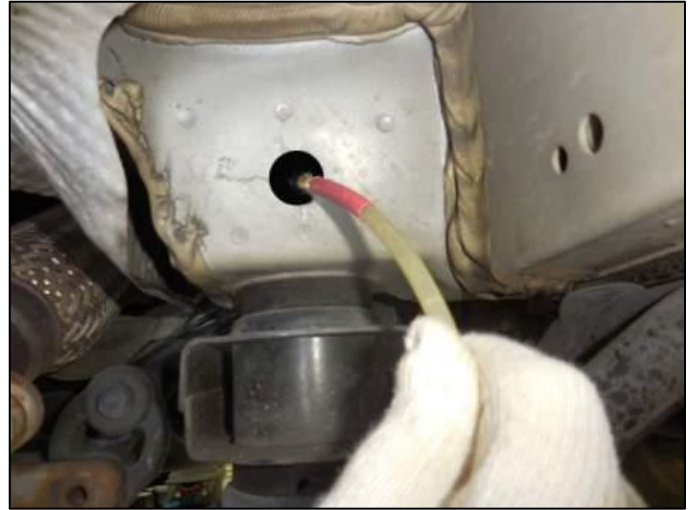
- 3a. Front cross member areas A and B, as previously drilled – Interior surfaces (using “*inside*” nozzle)

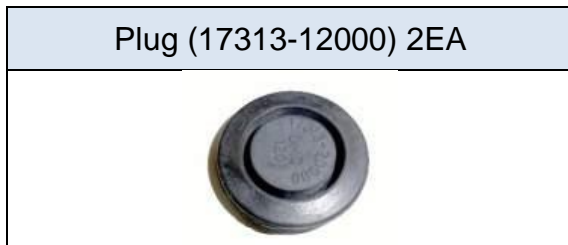
- 3b. Insert a plug into each hole after spraying the cavity wax.

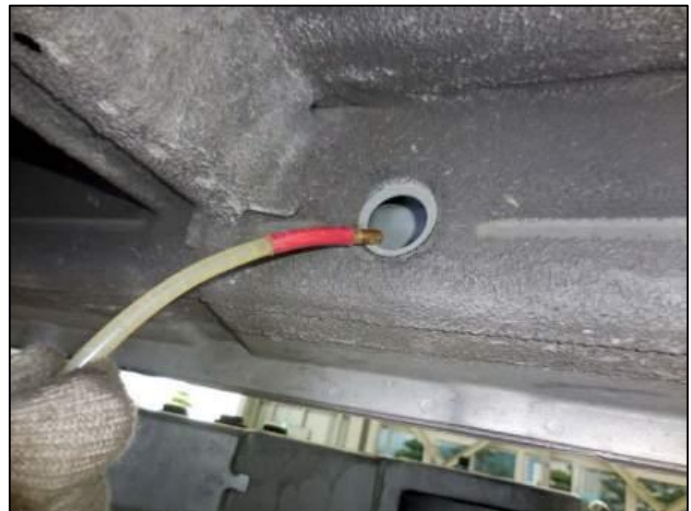
4. 6 side sill holes and 6 frame rail holes (using “*inside*” nozzle).

Reinstall the plugs that were removed earlier after applying the cavity wax.

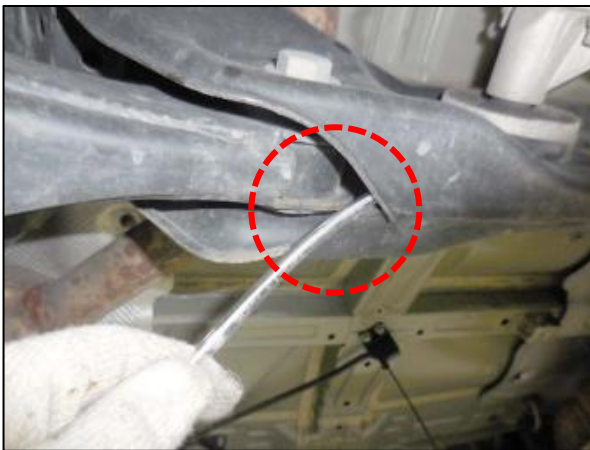
5. Rear cross member – Interior surfaces (using “*inside*” nozzle)

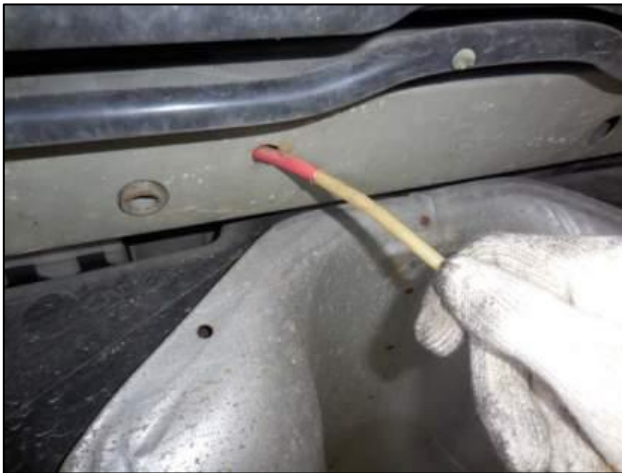
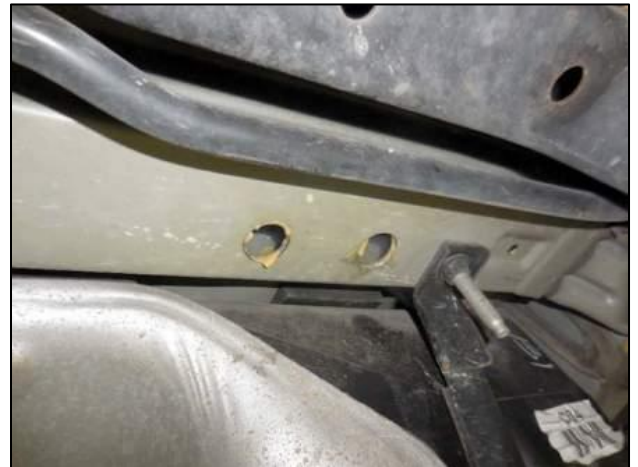
7. Holes immediately forward of the rear cross member (using “*inside*” nozzle)

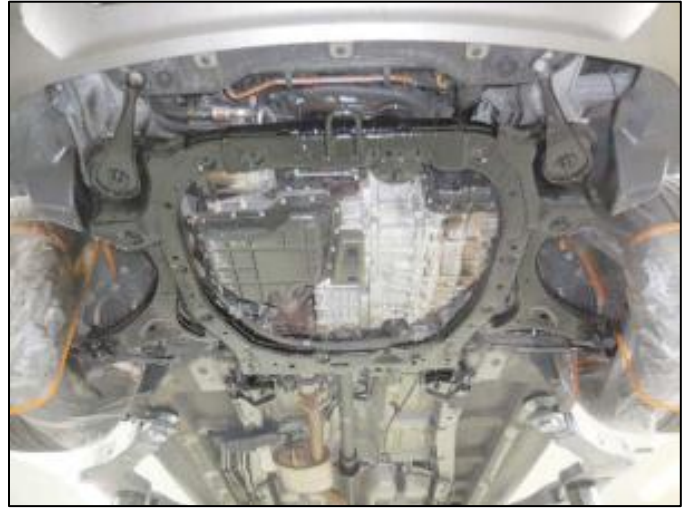
Spray the black undercoating on all exterior surfaces of the front and rear cross members, front and rear lower arms, front and rear brake hose mounting points, and the fuel & brake tubes. Refer to the following images.

- 1. Front cross member

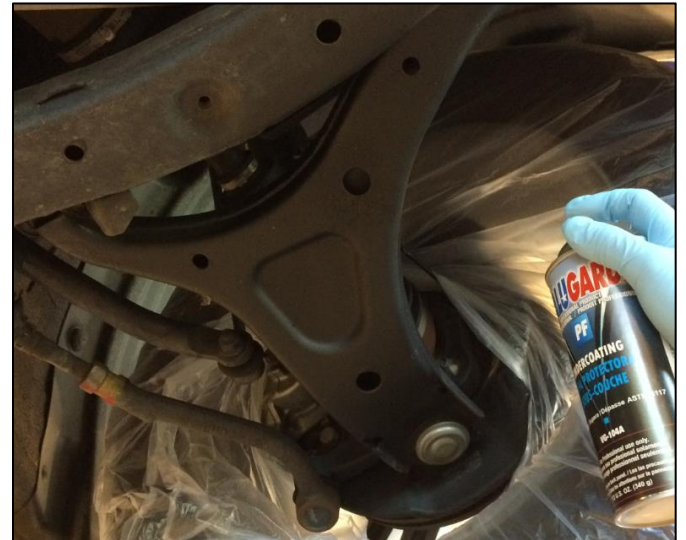
- 2. Front lower control arms

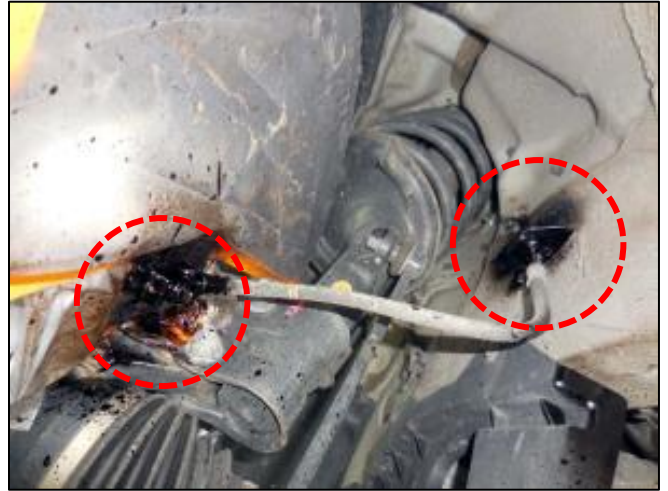
4. Front and rear brake banjo fittings and mounting brackets
