Technical Service Bulletin

GROUP CAMPAIGN	NUMBER 17-01-028
DATE MARCH 2017	MODEL(S) SANTA FE SPORT (AN)

SANTA FE SPORT SEAT VENTILATION MODULE
INSPECTION/REPLACEMENT (SERVICE CAMPAIGN T1V)

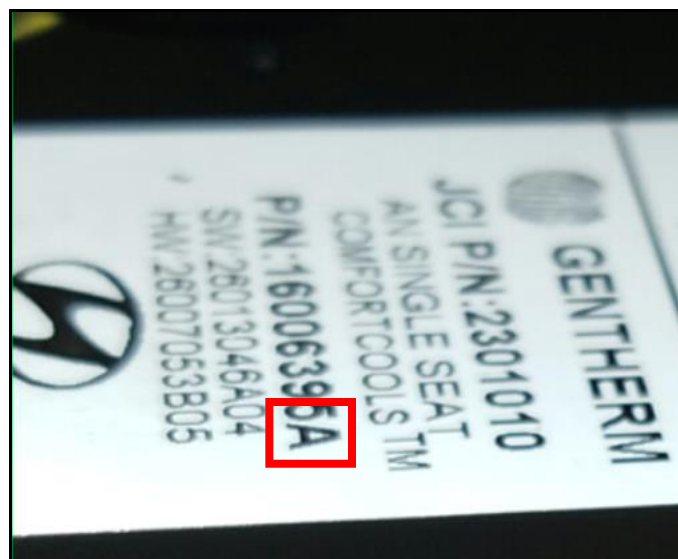
3. **If the P/N ends with "A" on both seats, they are the correct modules.** No need to replace the modules. TSB procedure is complete. Use labor op 70CG03R0 or 70CG03R3 depending upon the vehicle VIN, and place the seats back to their original position.

If either seat ventilation module P/N ends with "B", the module must be replaced.

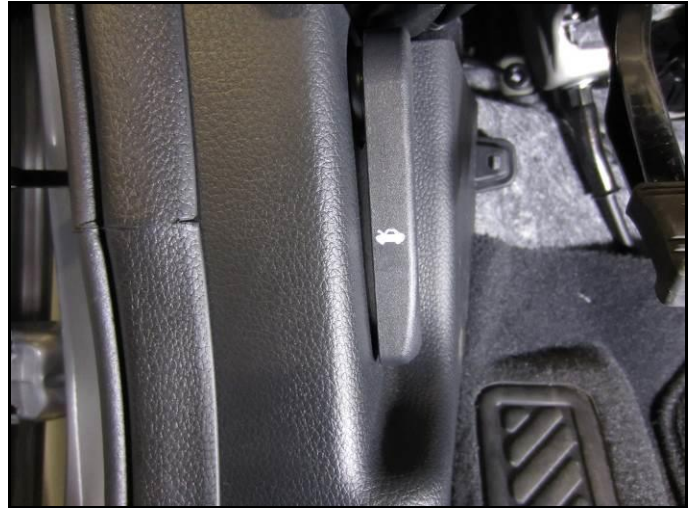
1. If applicable, record the customer's radio preset stations for AM/FM/XM.
2. Open the hood by pulling on the hood release to access the negative battery terminal.

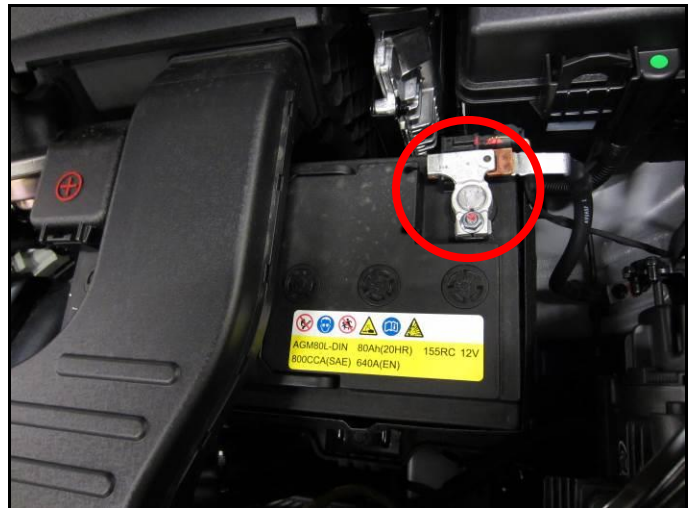
3. Disconnect the negative battery terminal.

**Negative battery terminal tightening torque:
4.0 ~ 6.0 N.m (0.4 ~ 0.6 kgf.m, 3.0 ~ 4.4 lb-ft)**

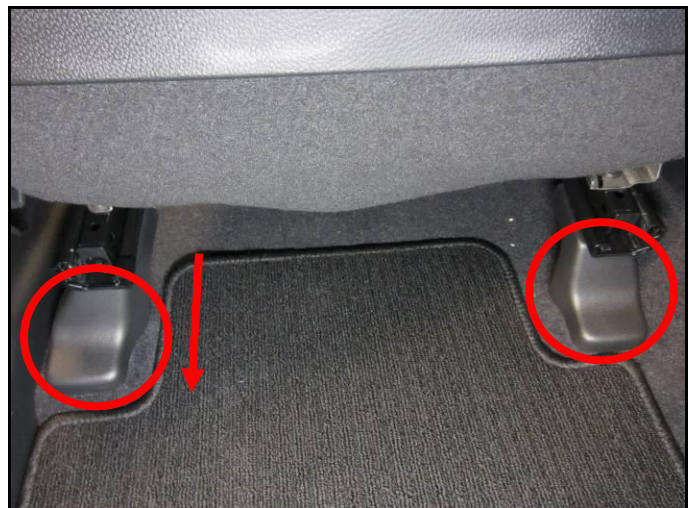
4. Remove the four seat bolt covers by gently pulling the covers outward and away from the seat rail.

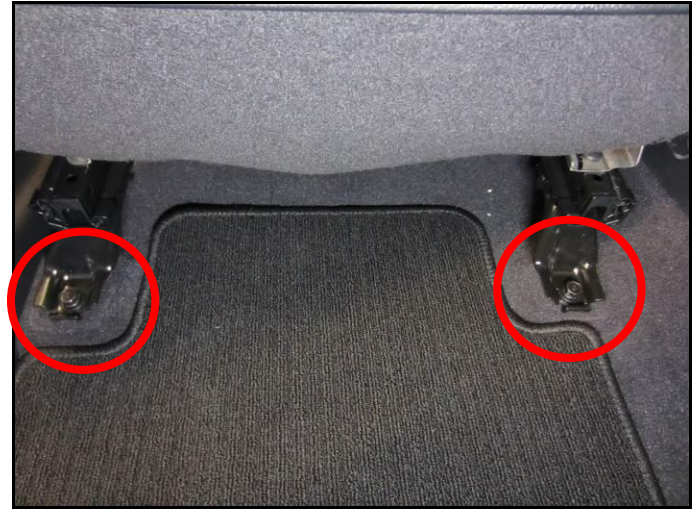
5. Remove the four seat bolts using a 14mm socket and ratchet.

Seat bolt tightening torque:***34.3 ~ 53.9 N.m (3.5 ~ 5.5 kgf.m, 25.3 ~ 39.8 lb-ft)***

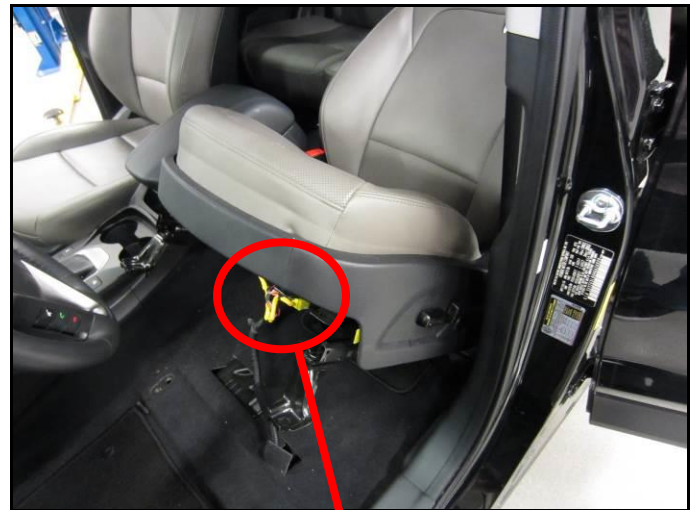
6. Tilt the seat backward and disconnect the three harness connectors from under the seat.

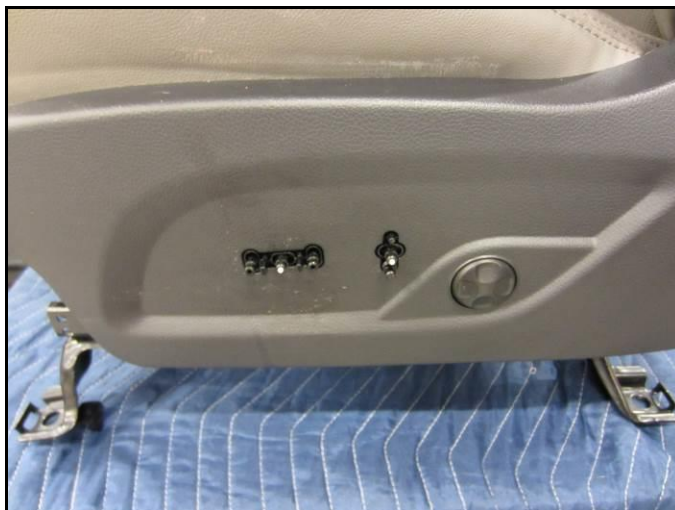
- 8. Use a panel removal tool and remove the switch buttons. Carefully pry the buttons outward.

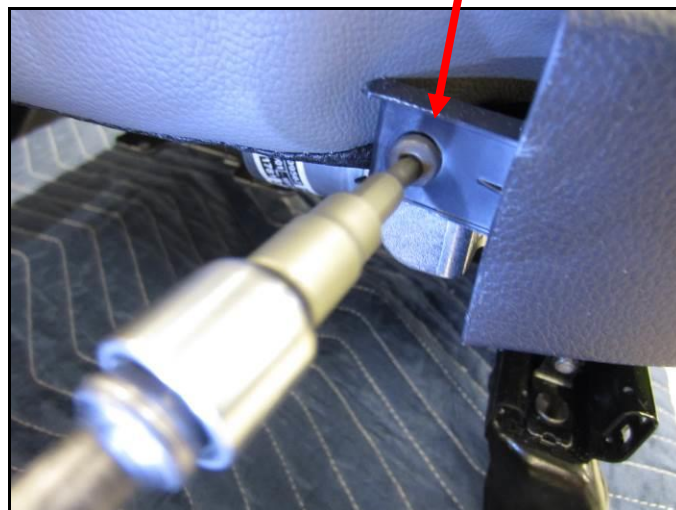
10. Remove the T25 Torx screw located in the picture shown to the right and remove the seat side cover.

The Torx screw is accessible after removing the front seat cover.

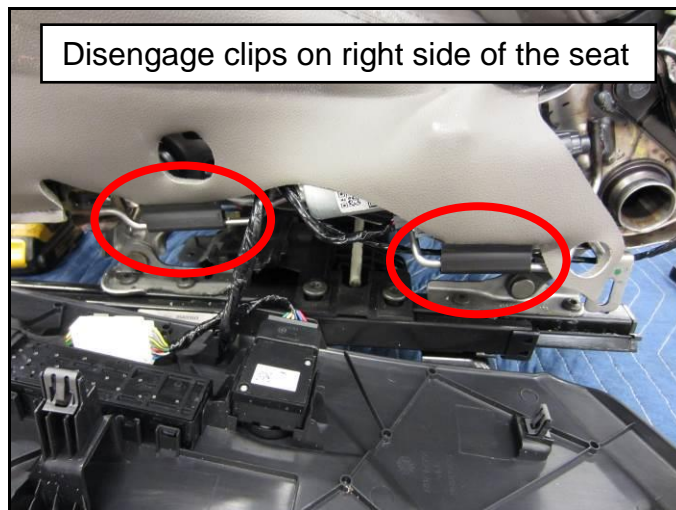
- 11A. To separate the bottom seat cushion from the seat frame, follow steps 11A-11F.

Disengage clips on right side of the seat.

To disengage the cushion clips, pull down and outward.

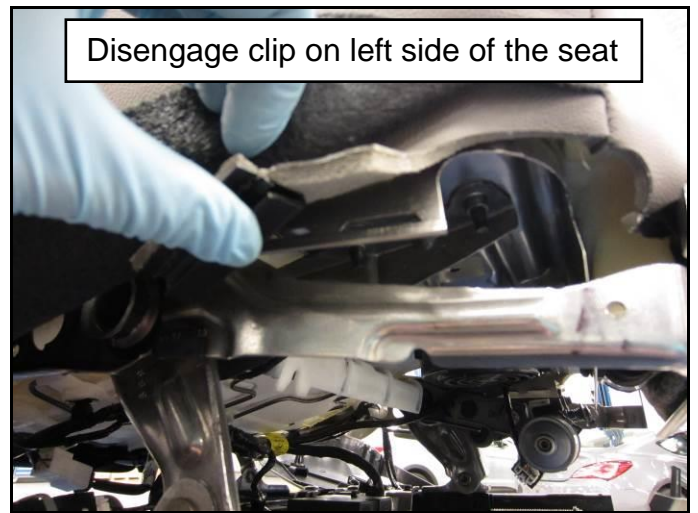
11C. Disengage clip on left side of the seat.

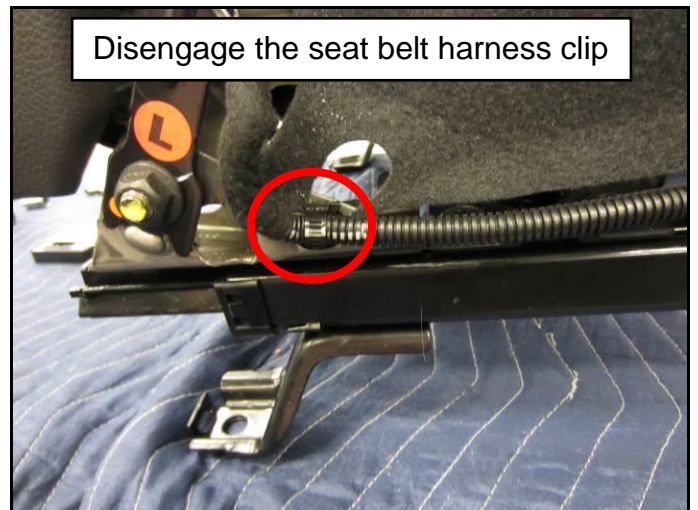
11D. Use a small Flathead screwdriver to disengage the seat belt harness clip.

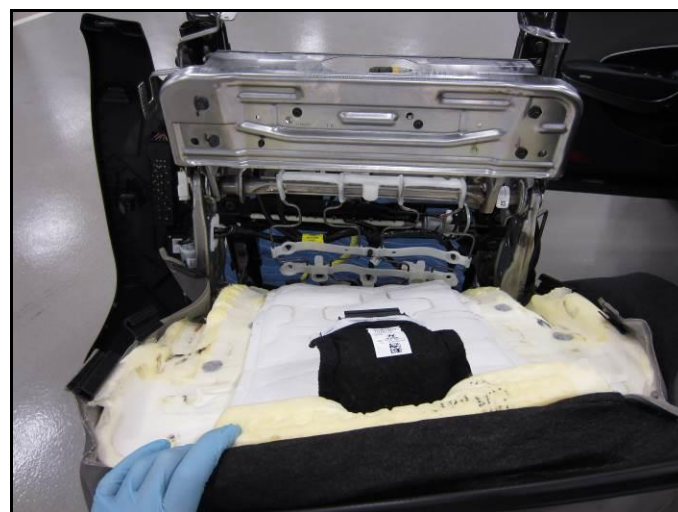
11F. Tilt the seat to lay it on the backrest, and lift the bottom cushion to access the seat ventilation module.
