HYUNDAI NEW THINKING. NEW POSSIBILITIES. Technical Service Bulletin	GROUP FUEL SYSTEM	NUMBER 17-FL-002
	DATE MARCH 2017	MODEL VELOSTER (FS) SONATA HYBRID (YF HEV)
SUBJECT: CANISTER INSPECTION AND REPAIR (WARRANTY EXTENSION TXX9)

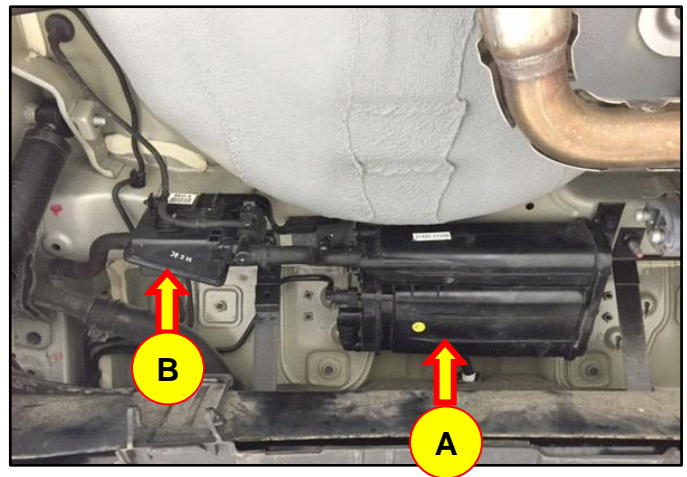
1. Lift the vehicle on a hoist.
2. Remove the complete assembly of canister (A), air filter (B), and both attached brackets as a whole assembly from the vehicle for easier ability to perform inspection and repair.

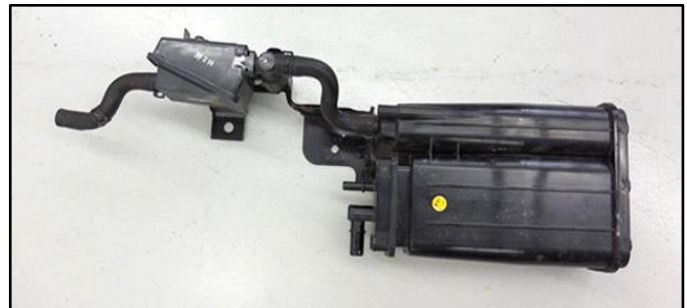
Canister, filter and brackets shown removed as a complete assembly from the vehicle.

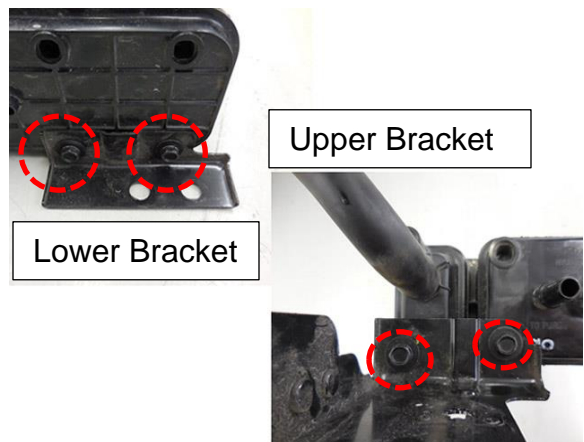
3. Remove the mounting bolts from the canister's lower and upper brackets. **Veloster** has 4 bolts total to remove.

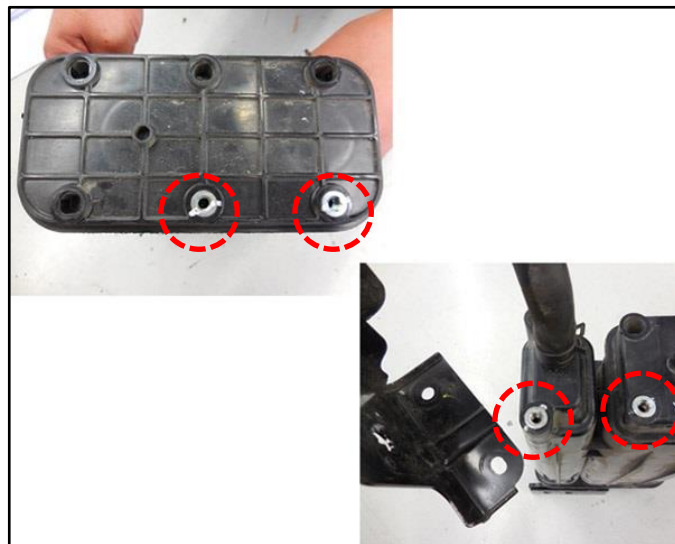
4. Clean the rust / foreign material from the insert nut surfaces by using a steel brush.
5. Blow out inside and around the insert nuts by using an air gun for 5 seconds.

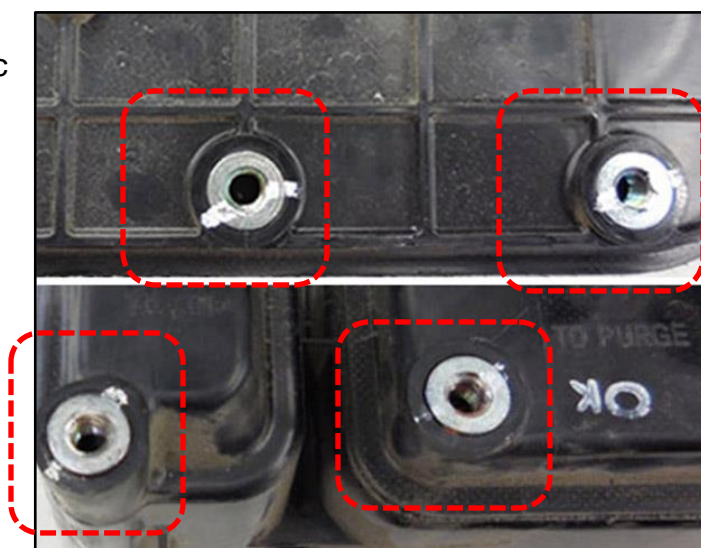
6. Inspect for any crack(s) found at the canister insert nut surfaces or in the surrounding plastic at the bottom and top of the canister.

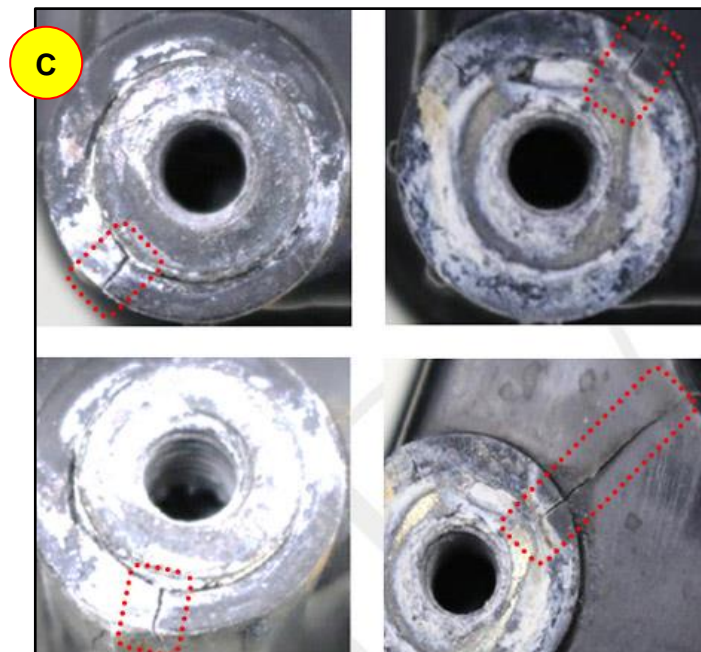
Examples of cracks found at the insert nut (C) or in the surrounding plastic.

The cracks may be very fine. Use a magnifying glass if available.

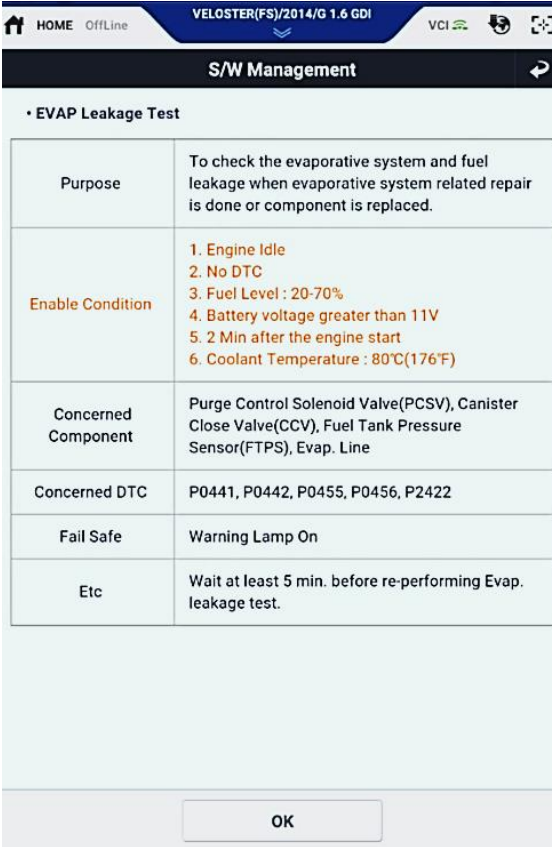
Purpose	To check the evaporative system and fuel leakage when evaporative system related repair is done or component is replaced.
Enable Condition	<ol style="list-style-type: none"> 1. Engine Idle 2. No DTC 3. Fuel Level : 20-70% 4. Battery voltage greater than 11V 5. 2 Min after the engine start 6. Coolant Temperature : 80°C(176°F)
Concerned Component	Purge Control Solenoid Valve(PCSV), Canister Close Valve(CCV), Fuel Tank Pressure Sensor(FTPS), Evap. Line
Concerned DTC	P0441, P0442, P0455, P0456, P2422
Fail Safe	Warning Lamp On
Etc	Wait at least 5 min. before re-performing Evap. leakage test.

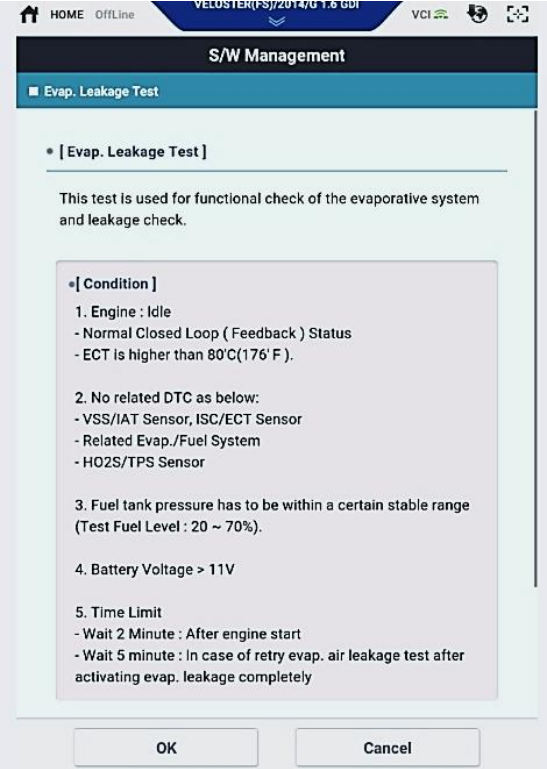
This test is used for functional check of the evaporative system and leakage check.

1. Engine : Idle
 - Normal Closed Loop (Feedback) Status
 - ECT is higher than 80°C(176° F).
2. No related DTC as below:
 - VSS/IAT Sensor, ISC/ECT Sensor
 - Related Evap./Fuel System
 - HO2S/TPS Sensor
3. Fuel tank pressure has to be within a certain stable range (Test Fuel Level : 20 ~ 70%).
4. Battery Voltage > 11V
5. Time Limit
 - Wait 2 Minute : After engine start
 - Wait 5 minute : In case of retry evap. air leakage test after activating evap. leakage completely

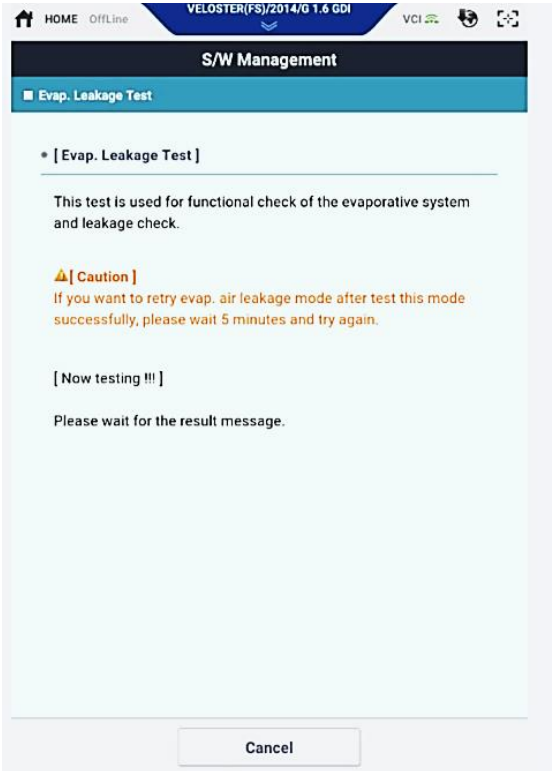
This test is used for functional check of the evaporative system and leakage check.

⚠ [Caution]
If you want to retry evap. air leakage mode after test this mode successfully, please wait 5 minutes and try again.

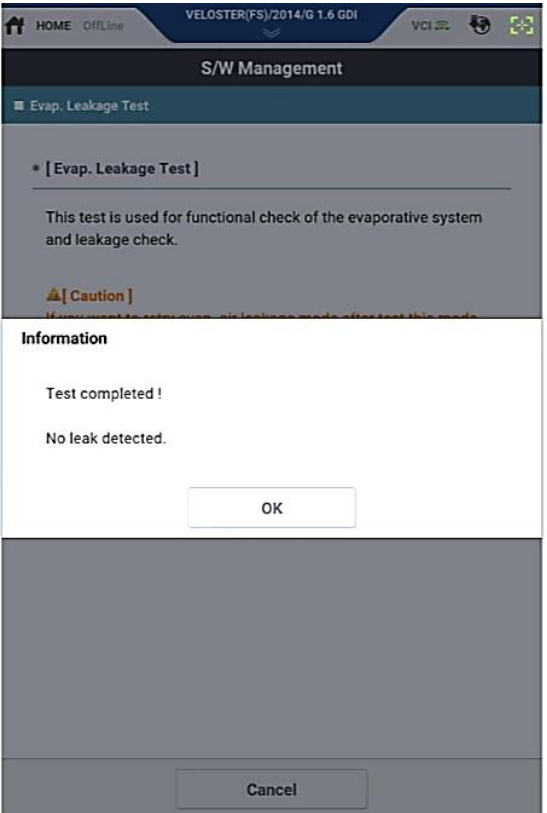
Test completed !

No leak detected.

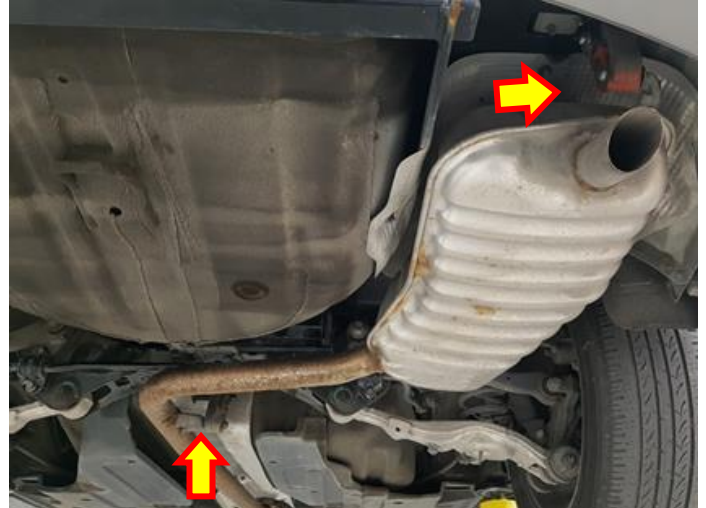
- i. Lift the vehicle on a hoist.
- ii. Disconnect the rear muffler from the 2 hangers as shown. Using a transmission jack, support the rear muffler and slowly lower to gain access to the canister assembly.

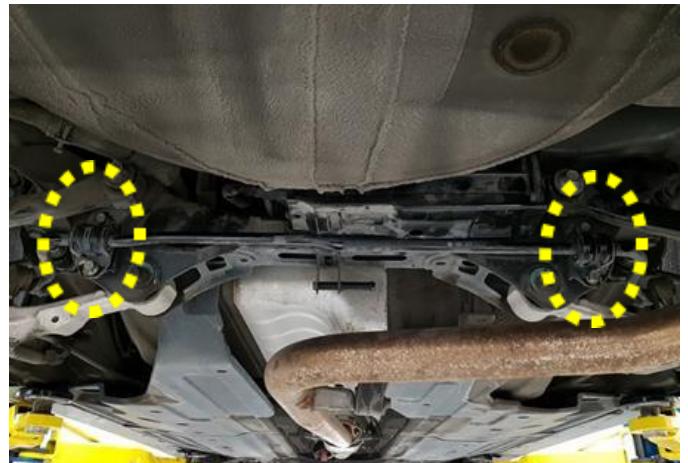
- iii. Remove the 4 bolts from the rear stabilizer bar (sway bar) from the rear cross member.

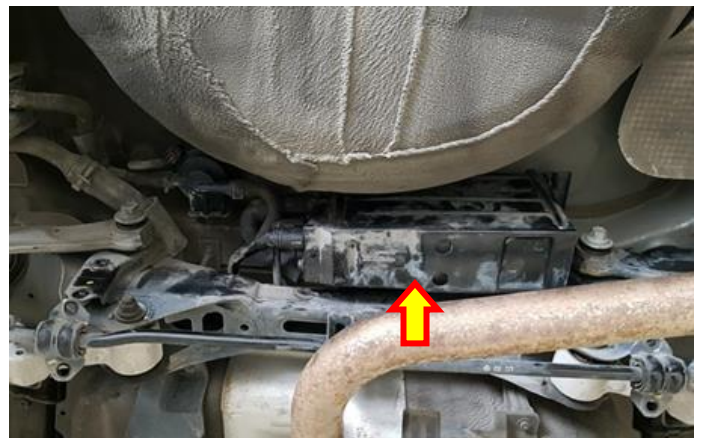
Remove the complete canister assembly with NVLD, brackets, and hose as shown.

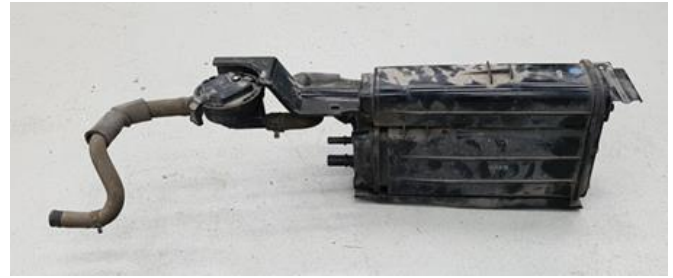
2011-2012MY YF HEV canister, NVLD, bracket and hose shown removed as a complete assembly from the vehicle.

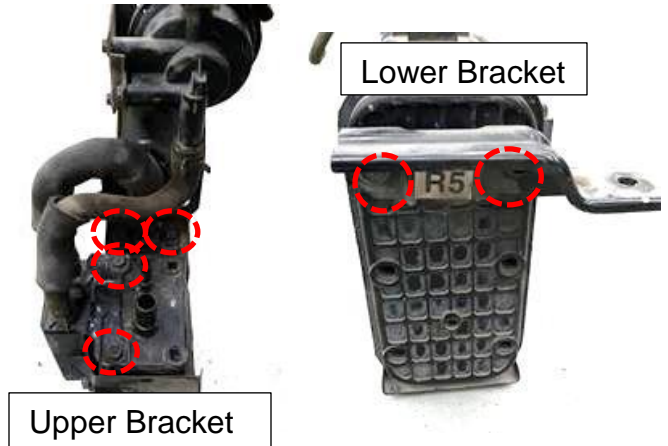
- 3. Remove the 6 mounting bolts from the canister lower and upper brackets.

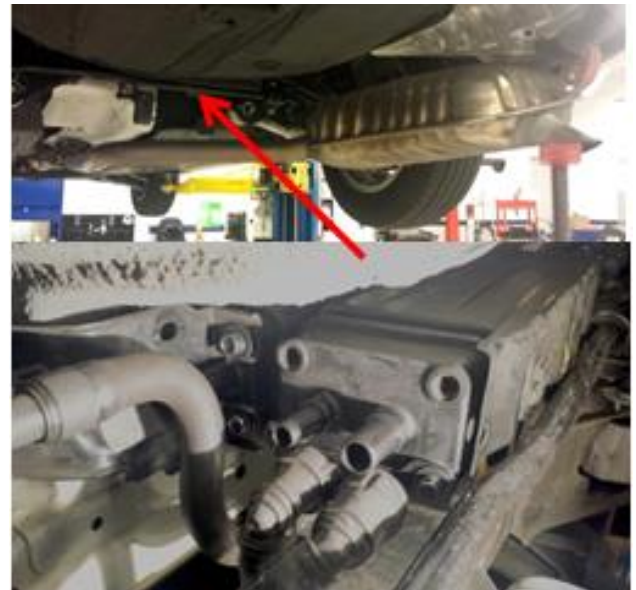
13-15MY vehicles have a different canister from 11-12MY vehicles. In 13-15MY, the complete canister assembly with NVLD, brackets and hose cannot be removed from the vehicle due to interferences at reinstallation of the canister.

Only the canister and its lower bracket as shown here can be removed from the vehicle for the inspection and repair procedures. The 4 bolts to the two upper brackets must be detached from the canister. The upper brackets are to be left in the vehicle.

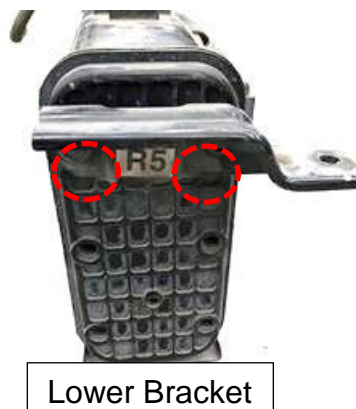
- 5. With canister and its lower bracket removed from the car, remove the 2 mounting bolts from the canister lower bracket.

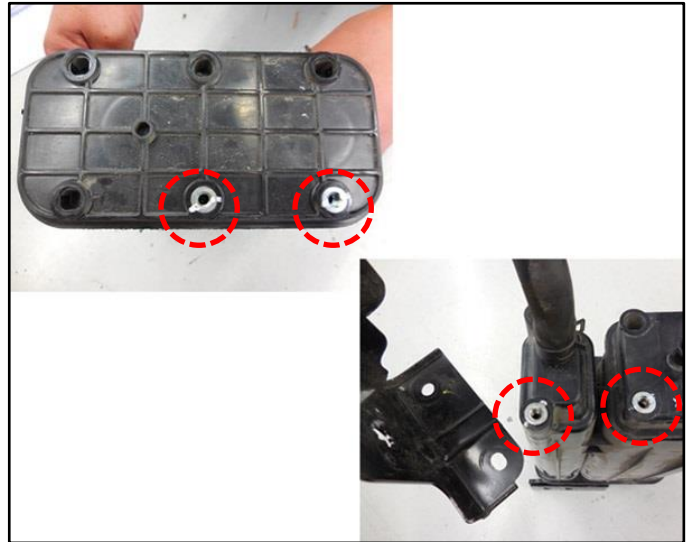
6. Clean the rust / foreign material from the insert nut surfaces by using a steel brush.
7. Blow out inside and around the insert nuts by using an air gun for 5 seconds.

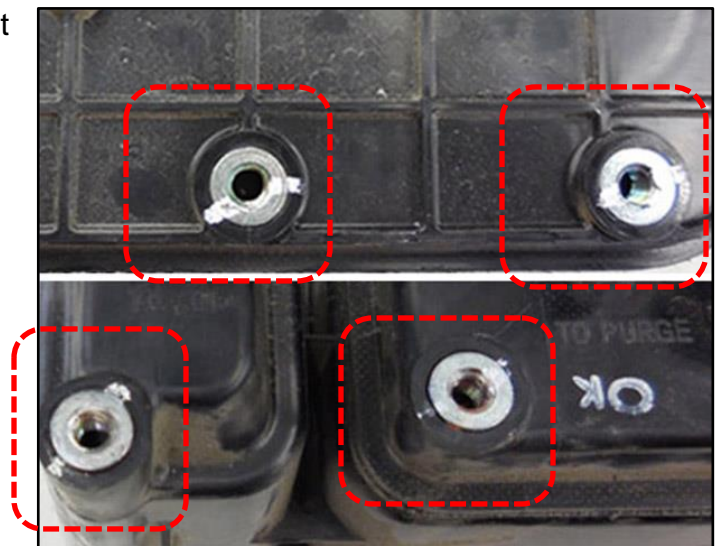
8. Inspect for any cracks at the canister insert nut surfaces or in the surrounding plastic at the bottom and top of the canister.

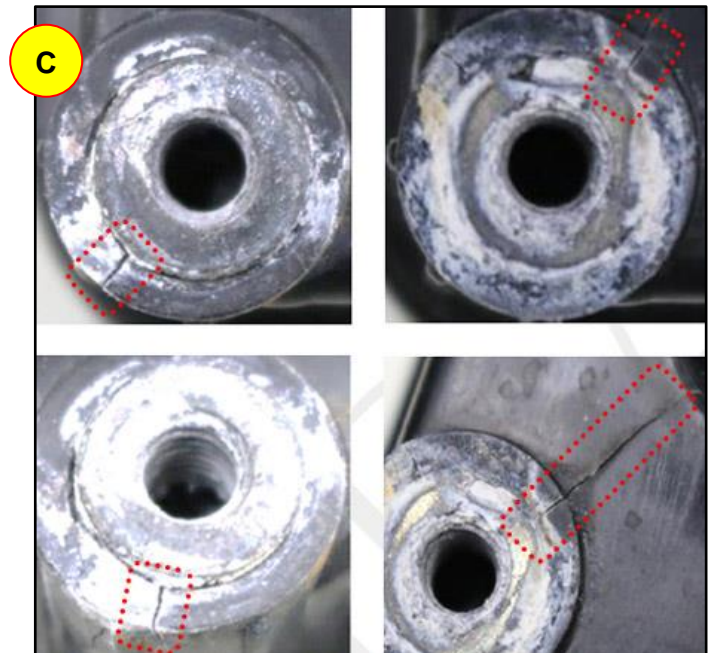
Examples of cracks found at the insert nut (C) or in the surrounding plastic.

The cracks may be very fine. Use a magnifying glass if available.
