Service Bulletin

PRELIMINARY INFORMATION

Subject: Fuel Gauge Displays Empty / Low Fuel Light On / DTC P2636

Models: 2016 Chevrolet Silverado 3500 Chassis Cab
2016 GMC Sierra 3500 Chassis Cab
With 6.6L Diesel Engine RPO LML and Dual Fuel Tanks RPO N2N

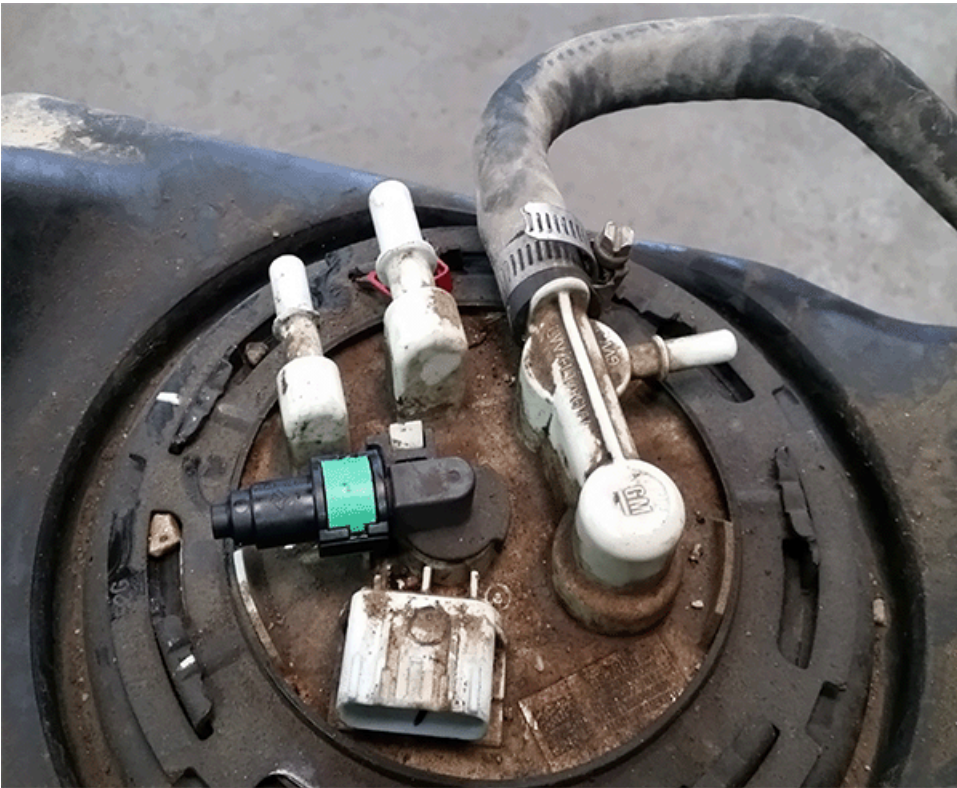
Some owners may comment that the fuel gauge shows empty and the low fuel level indicator is on. When checking for DTCs, a P2636 will be set in the ECM.

1. If Chassis Up-fit bed or body cannot be easily removed, remove the FRONT fuel tank. Refer to Fuel Tank Replacement (Cab/Chassis - Front) Doc Id # 2456119.
2. With the front tank removed, install cap from line kit onto rear balance pump inlet port on front tank (1) Refer to Plastic Collar Quick Connect Fitting Service. Doc Id# 2147646.
