Service Bulletin

Bulletin No.: PIP5465

Subject: Diagnostic Tip - Exhaust Heat Exchanger Coolant Leak

Brand:	Model:	Model Year:		VIN:		Engine:	Transmission:
		from	to	from	to		
Chevrolet	Malibu	2016	2017	All		1.8L LKN	N/A

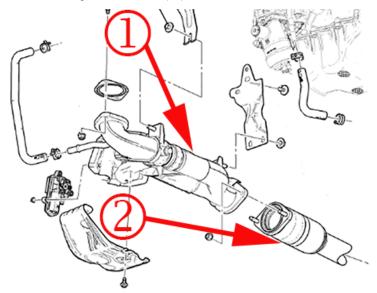
Exhaust Heat Exchanger shown below (#1)

Involved Region or Country	North America
Additional RPO/s:	(1.8L) LKN
Condition	Smoke from exhaust system, coolant loss.

When Pressure testing the coolant system to isolate a coolant loss concern, remove the Exhaust front pipe assembly (2) from the Exhaust Heat Exchanger assembly (1) and check it for signs of internal coolant leakage.

If an internal leak is found in the Exhaust Heat Exchanger, replace and retest for system leakage.
