# Preliminary Information

PIT5321A Normal Characteristic - Missing Underhood Trim At Front Left Fender Area

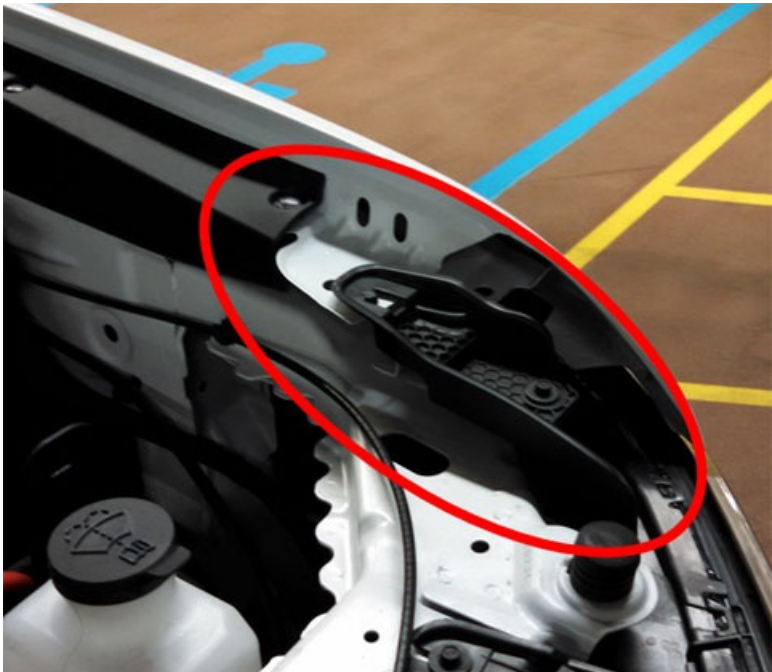
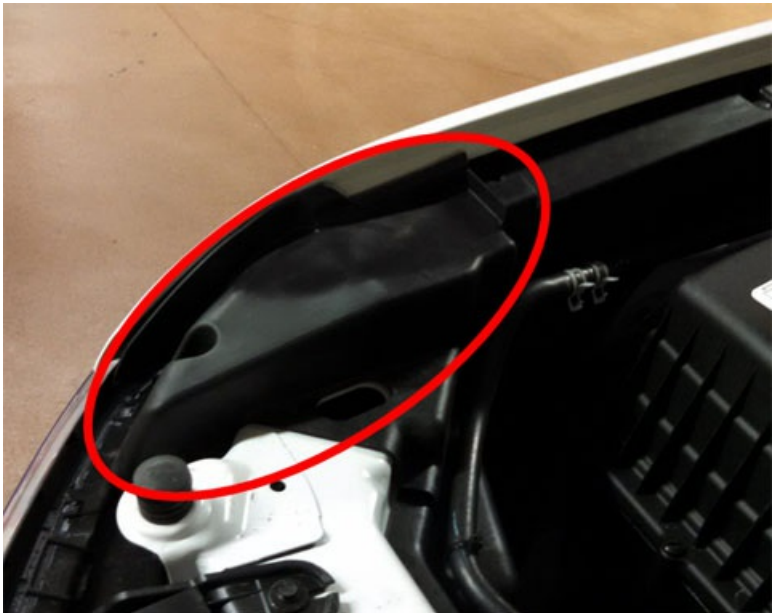
A dealer or customer may report that a trim piece is missing from the left front of the engine compartment where the fender and radiator support meet.

The upper intake air baffle is present on the right side to protect the engine air filter inlet. Since no engine air inlet exists on left side, no baffle was used there.

Make no repair attempts or modifications to the vehicle, this is built to design intent.

Please communicate to the customer this condition is a normal build characteristic of their vehicle. It will not impact the designed performance or reliability of the vehicle. Please share this information with the customer, including a copy of this message  
Please follow this diagnostic or repair process thoroughly and complete each step. If the condition exhibited is resolved without completing every step, the remaining steps do not need to be performed.
