Preliminary Information

PIC6254A Information On Servicing The 3M Vinyl Hood Wrap

Models

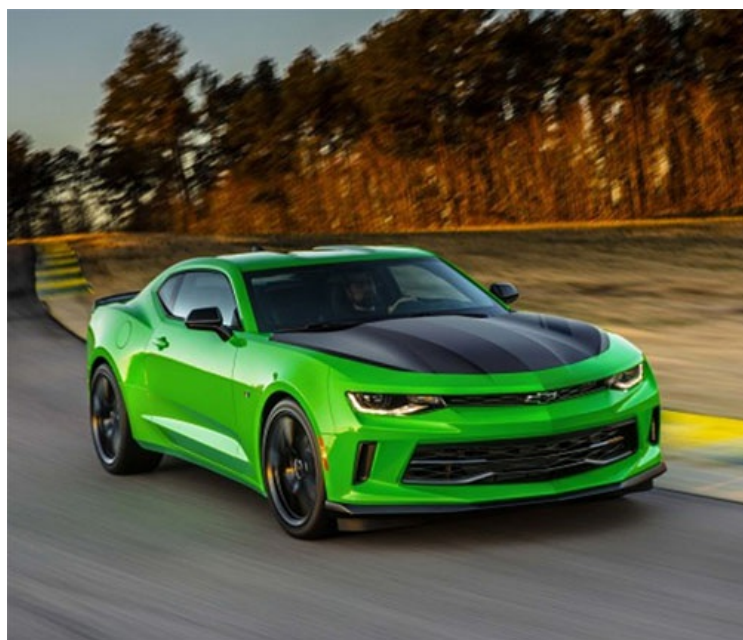
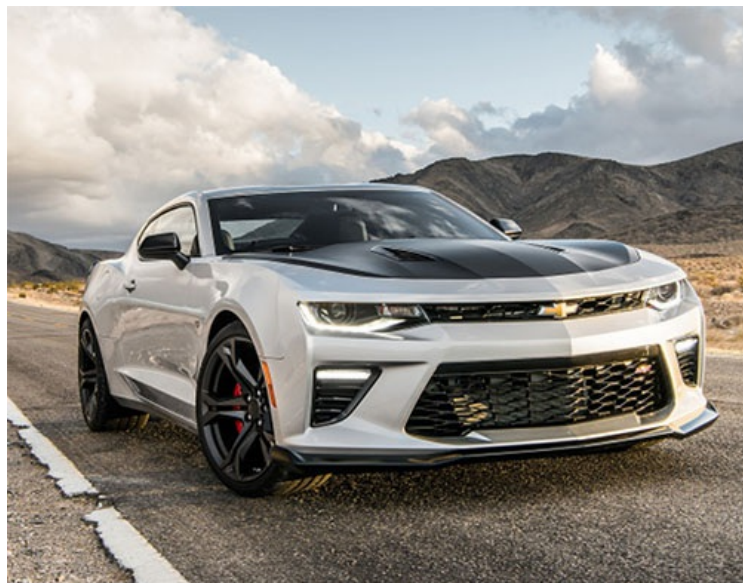
Brand:	Model:	Model Years:	VIN:		Engine:	Transmissions:
			from	to		
Chevrolet	Camaro	2017	All	All	All	All
Involved Region or Country	North America					
Additional Options (RPO)	Equipped with the 1LE track package, RPOs A1X or A1Y					
Condition	All 2017 Camaro 1LE cars come equipped with a 3M brand vinyl hood wrap that is applied before the cars arrive at the dealership. These hood wraps can be seen in the photos below. The green car is a V6 1LE and the white car is the V8 1LE. Some dealerships may be looking for additional information on this wrap when it comes to care, cleaning, or in some situations, replacement of the entire hood wrap.					
Cause	These hood wraps are all made of a matte finished vinyl material and all of them are black in color. They can be damaged if they are not cared for properly. The most common complaints are smudges or stains that are usually the result of fingerprints, improper cleaning practices and products or leaves that remain on the car and create an outline on the vinyl. In some situations, the customer may even comment on small rips / other physical damage to the wrap itself.

If any suspect damage is found on one of these hood wraps, dealerships are to first attempt to clean the hood before taking any other action. Hand washing is recommended using 3M or Meguiar's car care products. Immediately rinse the vehicle and dry the graphic with a soft squeegee and/or soft cloth to help restore the graphic's luster.

- Touchless car washing systems may be used. To avoid water spotting on graphic, always go through the drying cycle.
- To remove tar and bugs from the graphic, use a commercial cleaner designed for such use, but do not rub vigorously. Immediately wash with regular cleaning solution, rinse with water, and dry.

If the concern remains and it's determined a new hood wrap is needed, the 1LE hood wrap (Hood Wrap Decal) can be obtained thru GM Service Parts. The V6 and V8 1LE use the same part number hood wrap. It will be necessary to cut the holes in the hood wrap to accommodate the V8 hood vents. The 1LE hood wrap must be installed by a 3M certified technician. If your dealership/body shop does not have a 3M certified installer, contact 3M Technical Assistance at 1-800-328-3908
