# ***SERVICE PROCEDURE***

17503  
May, 2017

**SUBJECT:**    **SAFETY RECALL  
HEATER BOOSTER PUMP HARNESS** on certain CE school bus models built 11 May 2015 thru 20 March 2017 with feature codes 48PNW (Plastic Booster Pump), 49WXD (17k Webasto Heater), and 49MTB (Webasto Smart Temp Timer, Right of Driver).

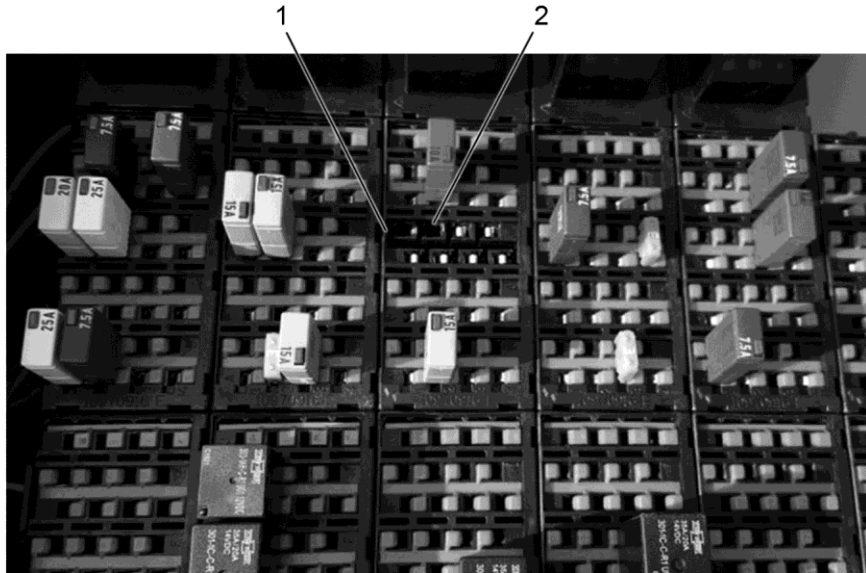
**Figure 4. Body Fuse / Circuit Breaker Panel, with Block 10303 Empty**

1. Block 10303
  2. Cavity F2
- 
17. Insert newly terminated wire into Cavity F2 (Figure 4, Item 2) in block 10303 (Figure 4, Item 1).
  18. Install electrical panel, install terminal lock, and install all fuses and circuit breakers in correct locations.
  19. Reconnect vehicle ground to main battery and close battery box compartment.
  20. Unlatch and open hood.

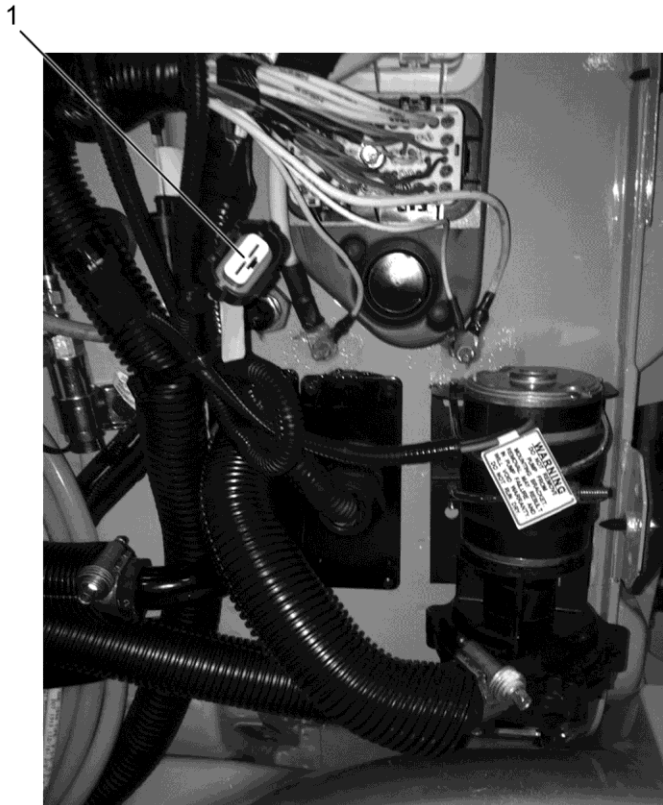
### Figure 5. Engine Compartment

1. Booster pump harness

21. If the booster pump harness (Figure 5, Item 1) was previously disconnected, connect booster pump harness.
22. Turn vehicle ignition to Key ON position.
23. Activate timer to start Heater Booster Pump and Webasto heater.

24. Using an ammeter, measure the booster pump amperage draw.
  - a. If measurement is 4.8 Amps with engine off and 5.5 Amps with engine running, pump is operating to spec. Proceed to Step 25.
  - b. If measurement exceeds 6 Amps, there is something wrong with the pump motor. Replace Booster Pump.
25. Deactivate timer for Heater Booster Pump and Webasto heater.
