HYUNDAI

Technical Service Bulletin

NUMBER
17-SS-002

SUBJECT: EQUUS (VI) REAR AIR SPRING PART SUPERSESSION INFORMATION

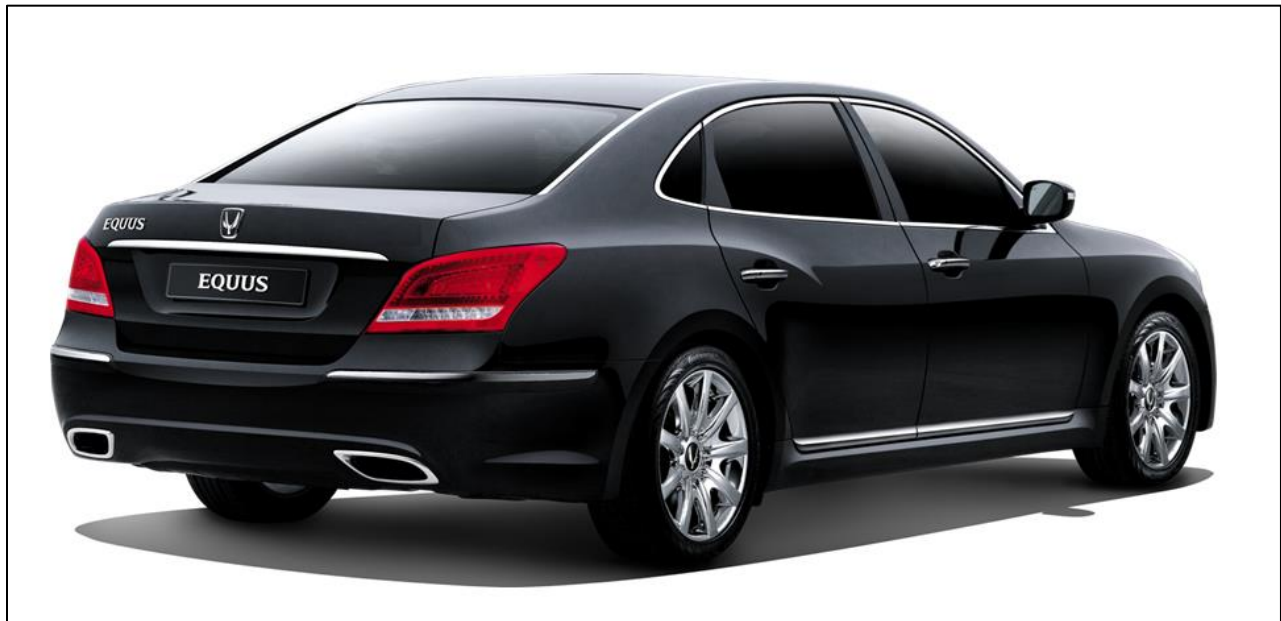
Description: This bulletin provides information regarding changes to the 11-12MY VI Equus rear spring service parts. The service part numbers for the rear left and rear right air spring assemblies have been superseded according to the Parts Information table below. There are some physical differences (top hat angle, air bladder dimensions). These changes have no impact on parts compatibility. Please use the new part numbers when replacing these parts.

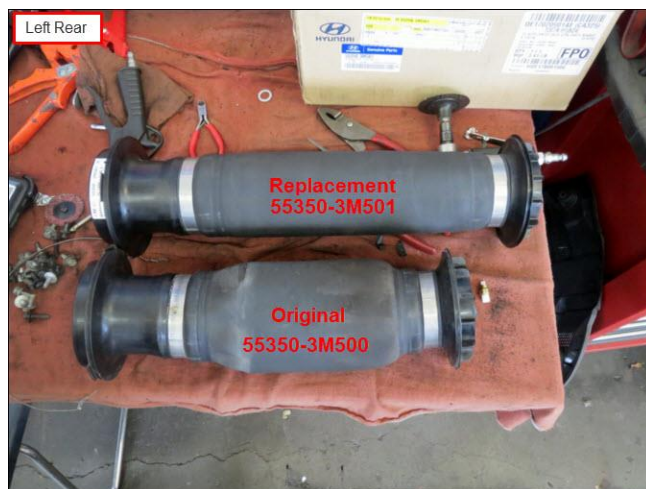
1. Dimensions of the new service parts have changed. The air spring assembly is longer and the diameter is smaller than the original parts.

The images shown are with the dust boots removed and are for illustrative purposes only.

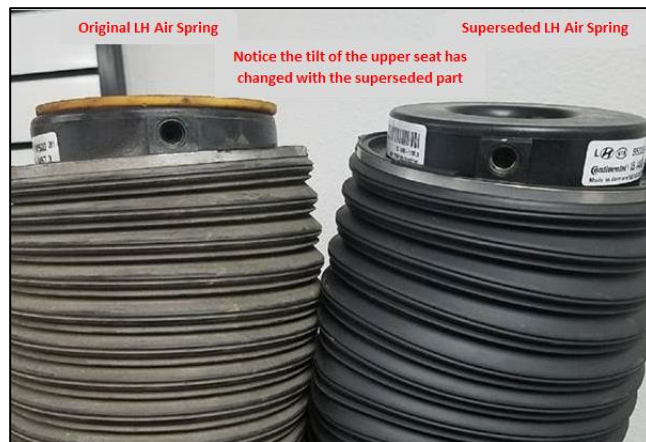
2. The top of the new air-springs are angled differently than the original parts. This can be seen when positioning the air fitting facing the same direction. This is normal.

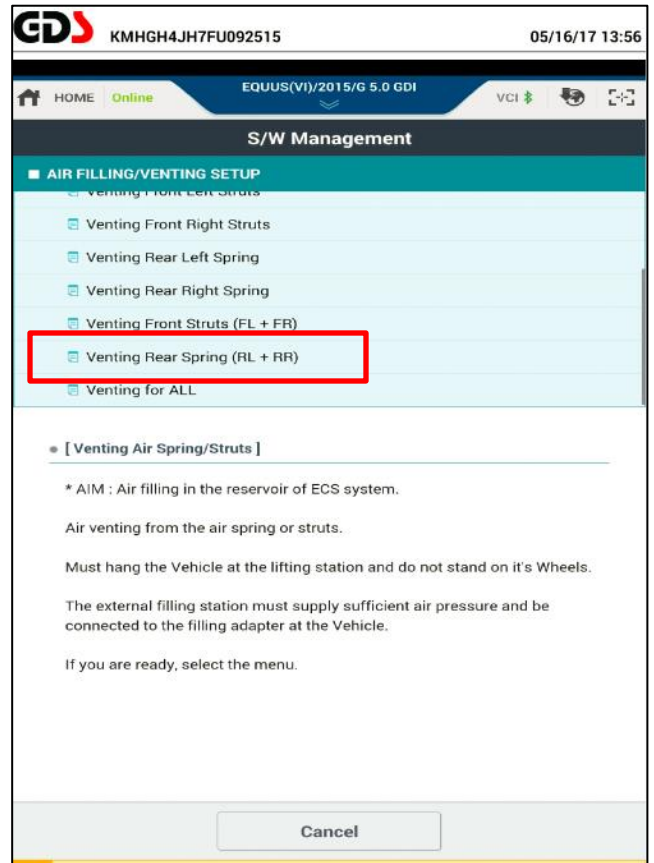
3. Always discharge the air before removing rear air springs using the GDS Tablet.

The air discharge can be found under:
“S/W Management -> Air Filling/Venting Setup -> Venting Air Springs/Struts -> Venting Rear Spring (RL + RR).”

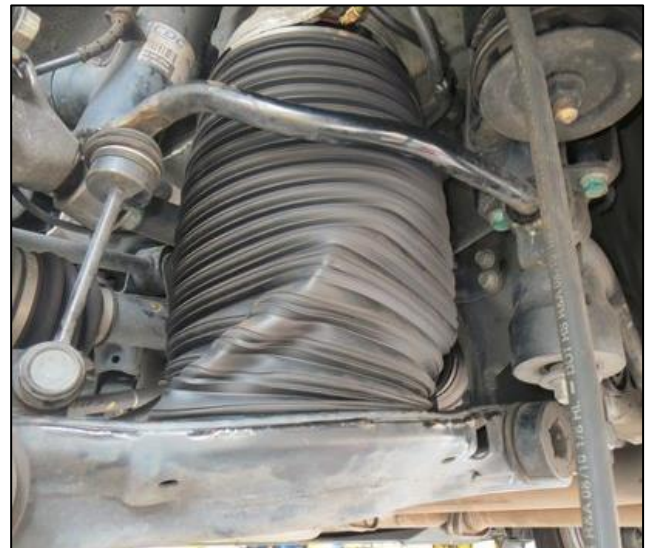
- 4a. When handling the new air springs, take care to not excessively twist/bend/extend the assemblies. Doing so can distort the air bladder.

The image to the right shows evidence of a distorted air bladder, *after introducing air pressure.*

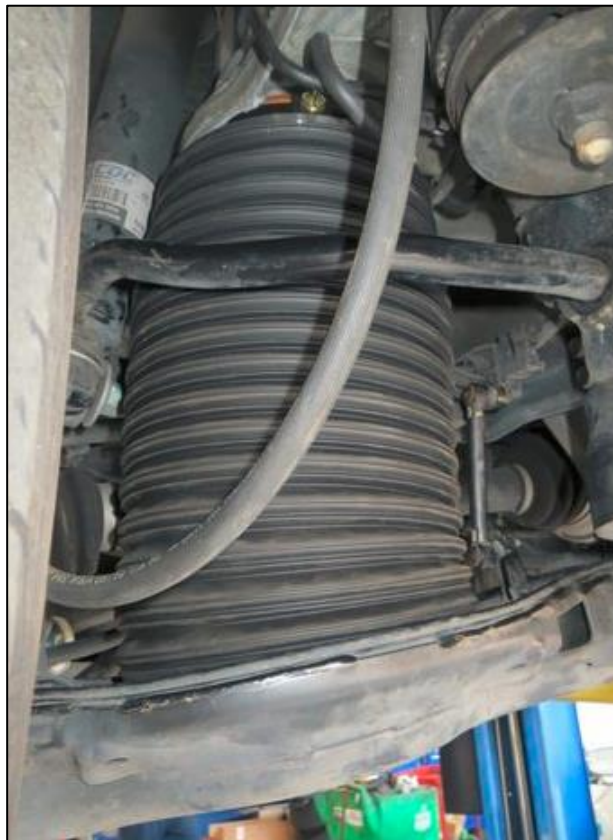
- 4b. The image to the right shows an example of a properly installed and pressurized air spring, with no dust boot distortion.

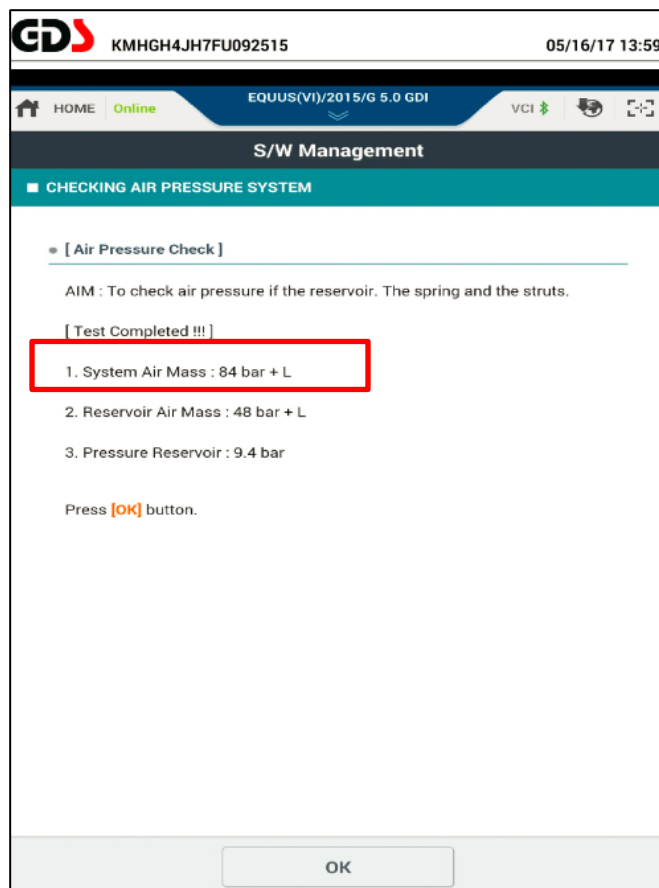
- 5. Check the system air mass using GDS. The minimum value should be 80 bar-liter.

The air mass check can be found under:
“S/W Management -> Checking Air Pressure System -> Air Pressure Check.”

If the system is below 80 bar-liter, fill the system with air according to the procedures described in TSB 12-SS-003.
