2018 Odyssey Rear Entertainment System Display Inspection

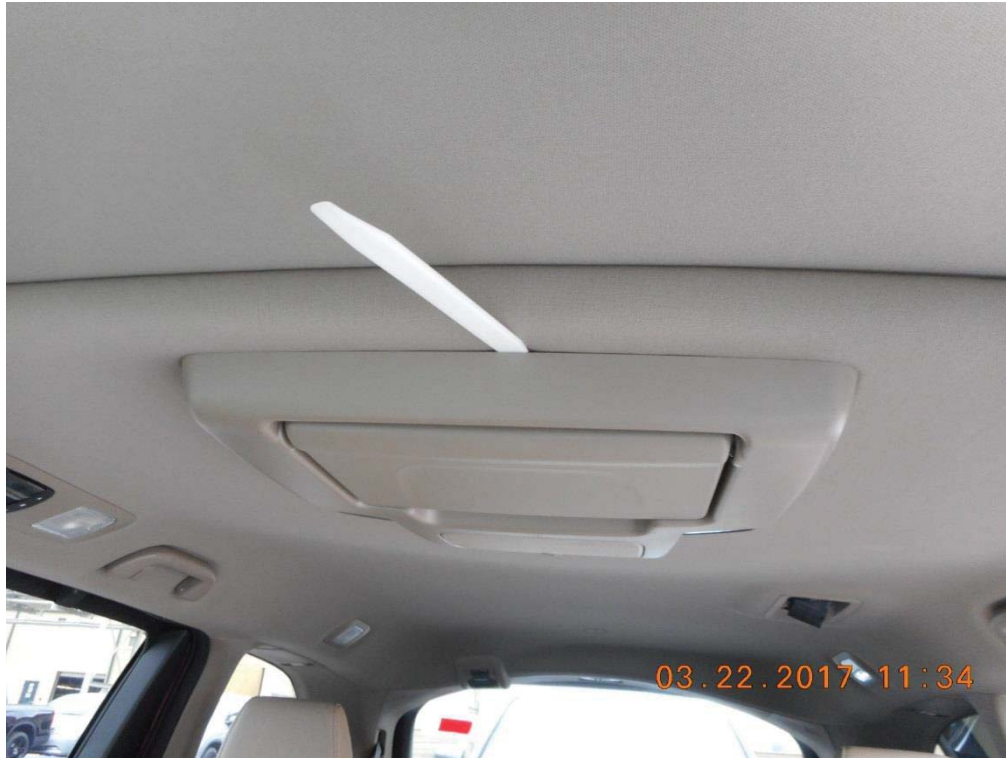
Using white stick remove front and sides of display garnish first by pulling down.

Do not damage the headliner or garnish during removal. Ensure no dirt or smudges on Headliner or RES garnish from hands or tools during repair process.

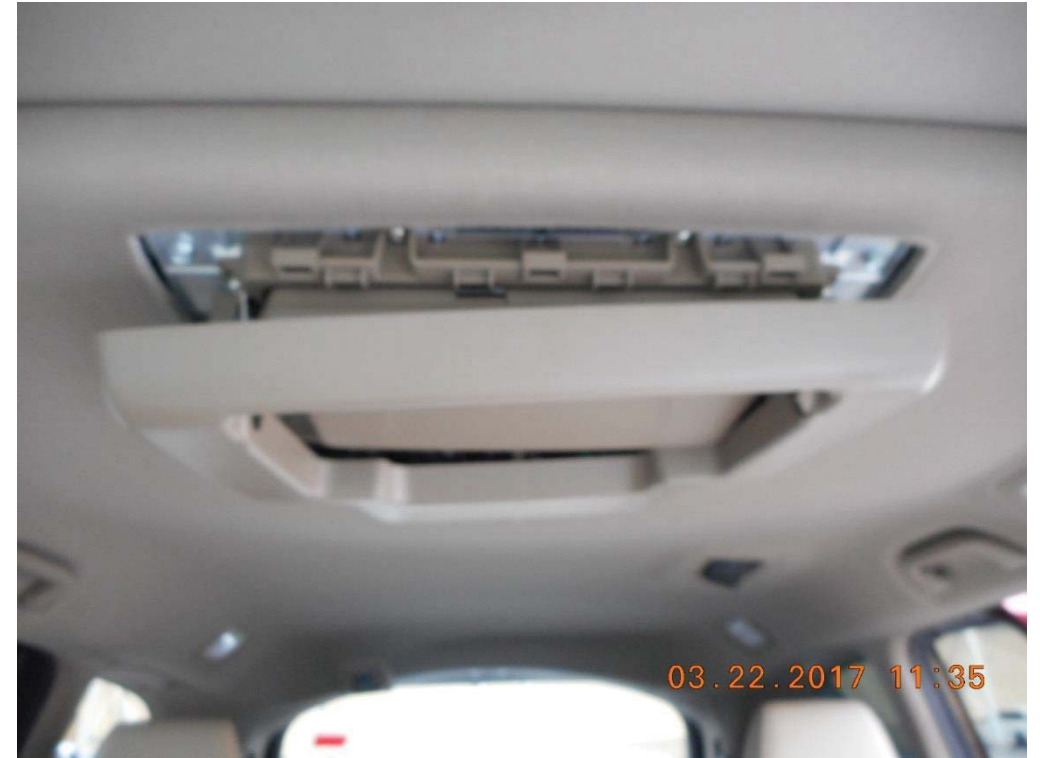
Front and sides of display garnish removed.

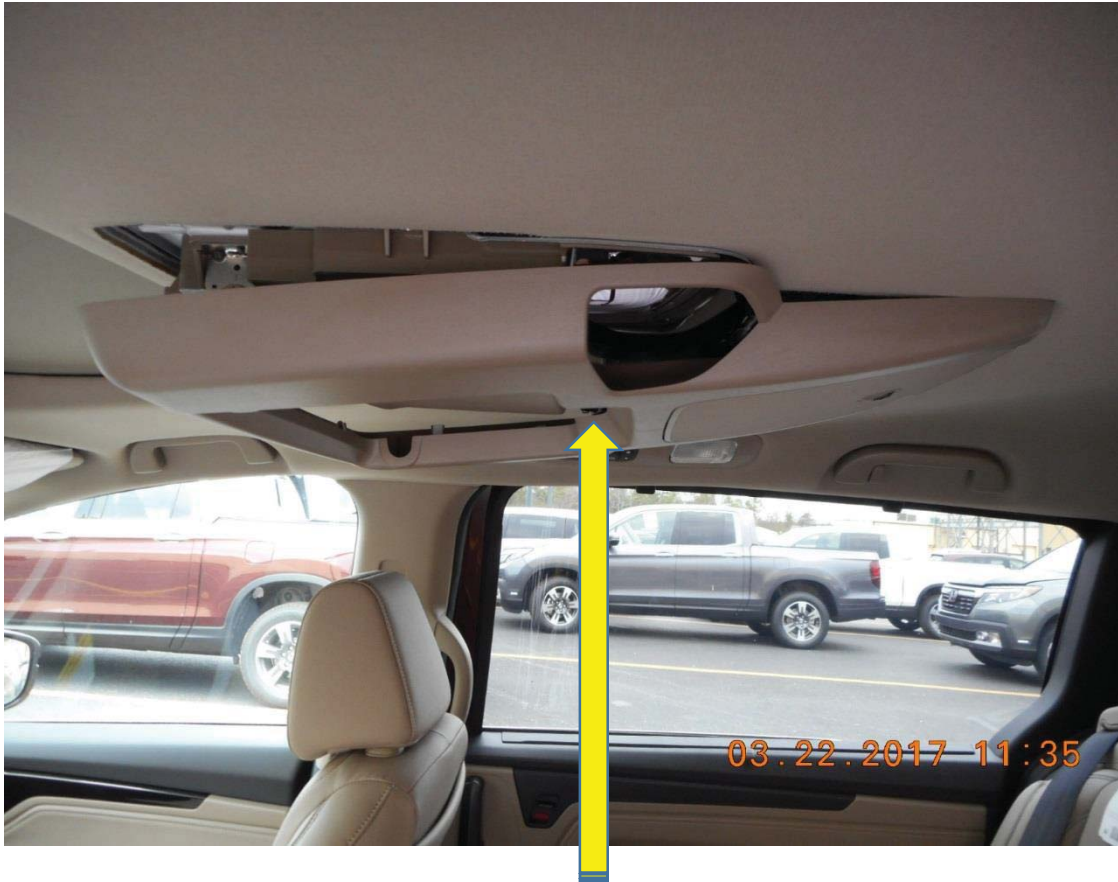
Grasp garnish here to pull down to remove rear clips.
Do not damage the headliner or garnish during removal.

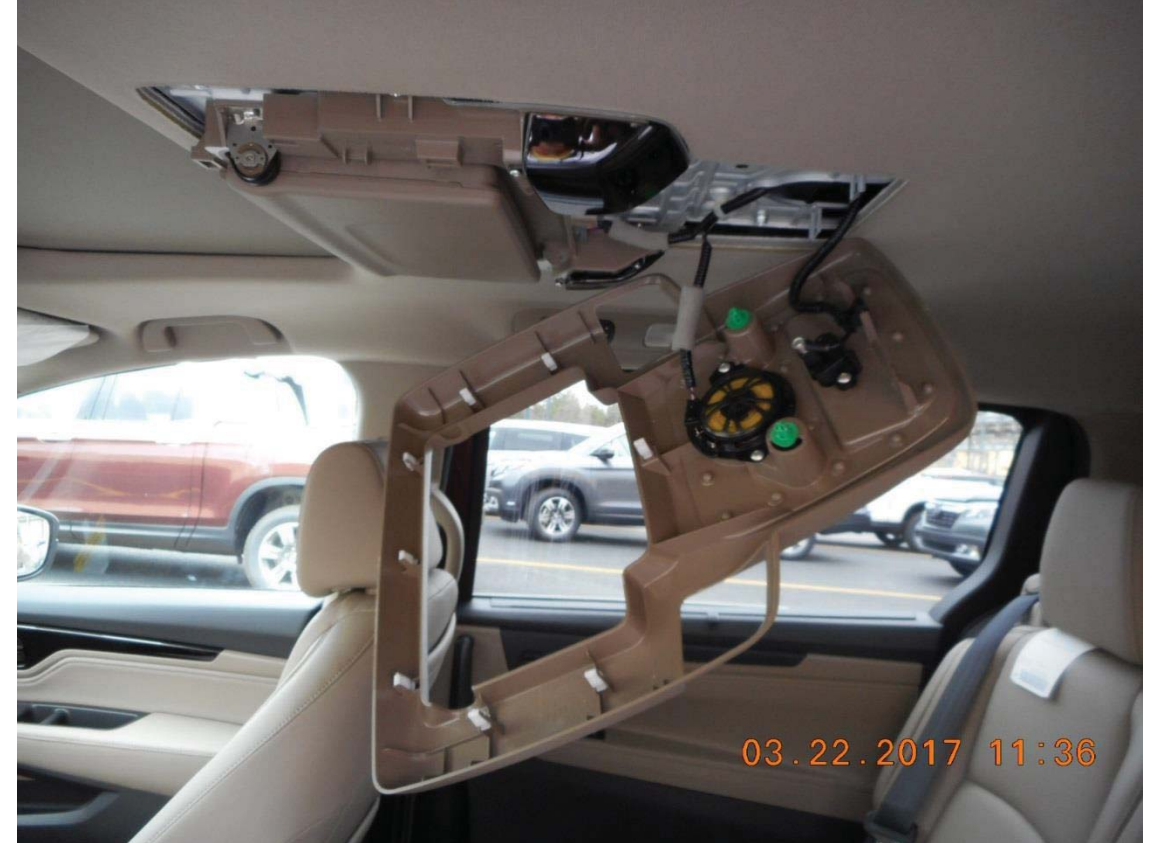
Display garnish removed.

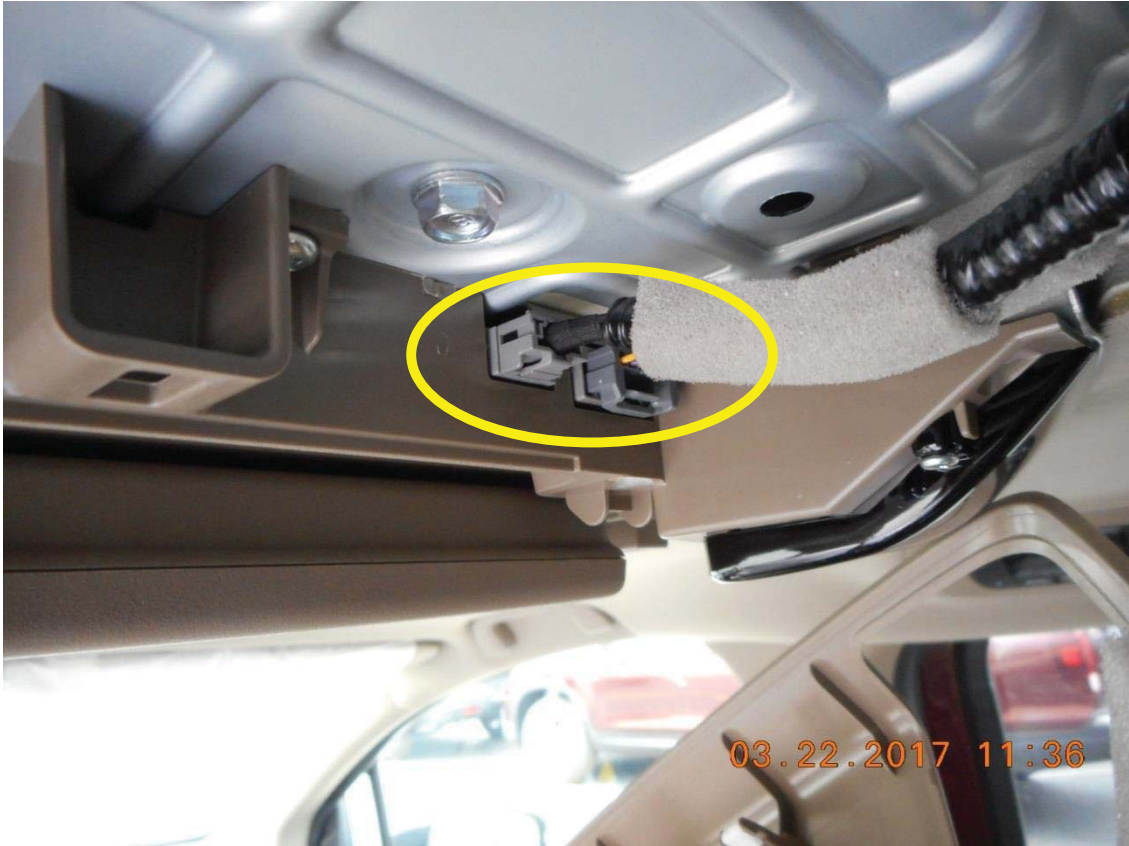
Remove two gray couplers

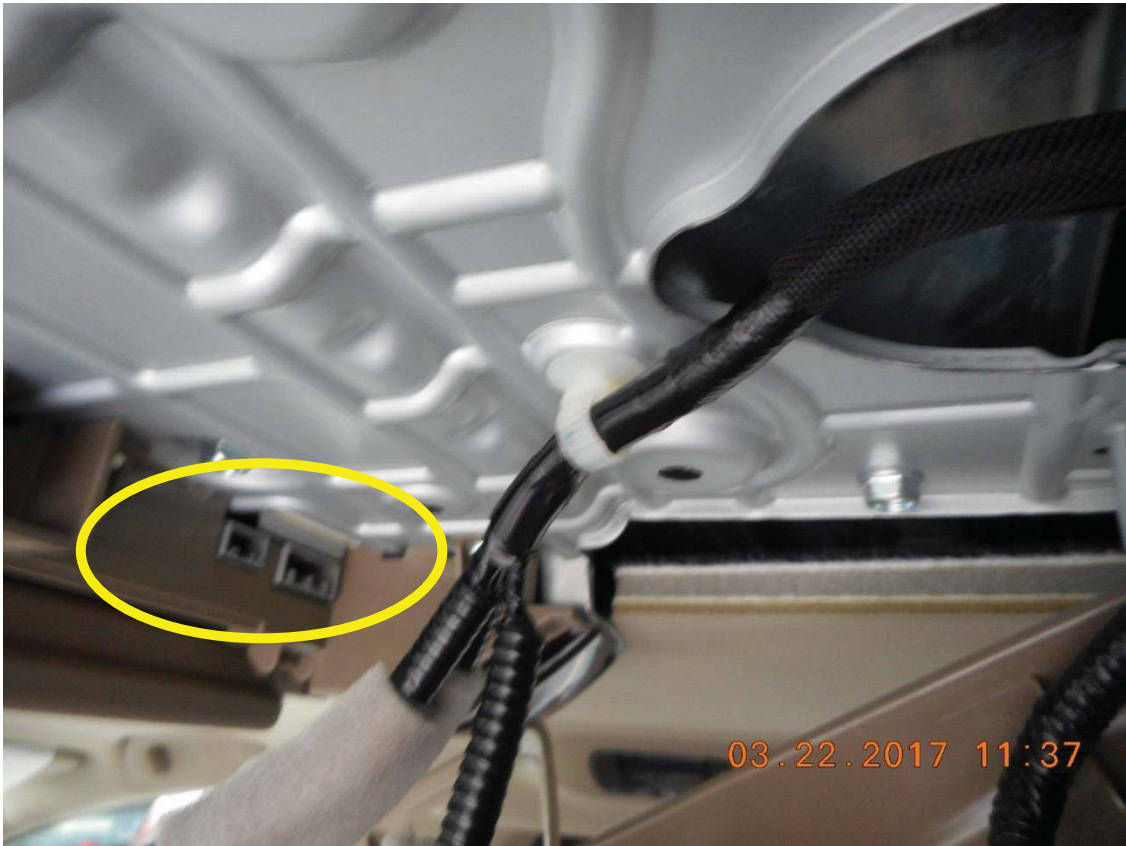
Two gray couplers removed

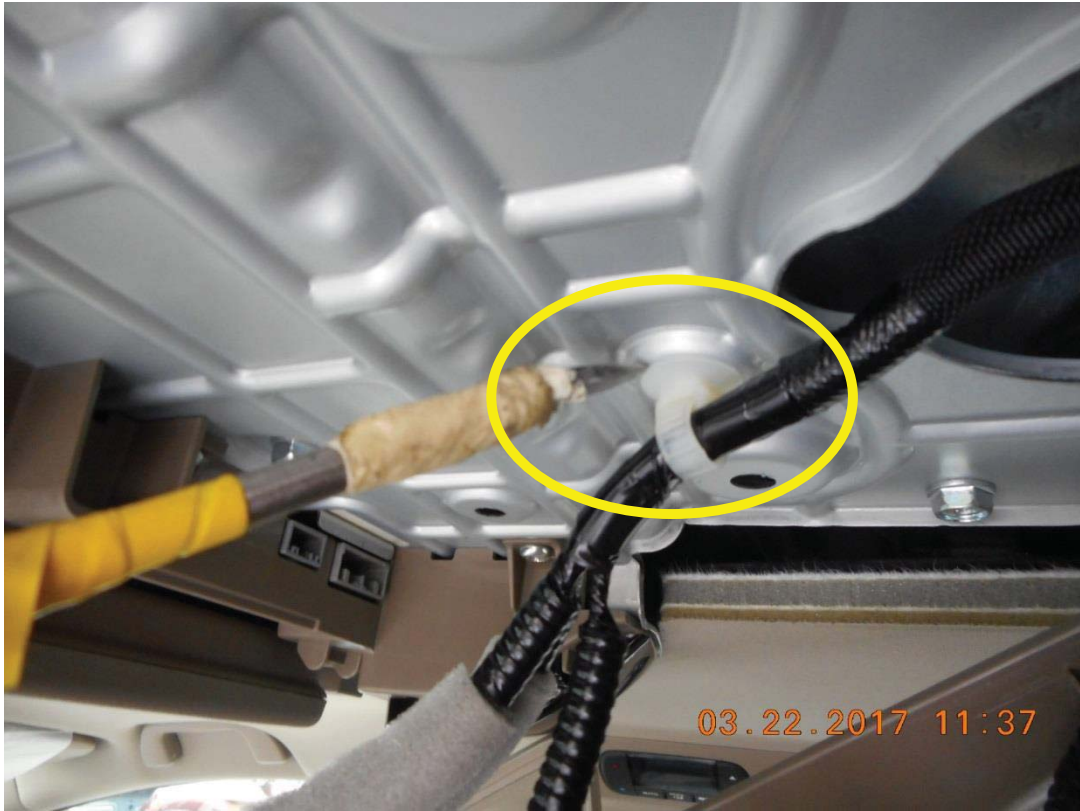
Using Crows Foot remove white harness clip

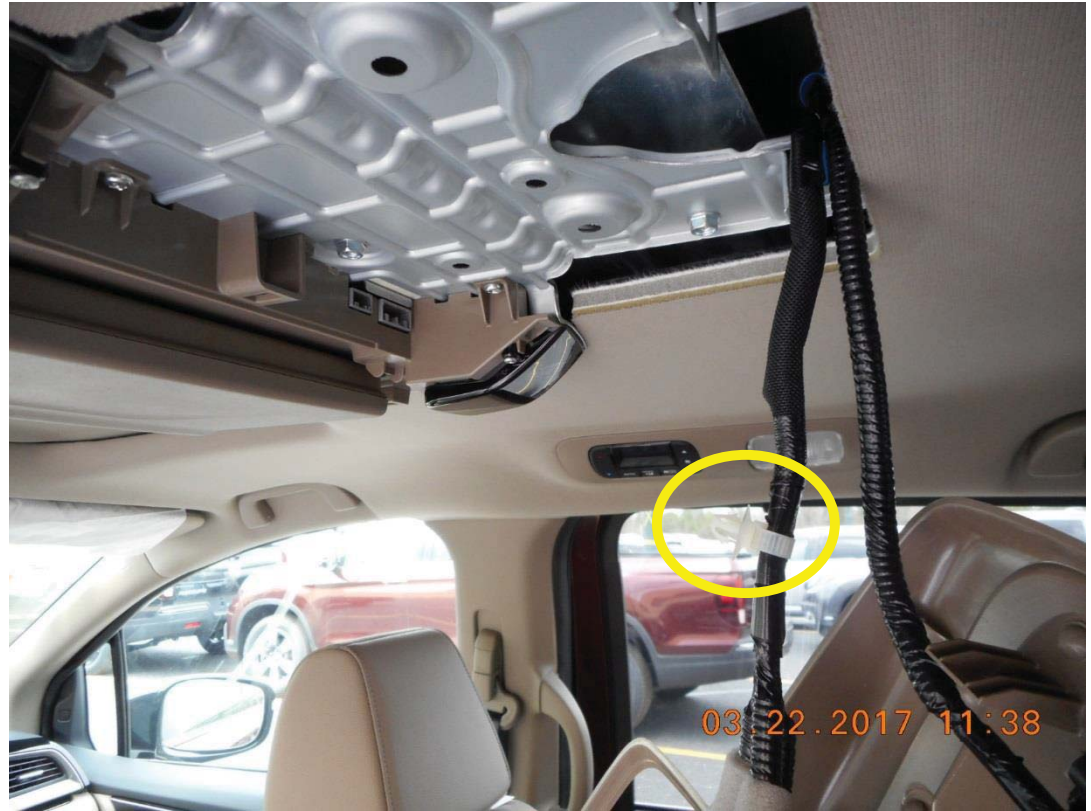
White harness clip removed

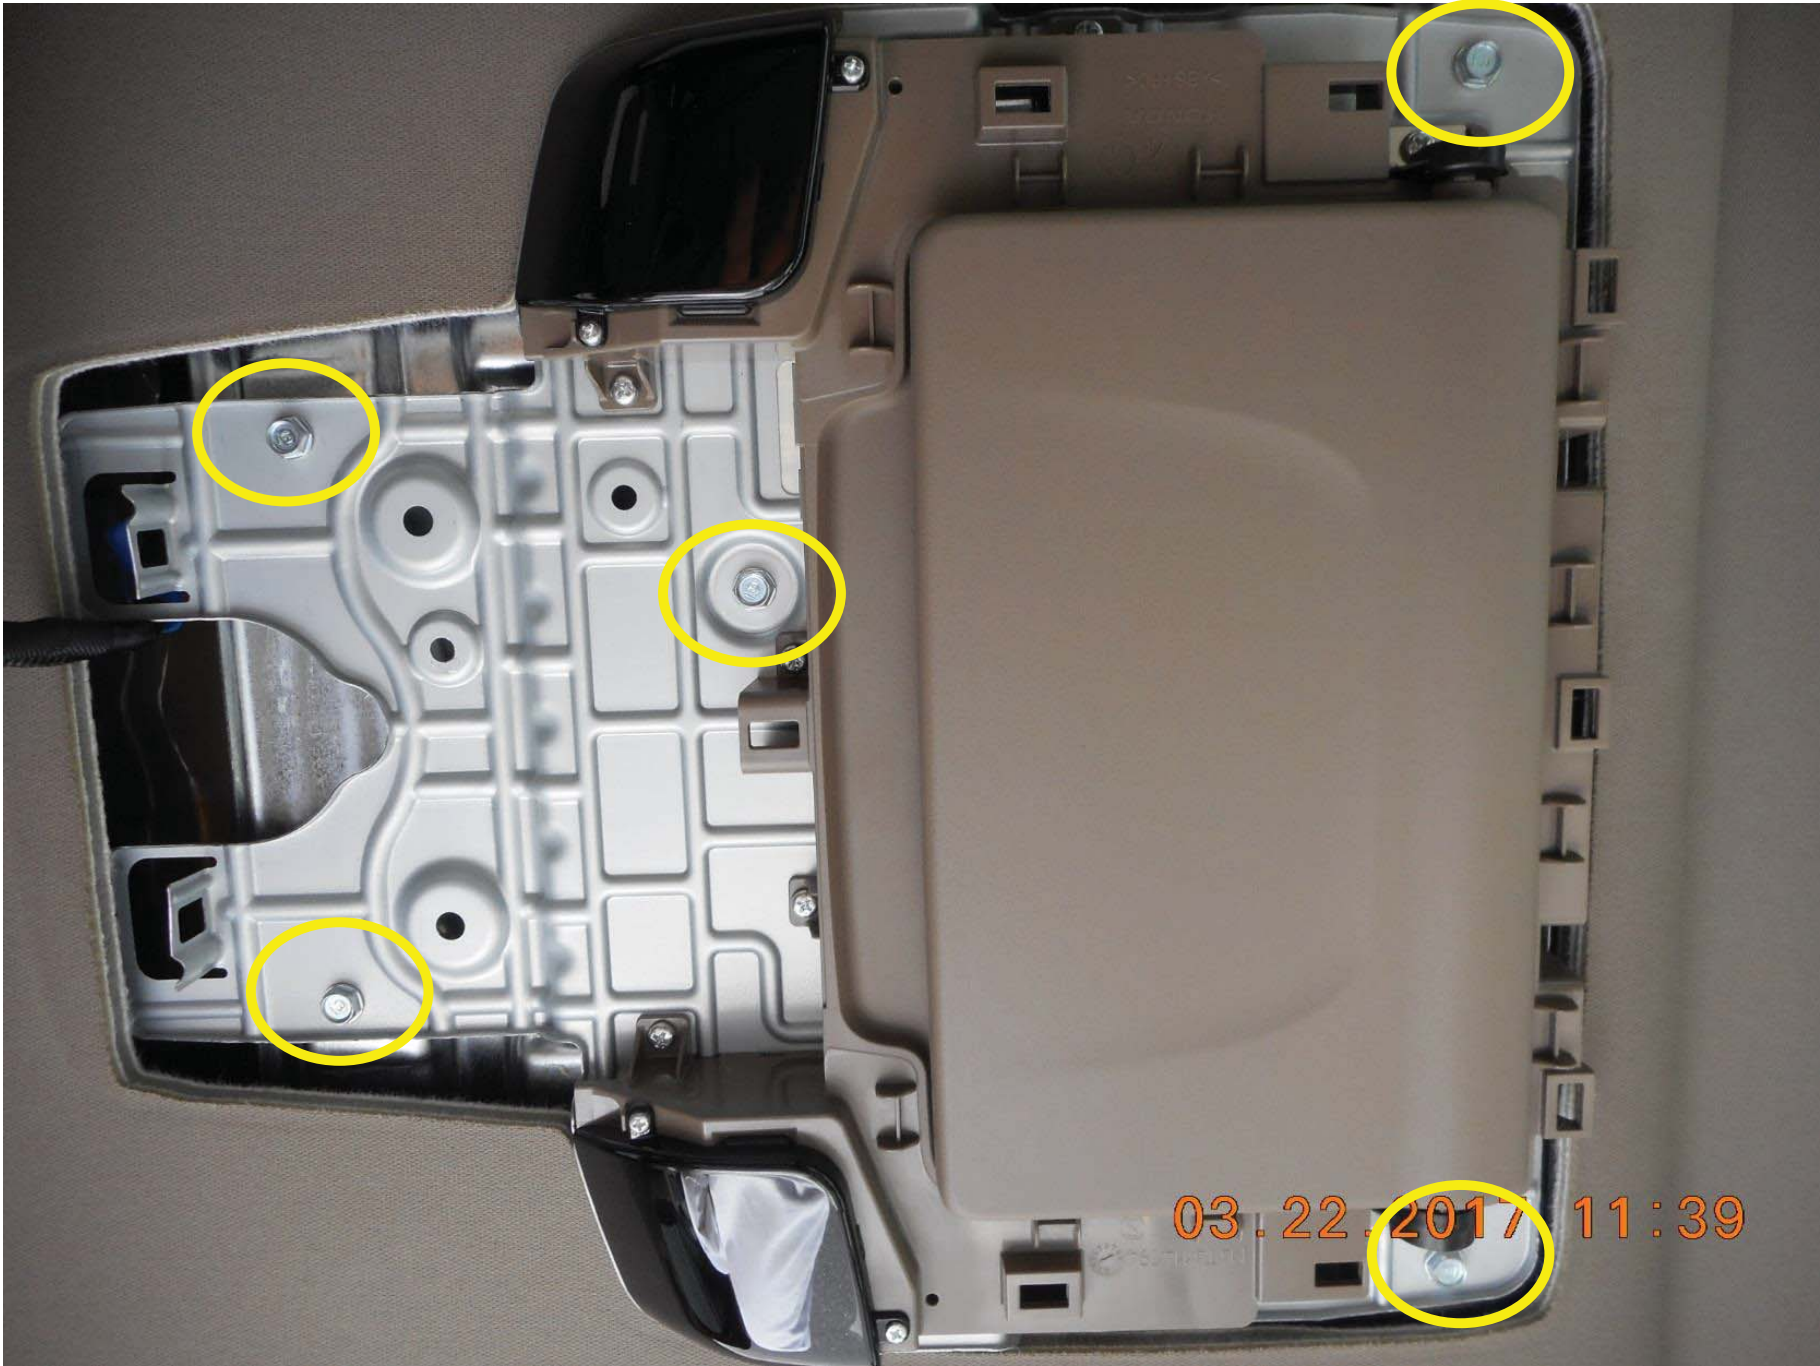
Locate 5 6x12 mm bolts

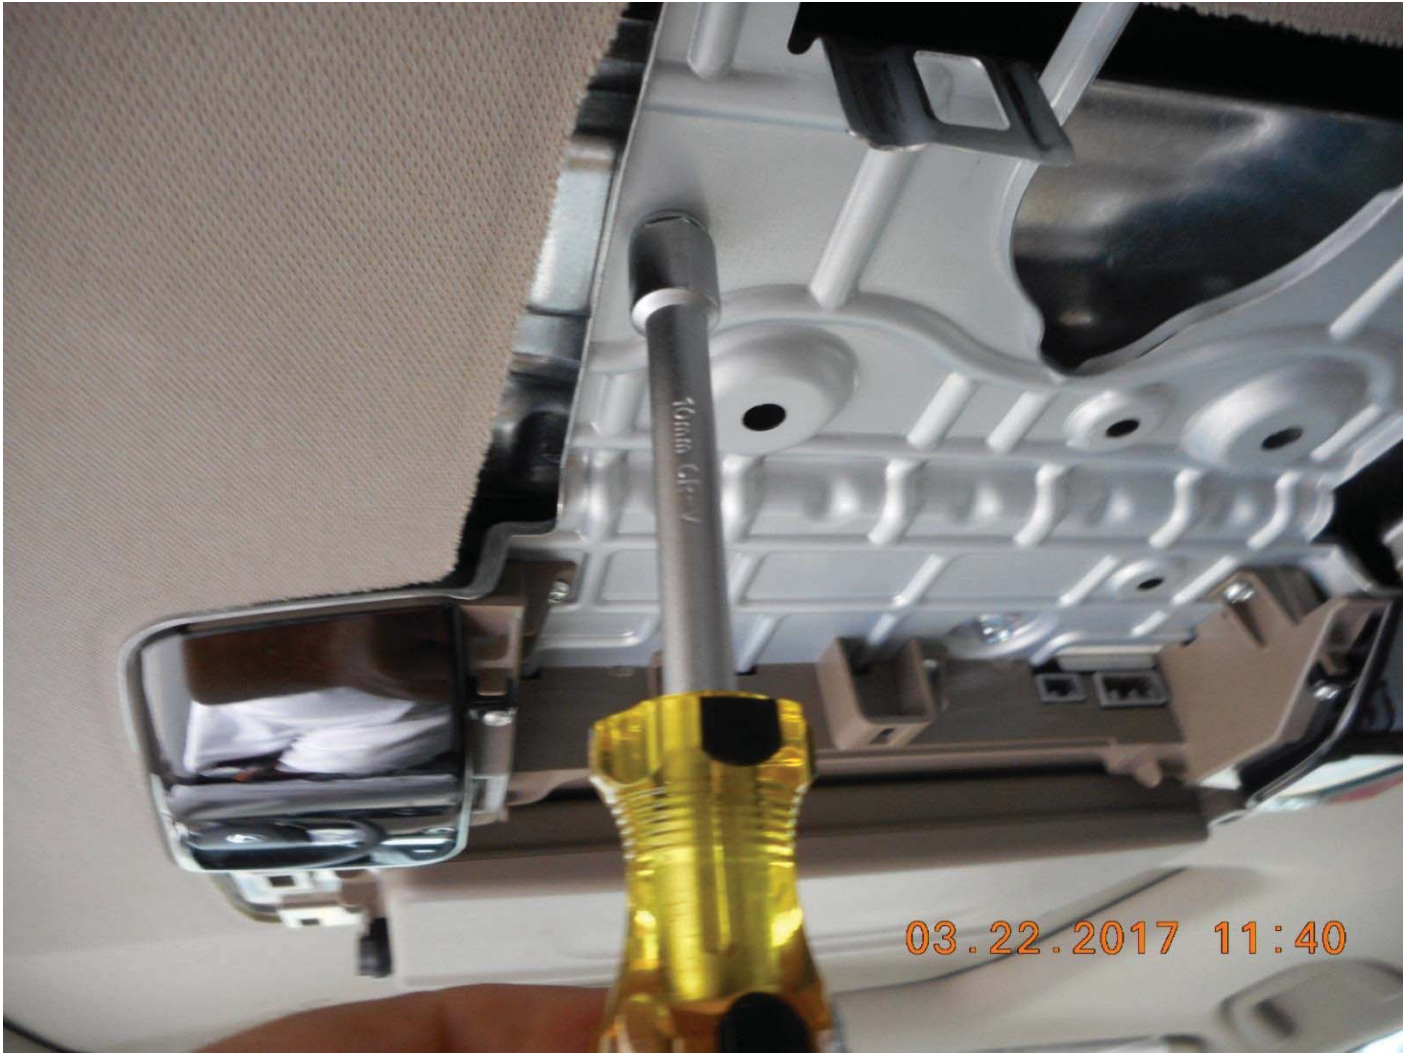
Using 10mm socket remove the five 6x12 mm bolts

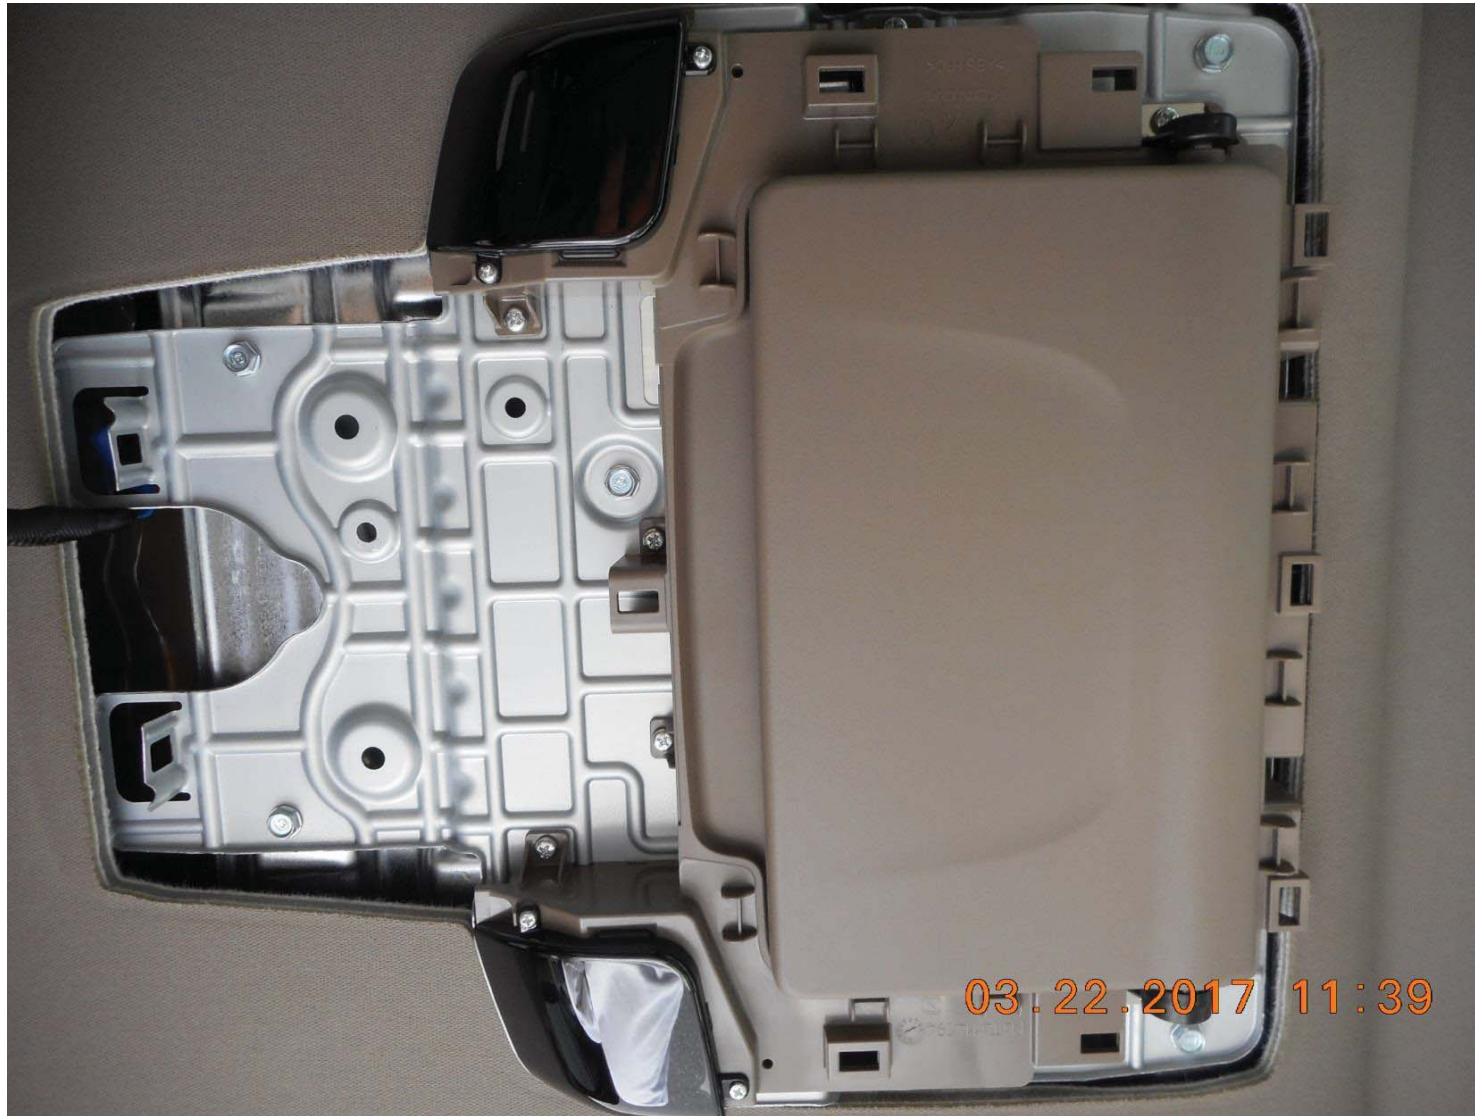
Confirm new RES Display is correct color for vehicle. Should be the same color as Headliner.

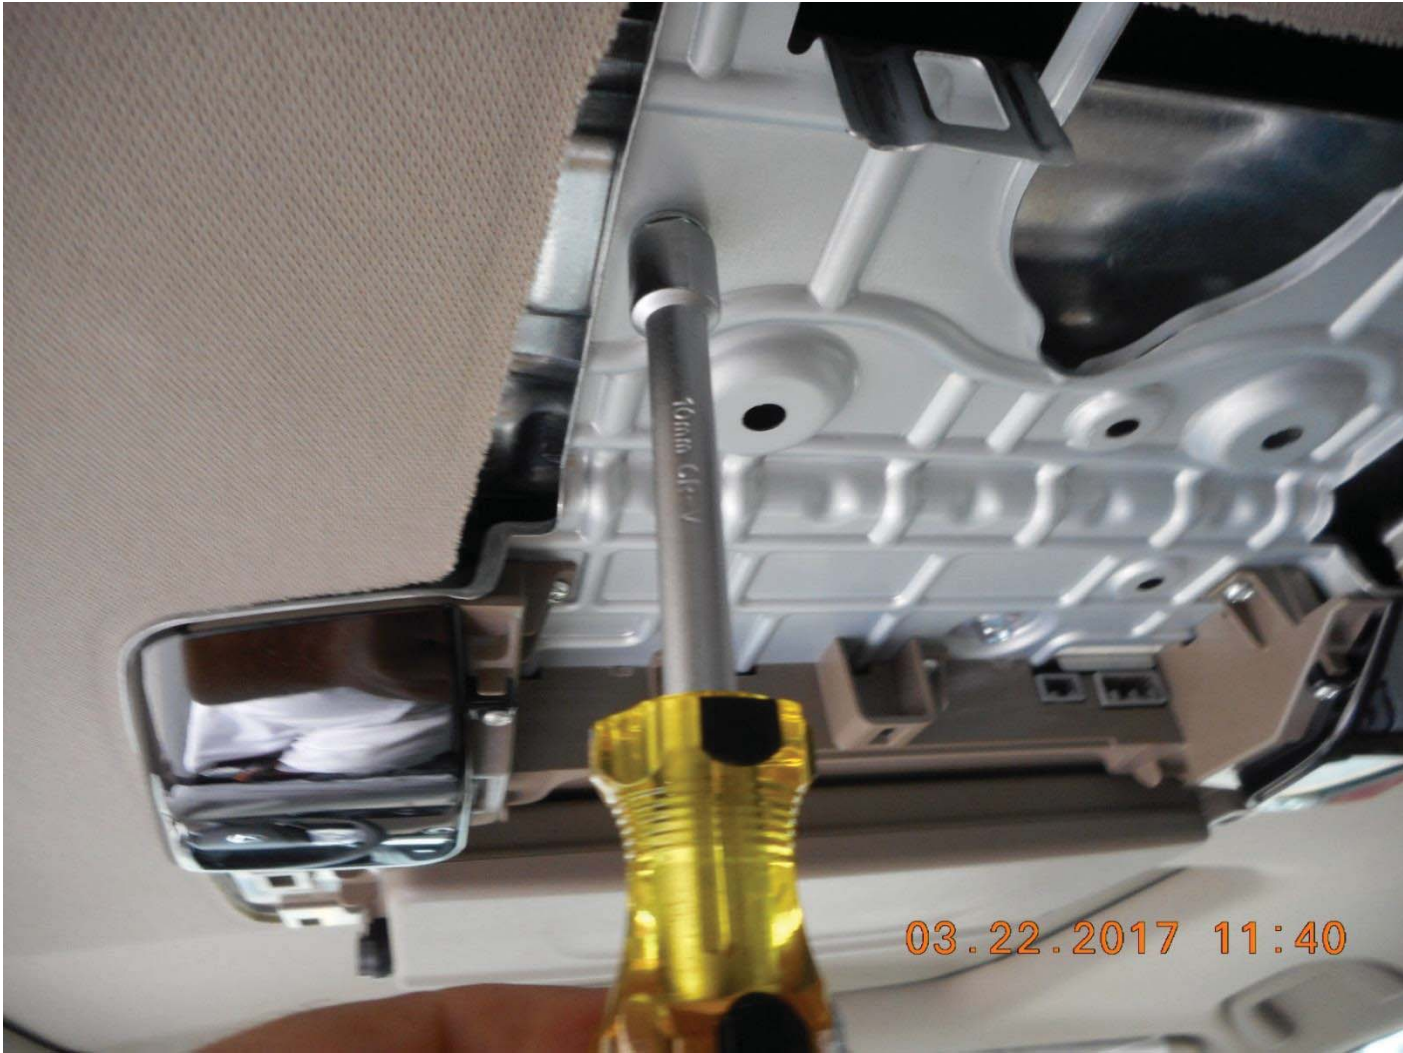
Using 10mm socket reinstall the five 6x12 mm bolts of the new RES Display

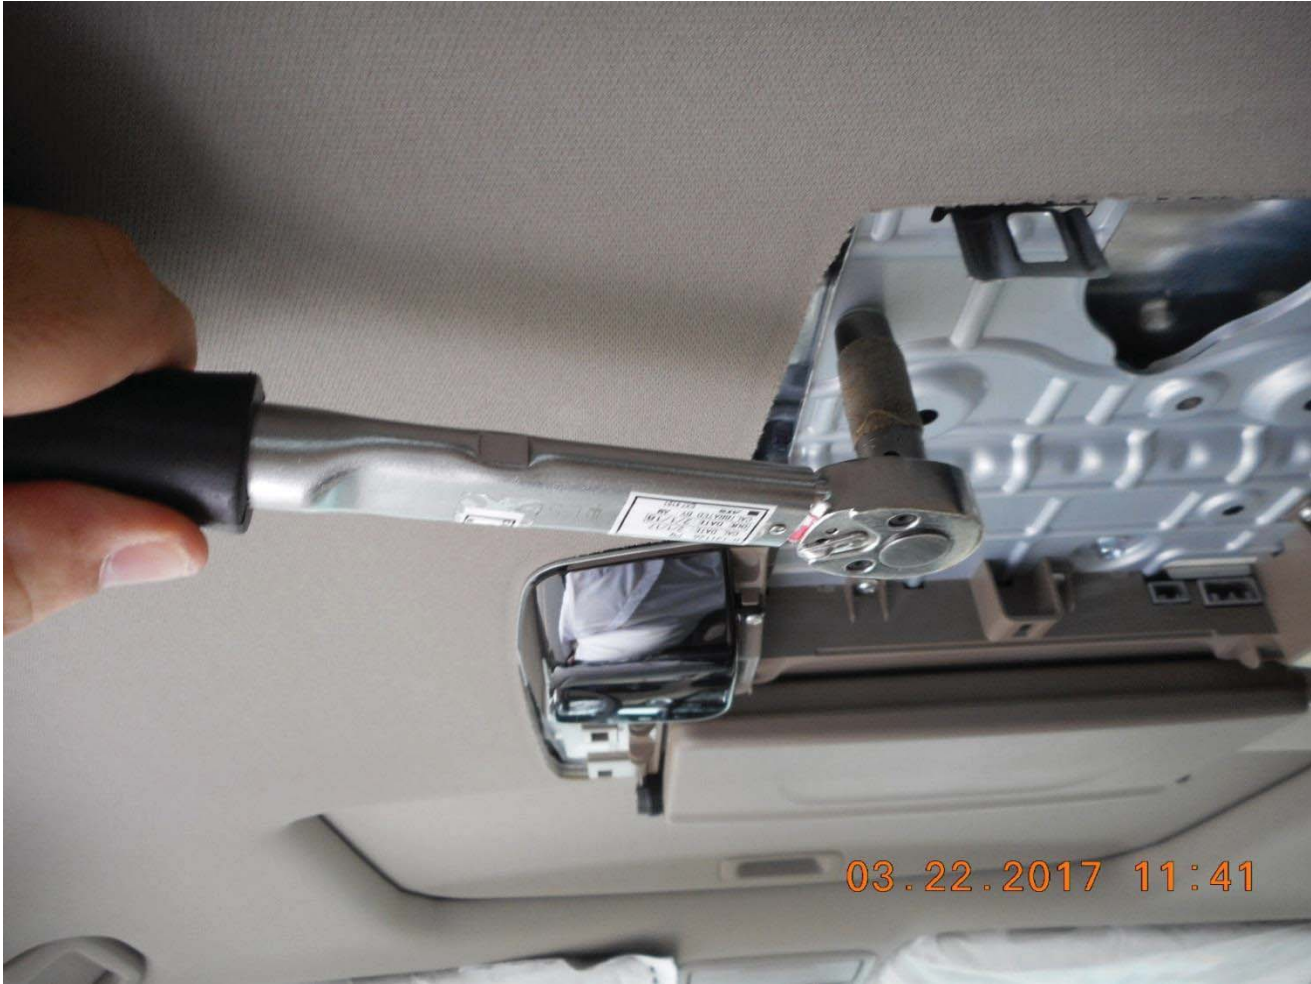
Using torque wrench set at 10Nm with 10mm socket confirm the torque of the five 6x12 mm bolts

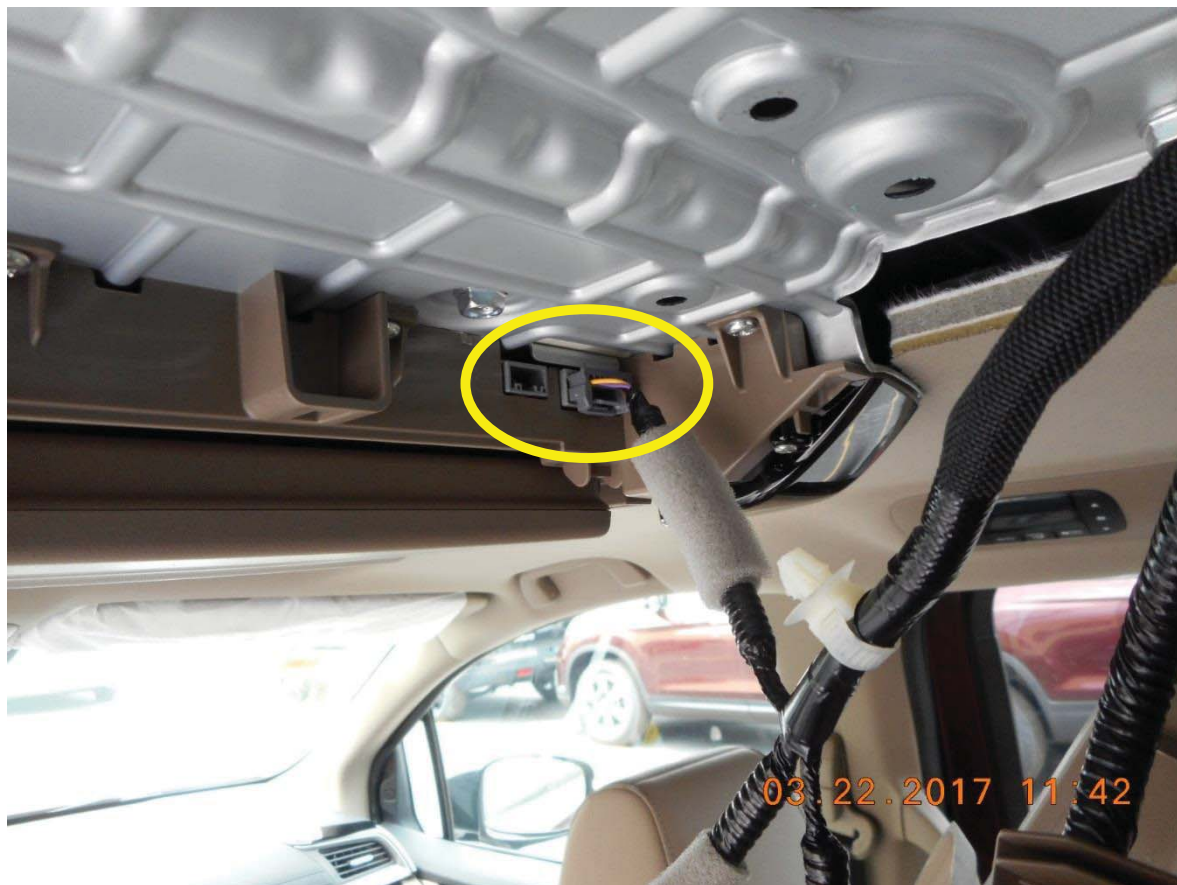
Reinstall the two gray couplers

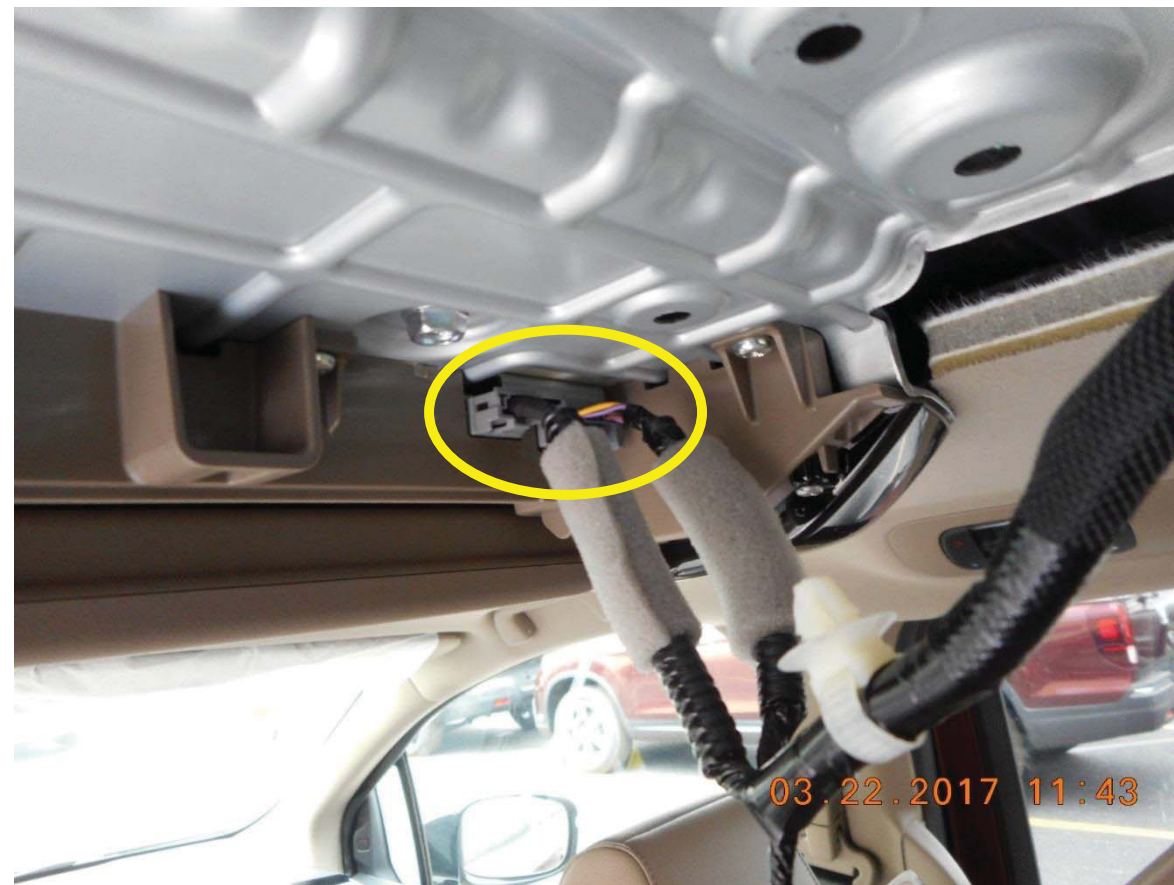
Confirm gray couplers installation by push-pull-push method.

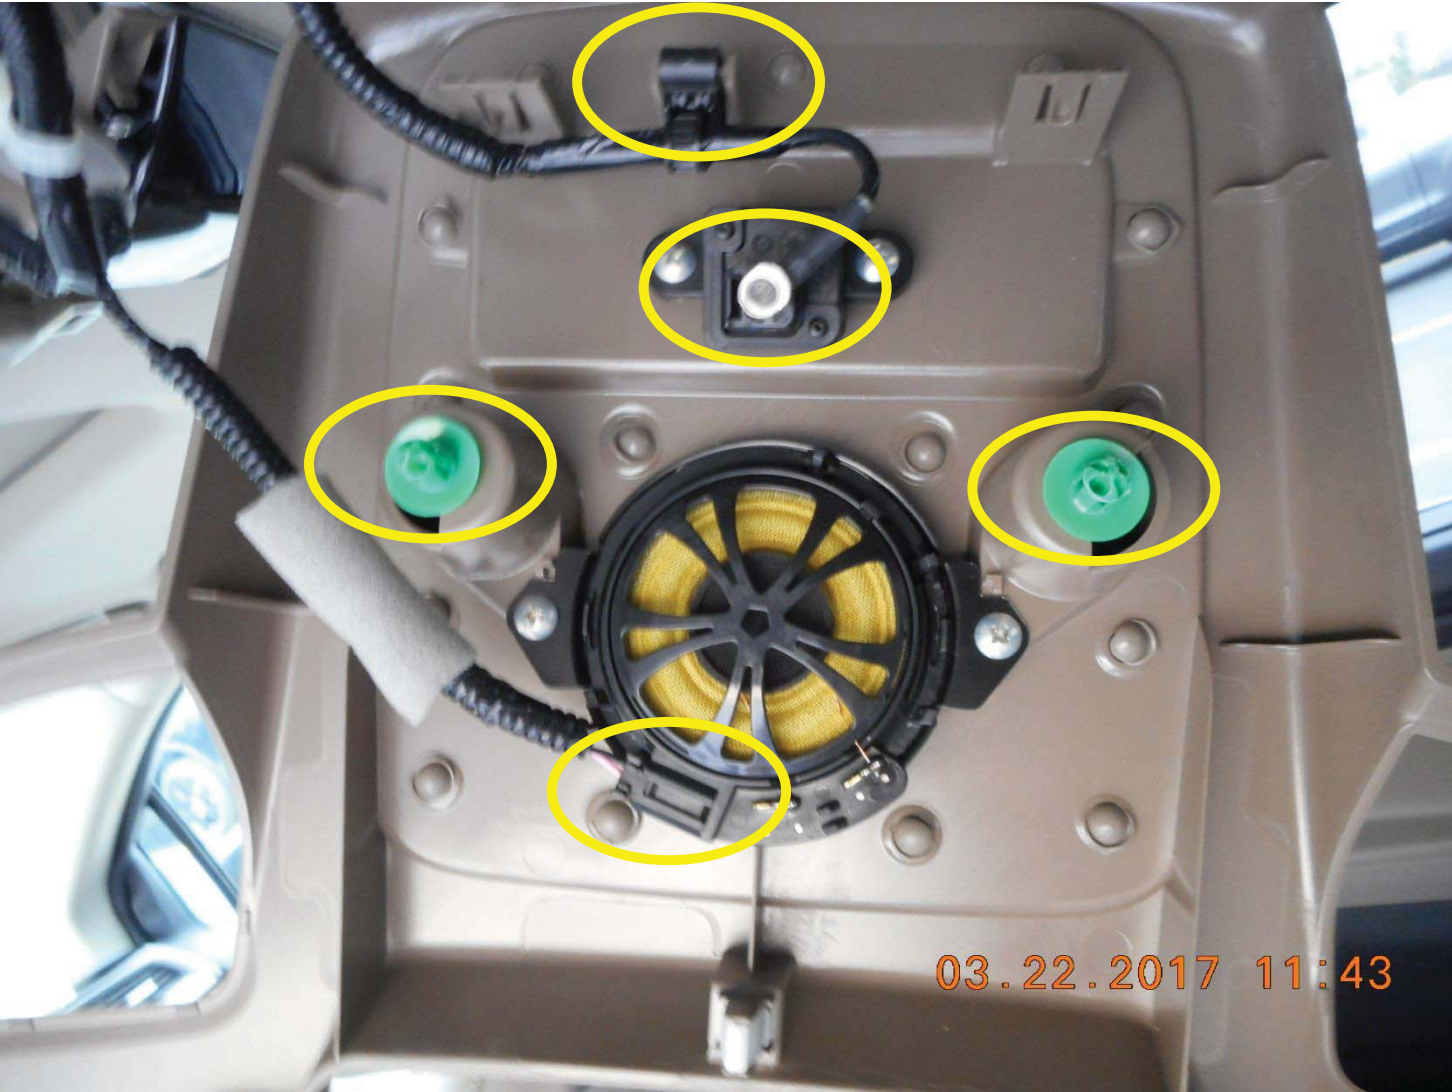
Confirm speaker coupler, green grommets, black camera clip and black camera coupler are secure on display garnish.

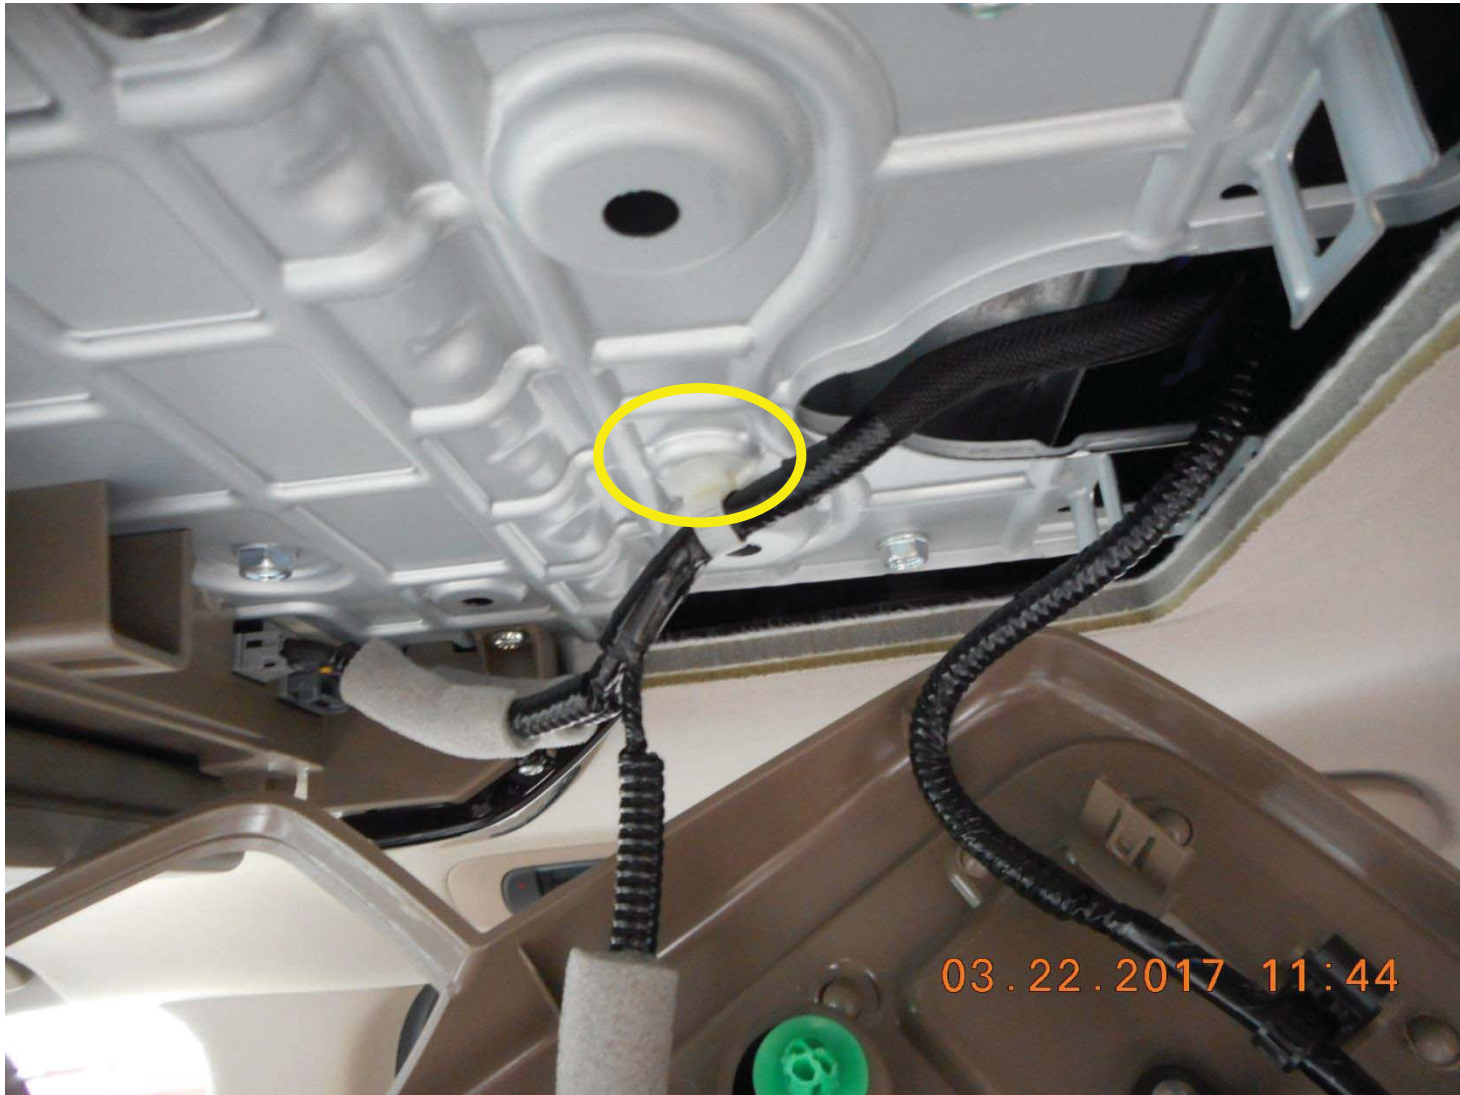
Reinstall white harness clip. **Note**
clip hole is between two larger
mounting holes.

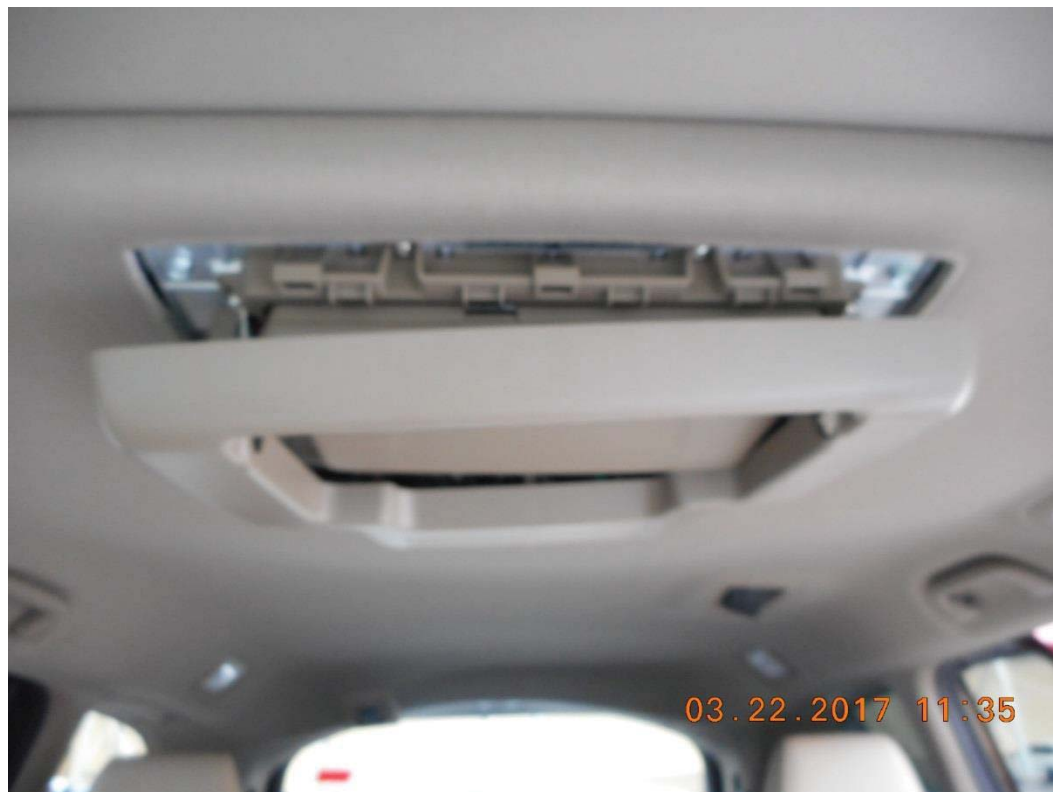
Line up front and side tabs push display garnish into place. **Do not damage headliner or display garnish during reinstall.**

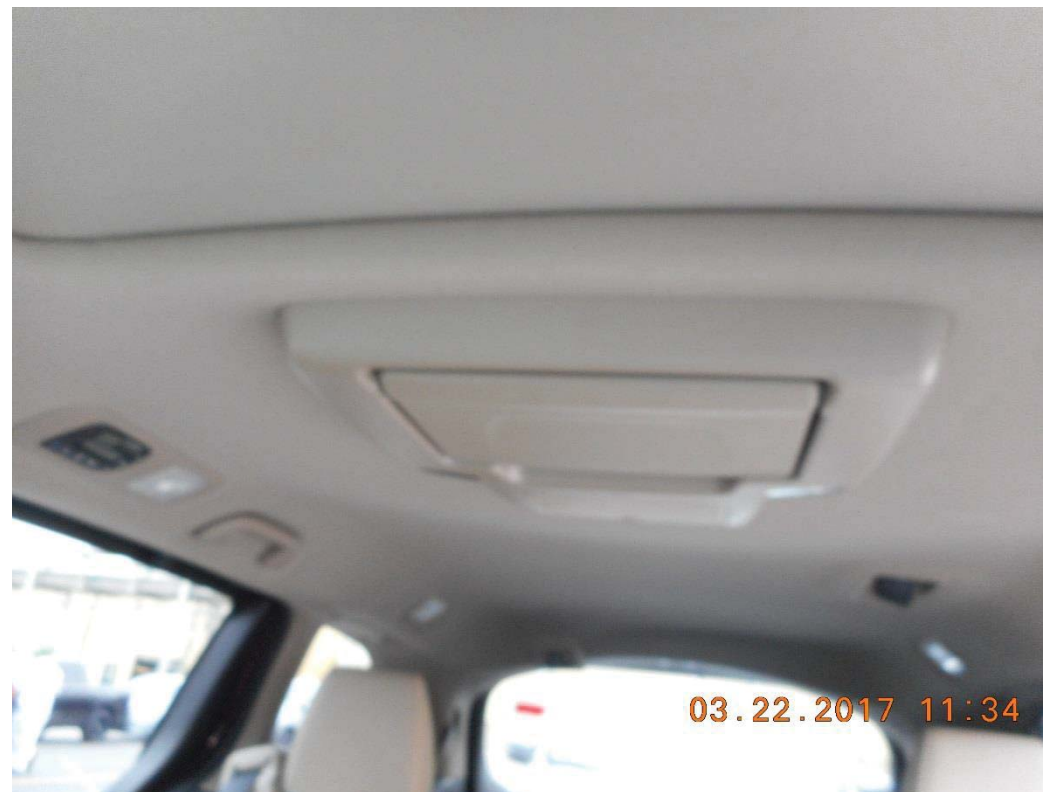
Confirm no gaps around edge between RES display garnish and Headliner. **Ensure Headliner and RES garnish area are clean no dirt no smudges.**
