2018 Odyssey Rear Entertainment System Display Inspection

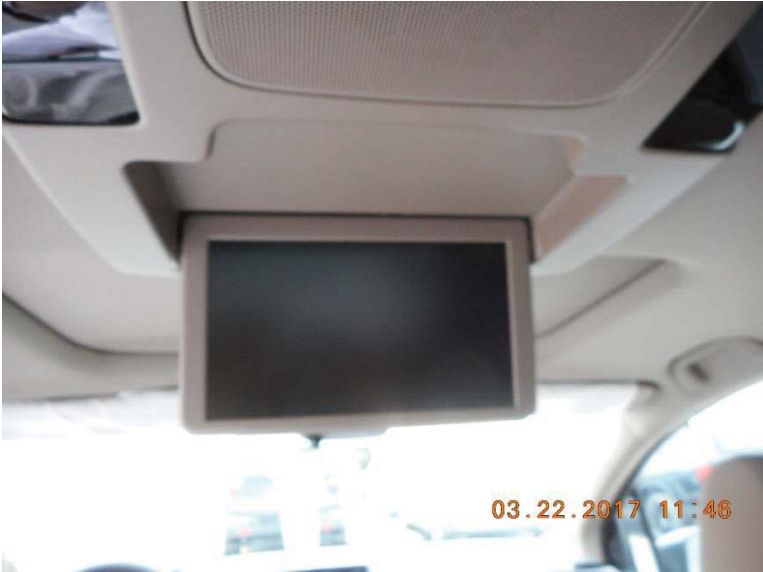
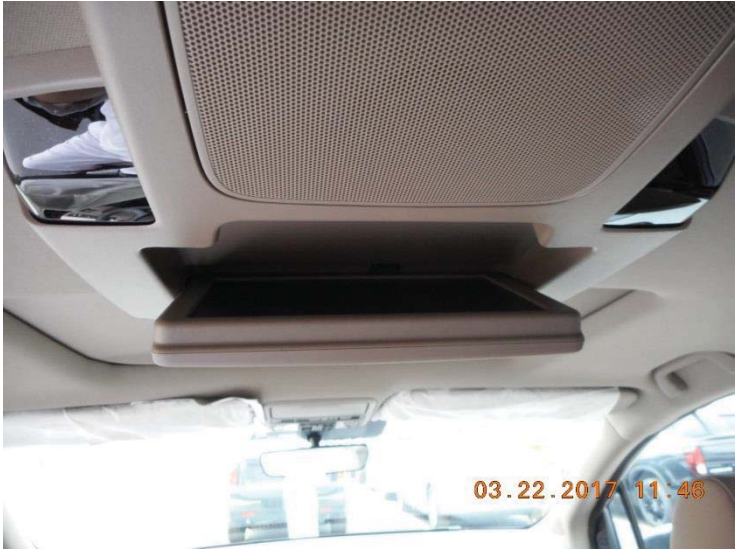
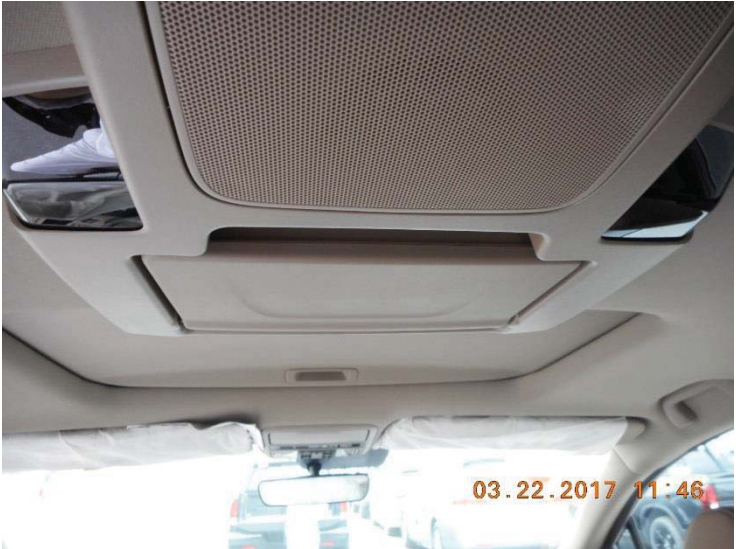
Open and close display screen ensure no rubbing or noise when functioning.

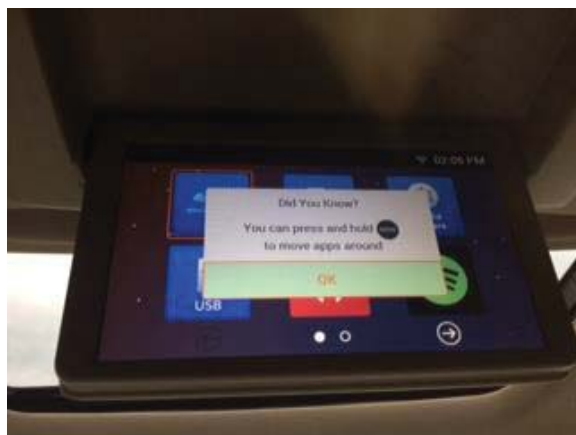
Confirm Rear Display is on and no distortion
