GROUP <b>BOD</b>	MODEL <b>2015-2017MY Sedona (YP)</b>
	NUMBER <b>165</b>	DATE <b>June 2017</b>
<b>TECHNICAL SERVICE BULLETIN</b>		
<b>SUBJECT: COMBINATION TSB/SERVICE ACTION: POWER SLIDING DOOR (PSD) DRIVE UNIT REPLACEMENT (SA271)</b>

**SUBJECT: POWER SLIDING DOOR (PSD) DRIVE UNIT REPLACEMENT (SA271)**

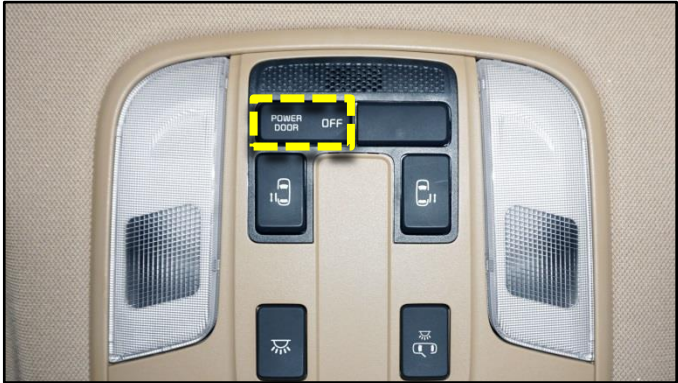
1. Press the Power Sliding Door (PSD) button to turn the PSD system OFF.

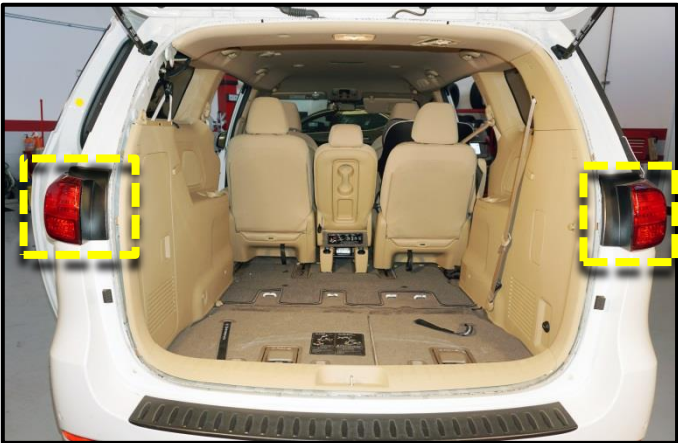
2. Open the tailgate and remove the LH/RH rear combination tail lamps.

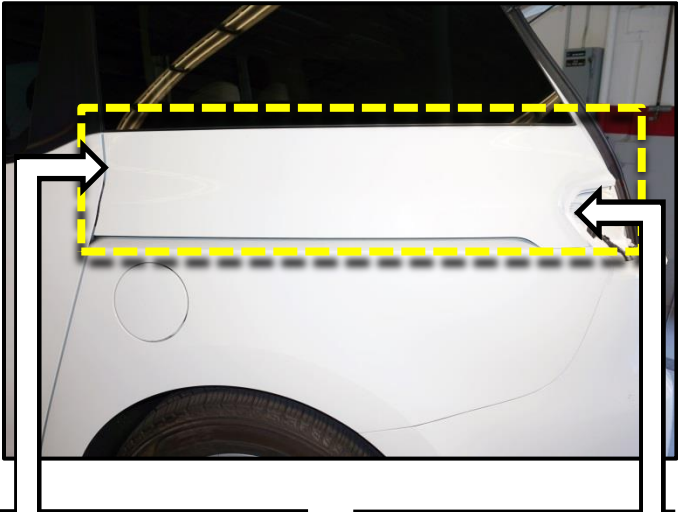
3. Remove one (1) screw from the front and one (1) screw from the rear of the sliding door trim panel, as shown.

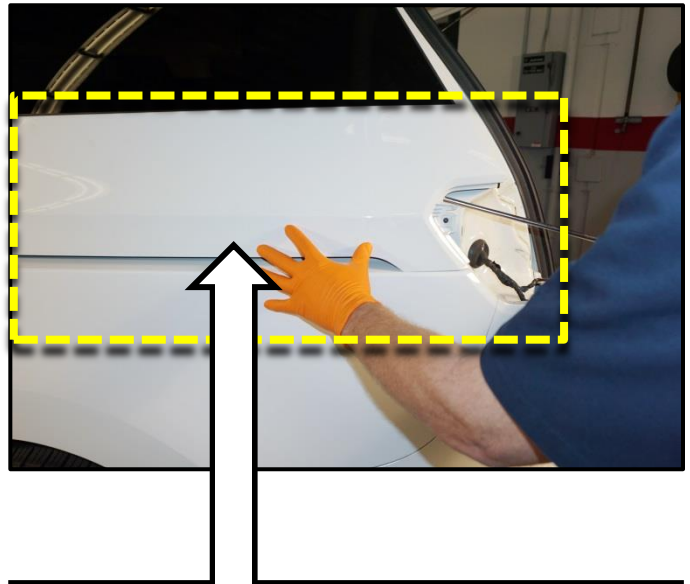
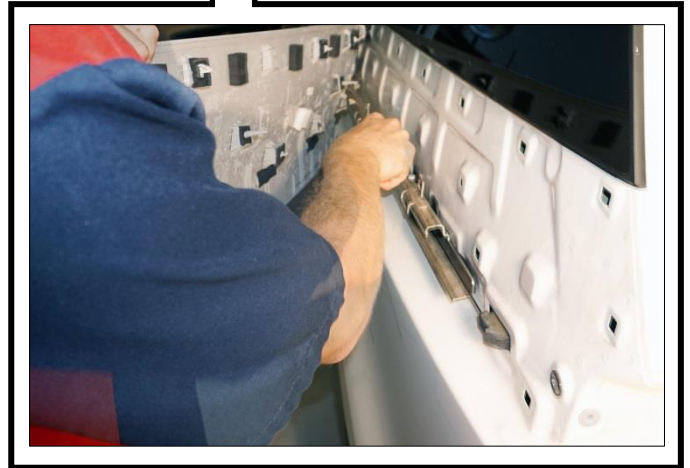
4. Use a panel removal tool to carefully remove the sliding door trim panel, as shown.

To prevent damaging the sliding power door trim panel, apply only even, and gentle, outward force to the panel, as the clips are being removed.

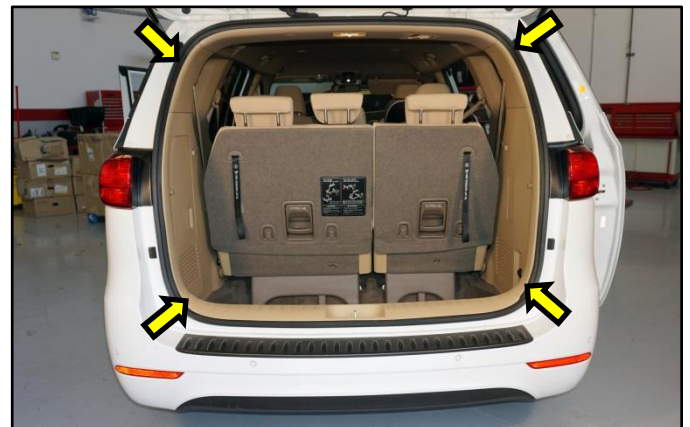
5. Remove the weather strip from the trunk compartment opening.

Use a non-marring trim removal tool (Such as Snap-on® Part Number PBN5 or equivalent) to avoid damaging trim pieces.

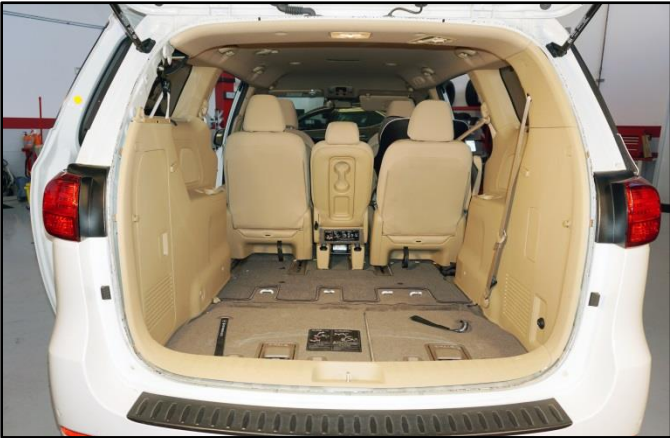
- 6. Fold and stow the third row seats, as shown.

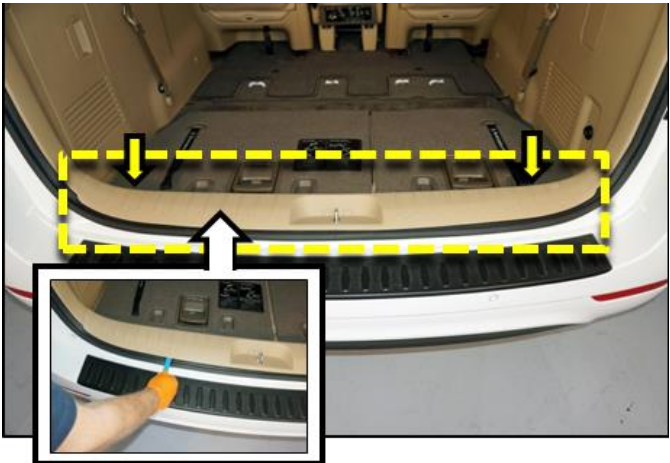
- 7. Remove two (2) screws from the leading edge of the trunk scuff guard. Then, use a non-marring trim removal tool to remove the trunk scuff guard trim, as shown. **NOTE: replace any broken clip(s) with new ones.**

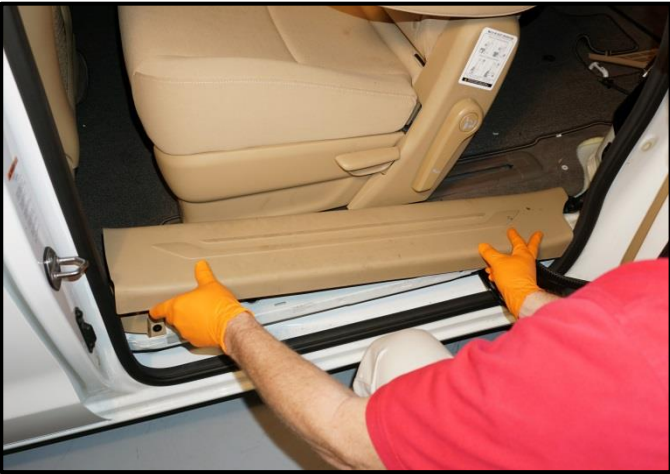
- 8. Remove the sliding door threshold trim piece, as shown. **NOTE: replace any broken clip(s) with new ones.**

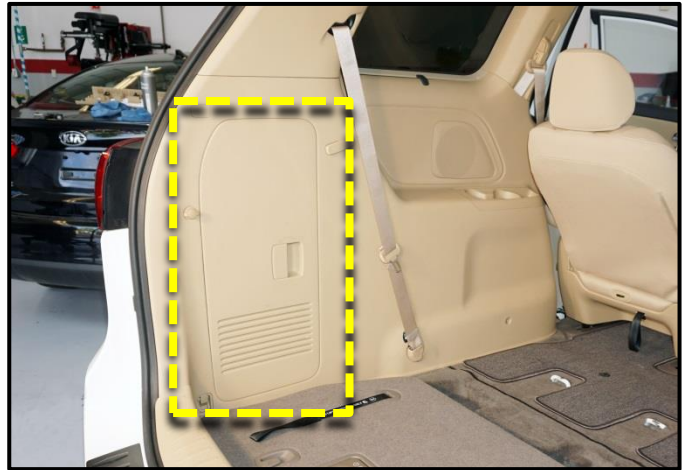
9. Remove the scissor jack storage compartment access door.

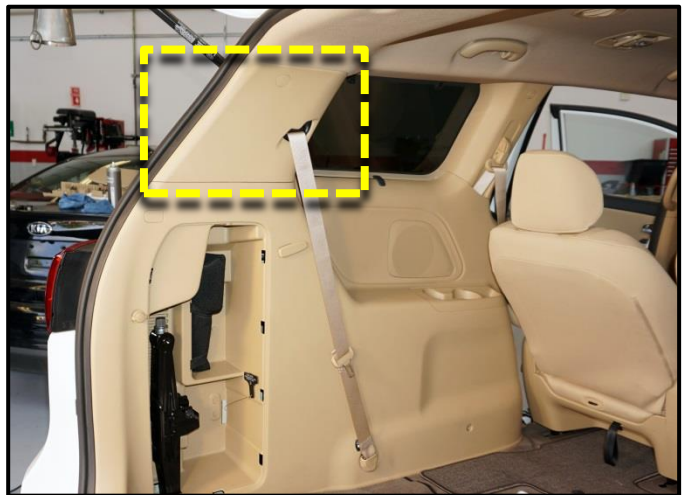
10. Remove the upper seat belt trim panel. **NOTE: replace any broken clip(s) with new ones.**

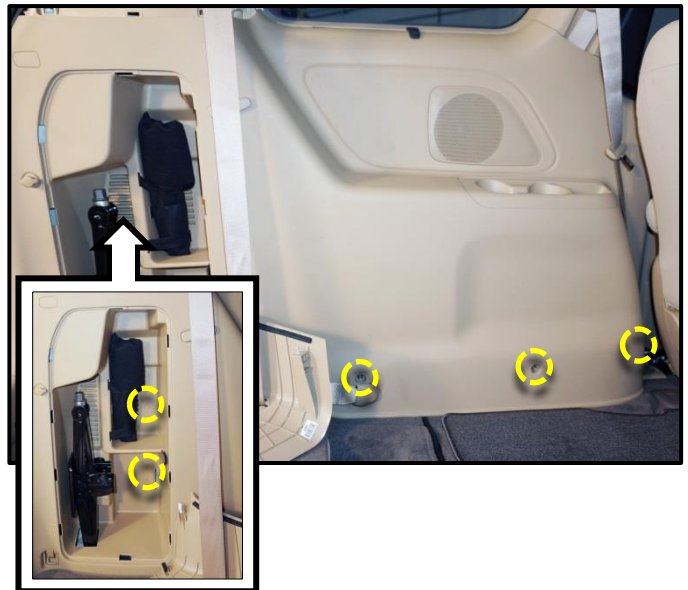
11. Remove multiple bolts from the side, trim panel, as shown, prior to removing the panel. **Note: replace any broken clip(s) with new clips.**

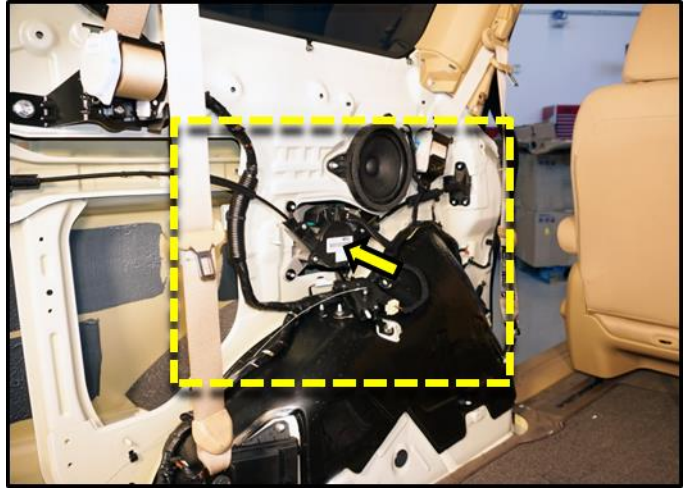
12. Once the side trim panel has been removed, locate the PSD motor housing, as shown.

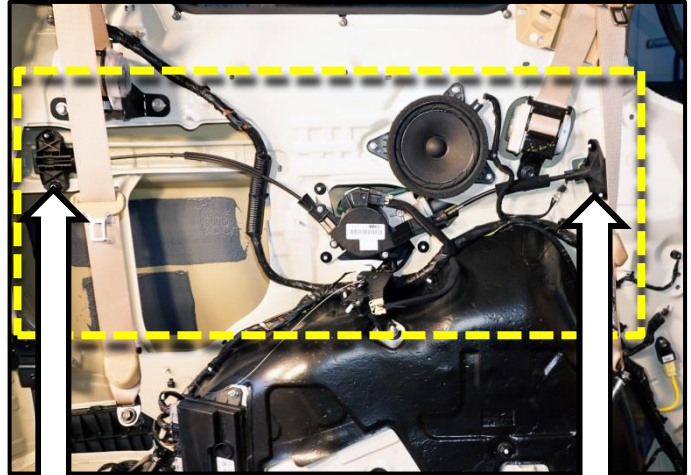
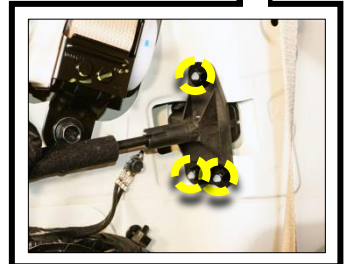
13. Remove two (2) nuts securing the left hand side PSD motor cable guide to the chassis and three (3) nuts securing the right hand side PSD motor cable guide to the chassis, as shown.

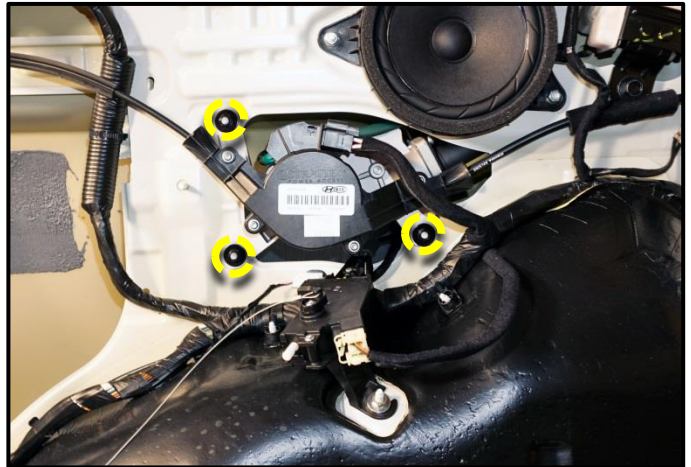
14. Remove three (3) nuts securing the PSD motor to the chassis, as shown.

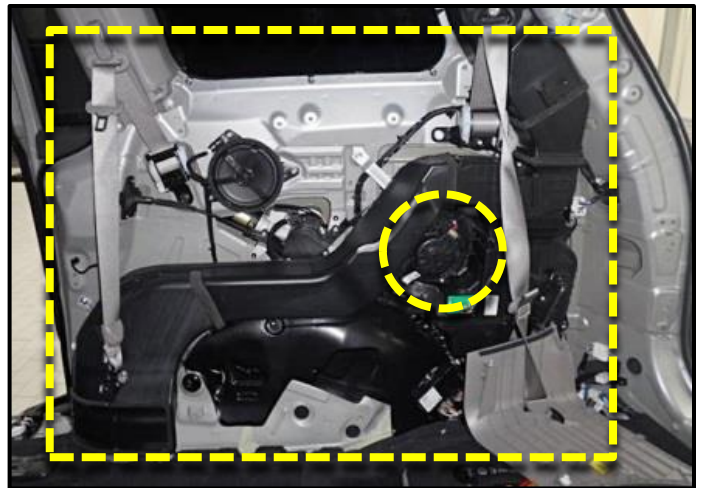
15. On the right hand side of the vehicle, remove the heater ducting, blower assembly, and related components, to access the PSD motor.

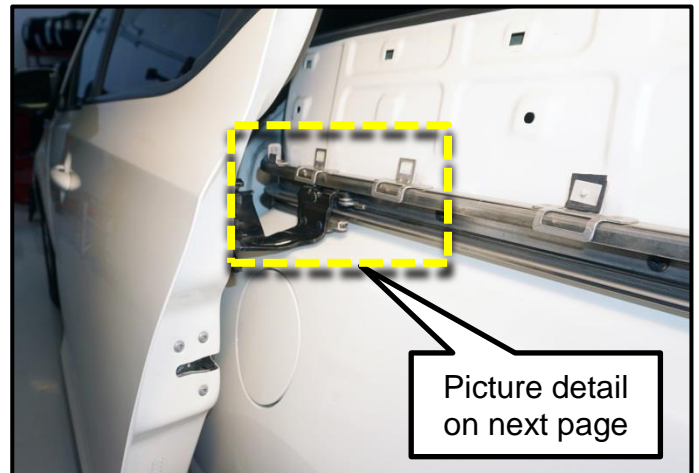
16. Pull and remove the rear cable by lowering the cable clip roller hinge post down. **NOTE: More detail on cable removal can be found in the notice box below.**

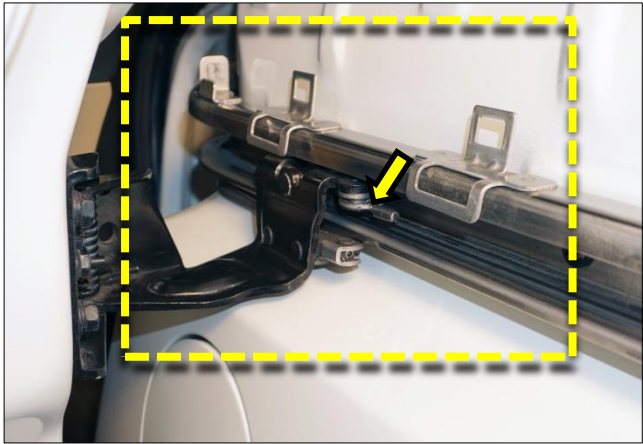
- 17. Remove the PSD motor cables from the center roller hinge. **NOTE: More detail on cable removal can be found in the notice box below.**

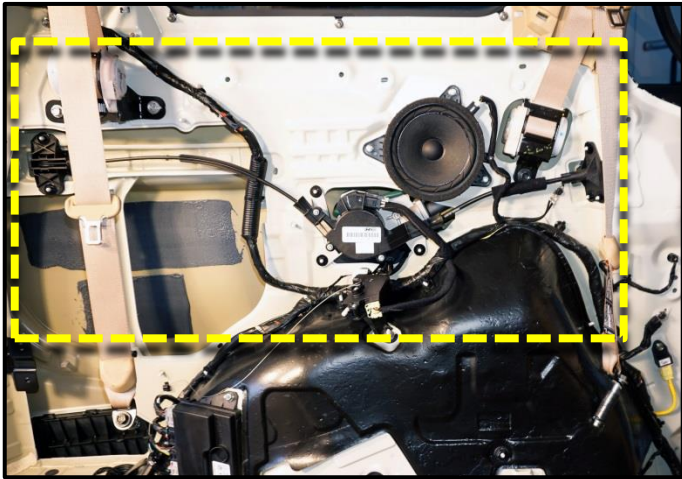
- 18. install the replacement PSD motor by reversing the removal steps.

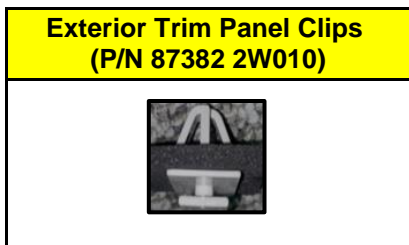
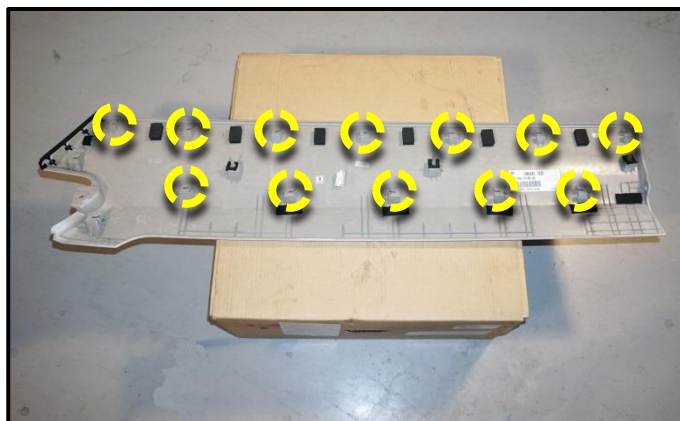
- 19. During Service Action repairs that utilize the kit P/Ns ending in “QQK,” install the replacement clips onto the LH and RH PSD exterior trim panels.

Trim panel clips are only provided in the QQK kit part numbers for Service Action applicable vehicles. For non-Service Action vehicles that require the FFF P/Ns, order the necessary clips separately to replace any broken ones.

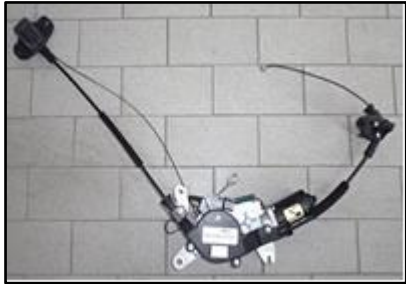
Part Name	Figure	Part #	Qty.	Figure	Remarks
Power Sliding Door Assembly, LH Kit

83810 A9000	1	See image on the left	Verify the contents of the kit
		87382 2W010 (Gray)	11

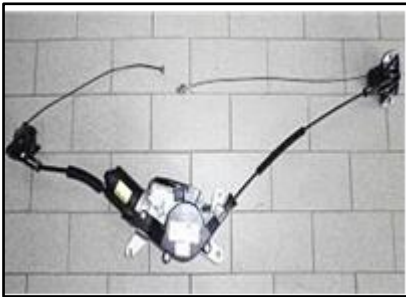
Part Name	Figure	Part #	Qty.	Figure	Remarks
Power Sliding Door Assembly, RH Kit

83820 A9000	1	See image on the left	Verify the contents of the kit
		87382 2W010 (Gray)	11
