## Service Bulletin No. 446B

| MODEL<br><b>J4500</b> | TYPE<br><b>Field Change Program</b> | SECTION/GROUP<br><b>3-Body</b> | DATE<br><b>June 19, 2017</b> |
| SUBJECT<br><b>A/C COMPRESSOR SUPPORT TUBE</b> | | | |

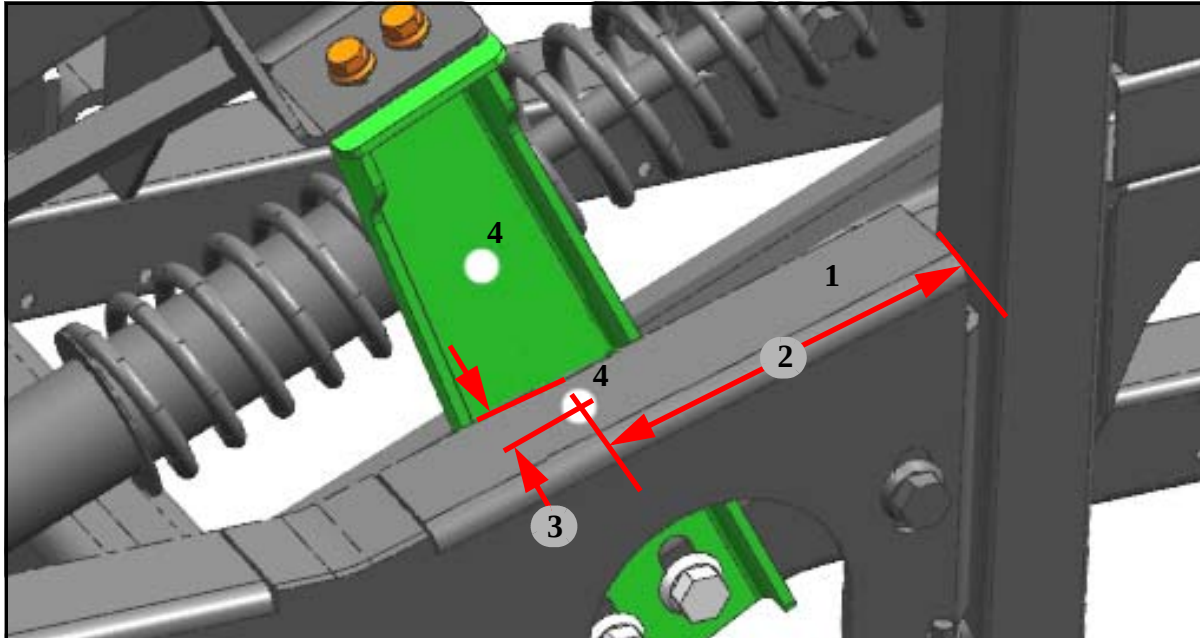
**Figure 3. Idler pulley bracket angle drilled mounting hole dimensions.**

| Item | Figure 3 Description |
| 1 | Tie bar plate |
| 2 | 6.00 inch |
| 3 | 0.87 inch |
| 4 | Mounting holes |

5. Locate the existing snubber bracket assembly shown in Figure 3. Remove and discard the existing snubber bracket and mounting hardware. Retain the idler pulley to be re-installed at a later step in this procedure.
6. Using a 17/32 inch drill bit and a drill, drill a mounting hole in the tie bar plate per the dimensions shown in Figure 3.

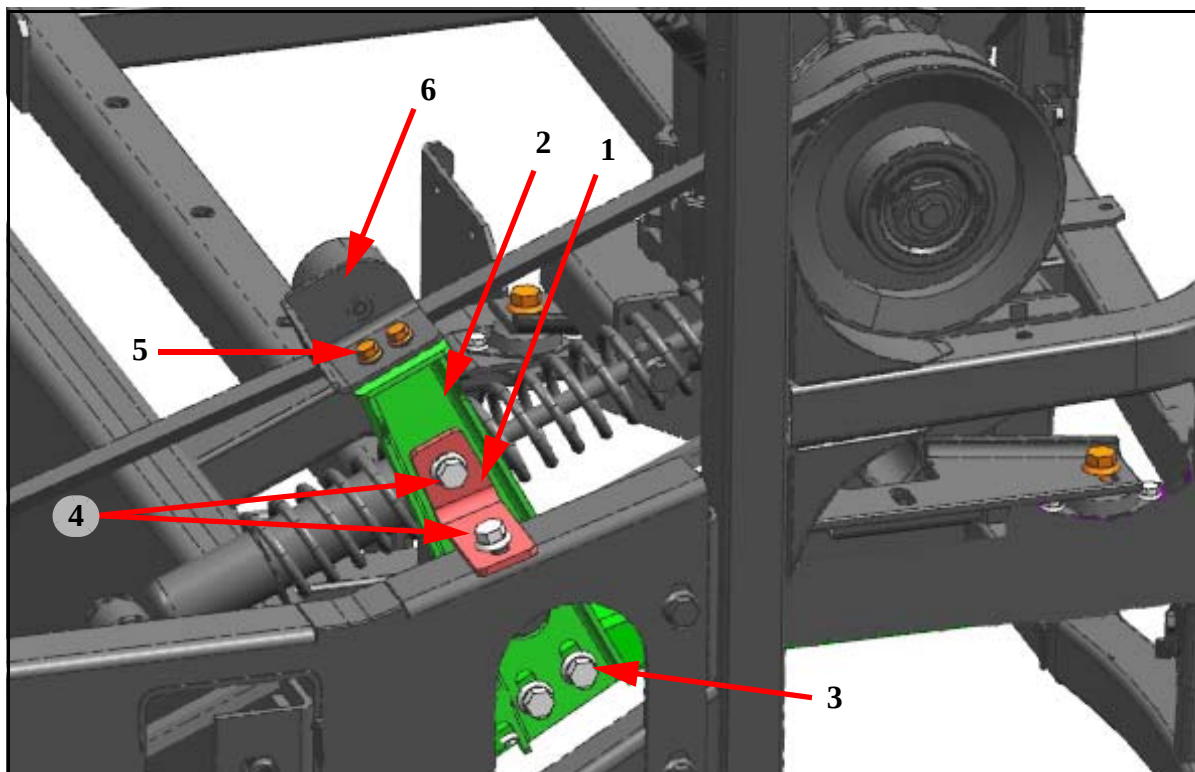
**Figure 4. Idler pulley bracket angle and snubber bracket installation.**

| Item | Figure 4 Description |
| 1 | Angle, idler pulley bracket |
| 2 | Snubber bracket |
| 3 | Snubber bracket cap screw, p/n 19-01-1526 and flange nut, p/n 19-03-0497. Torque to 77-93 ft.-lbs |
| 4 | Angle cap screw, p/n 19-01-1577 and flange nut, p/n19-03-0497. Torque to 77-93 ft.-lbs |
| 5 | Idler pulley cap screw, p/n 19-01-1570 and lock nut,19-03-0535. Torque to 43-47 ft.-lbs |
| 6 | Idler pulley |

7. Orient and install the new snubber bracket, p/n 08-27-1327, idler pulley bracket angle, p/n 08-27-1326, and existing idler pulley as shown in Figure 4.

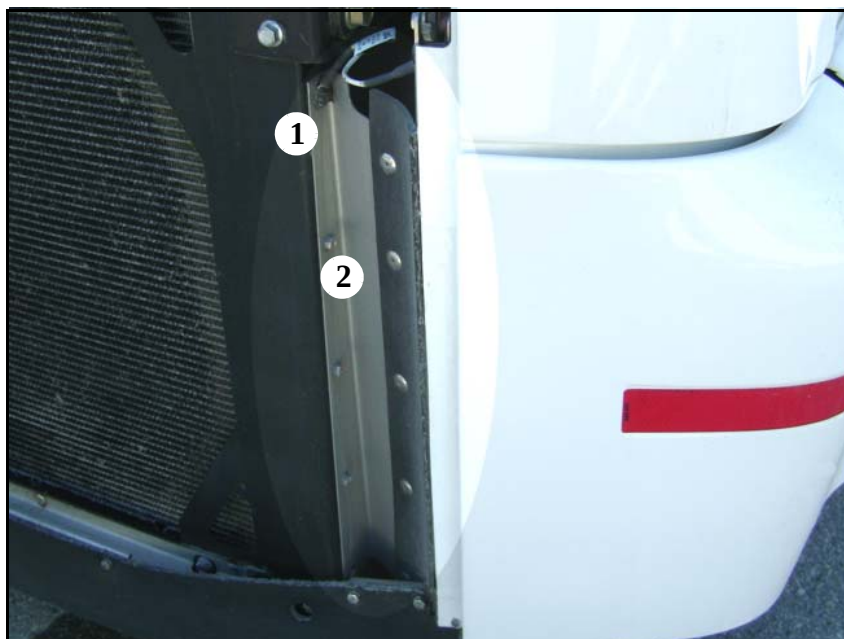
**Figure 6. Radiator closing panel strip assembly.**

| Item | Figure 6 Description |
| 1 | Ground cable secured with mounting hardware |
| 2 | Mounting hardware |

50. Torque the six ( 6 ) center bolts to 100-123 ft-lbs. ( refer to Figure 19 ).
51. Using the existing hardware, orient and mount the radiator closing panel strip assembly and ground cable shown in Figure 6.

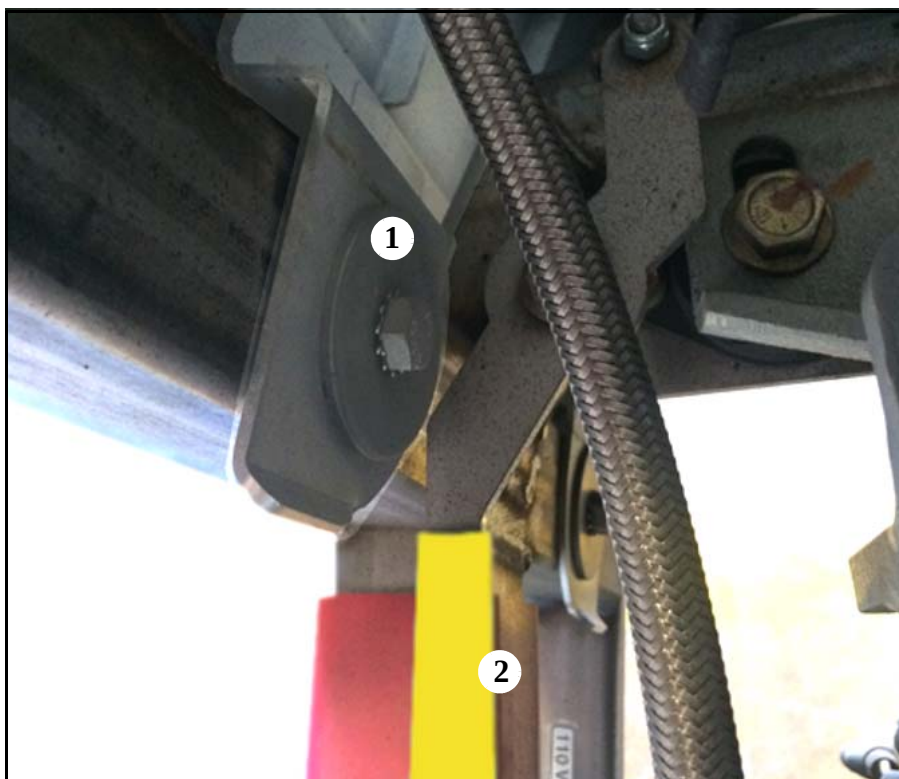
**Figure 7. Line of sight view looking straight down positioned at the curbside, rear side service compartment.**

| Item | Figure 7 Description |
| 1 | Rear bumper mounting hardware, Item 2 / Figure 8 |
| 2 | Engine compartment door release handle |

16. Remove and retain the rear bumper mounting hardware ( refer to Figures 7 and 8 ). Carefully remove the bumper and place aside to be re-installed at a later step in this procedure. Using a marker and tape, label the rear bumper mounting hardware for re-installation.

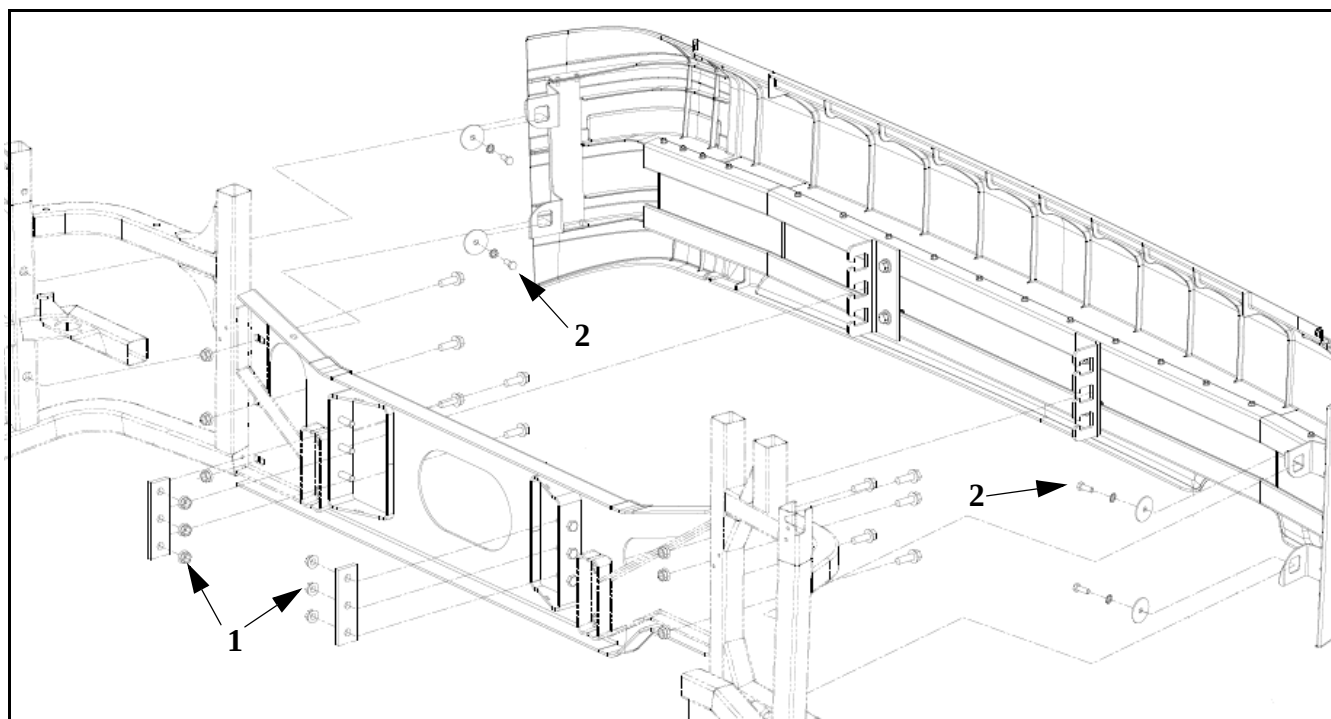
**Figure 8. Bumper installation to coach frame.**

| Item | Figure 8 Description |
| 1 | Six ( 6 ) nuts |
| 2 | Four ( 4 ) bolts. Refer to item 1 / Figure 7. |

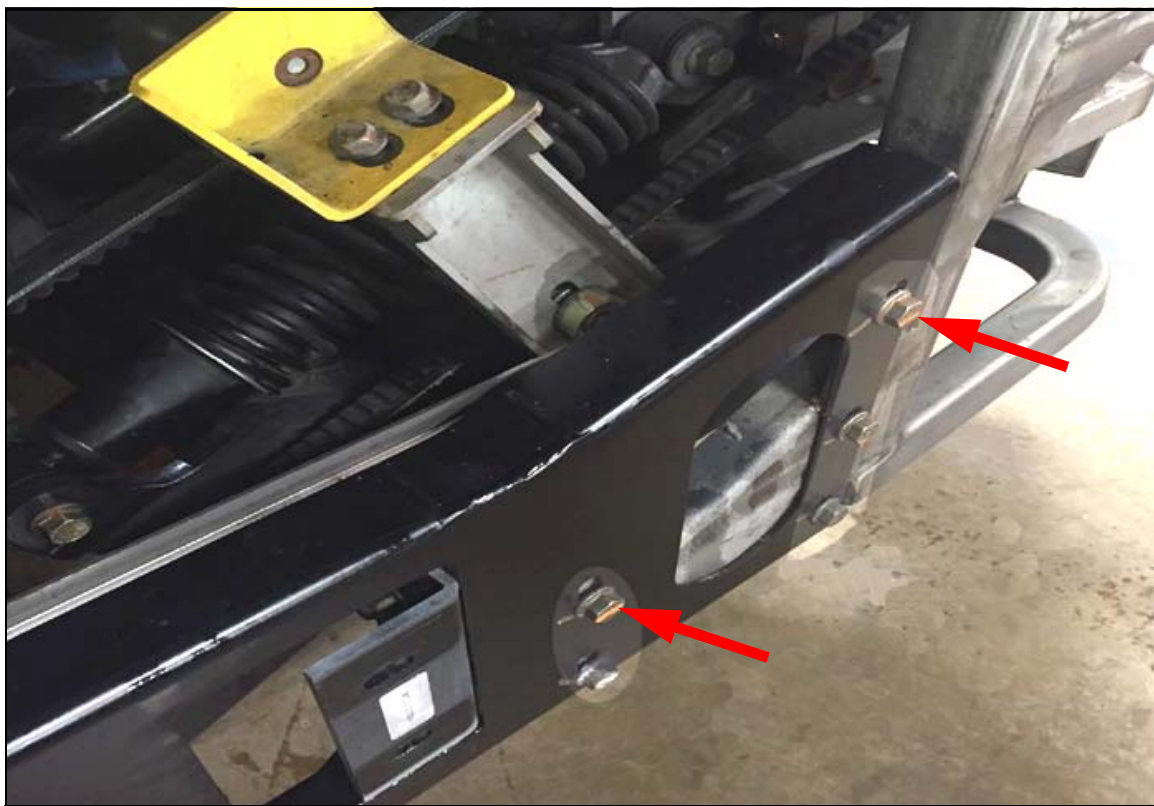
Figure 9. Tie bar plate installation.

17. Remove and retain the tie bar plate mounting hardware ( refer to Figure 9 ). Carefully remove the tie bar plate and place aside to be re-installed at a later step in this procedure. Using a marker and tape, label the tie bar plate mounting hardware, quantity of ten ( 10 ), for re-installation.

46. Using the existing hardware, orient and mount the tie bar plate to the coach frame ( refer to Figure 9 ). Torque capscrews to 100-104 ft-lbs. Apply torque seal to the capscrew heads.

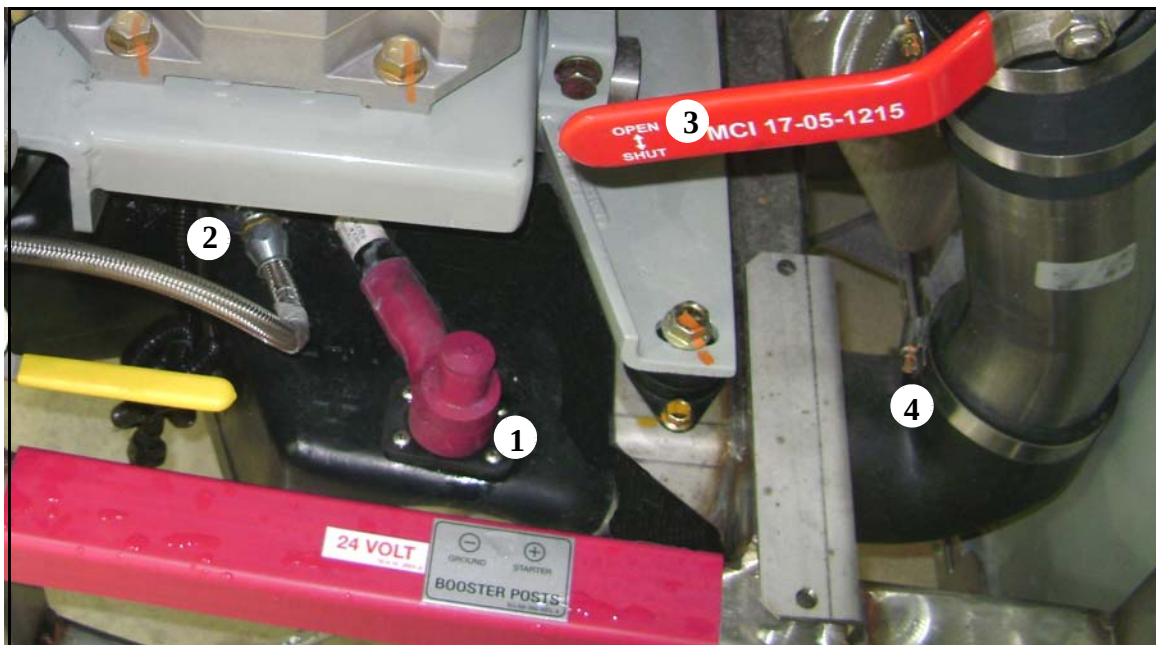
**Figure 10. Secondary, lower lavatory tank assembly.**

| Item | Figure 10 Description |
| 1 | engine ( positive ) power cable, with red protective cover, and booster post |
| 2 | vent hose |
| 3 | Lavatory dump ball valve in the SHUT position |
| 4 | dump tube assembly elbow hose clamp |

18. Locate the engine power( positive ) cable and booster post on the **drained**, secondary ( lower ) lavatory tank shown as Item 1 / Figure 10. Lift the protective red cover and remove the engine power cable and mounting hardware from the tank.
19. Locate and disconnect vent hose from the tank, Item 2 / Figure 10.
20. Ensure that the dump ball valve is in the SHUT position, Item 3 / Figure 10. Disconnect the hose clamp from the elbow on the dump tube assembly, Item 4 / Figure 10.

43. Orient and re-connect the hose clamp to the elbow on the dump tube assembly ( refer to Figure 10 ). Tighten the hose clamp to secure installation.
44. Orient and re-connect vent hose to the tank ( refer to Figure 10 ).

45. Orient and re-connect the engine power cable to the junction block on the secondary ( lower ) lavatory tank as shown in Figure 10. Shield with the red protective cover.

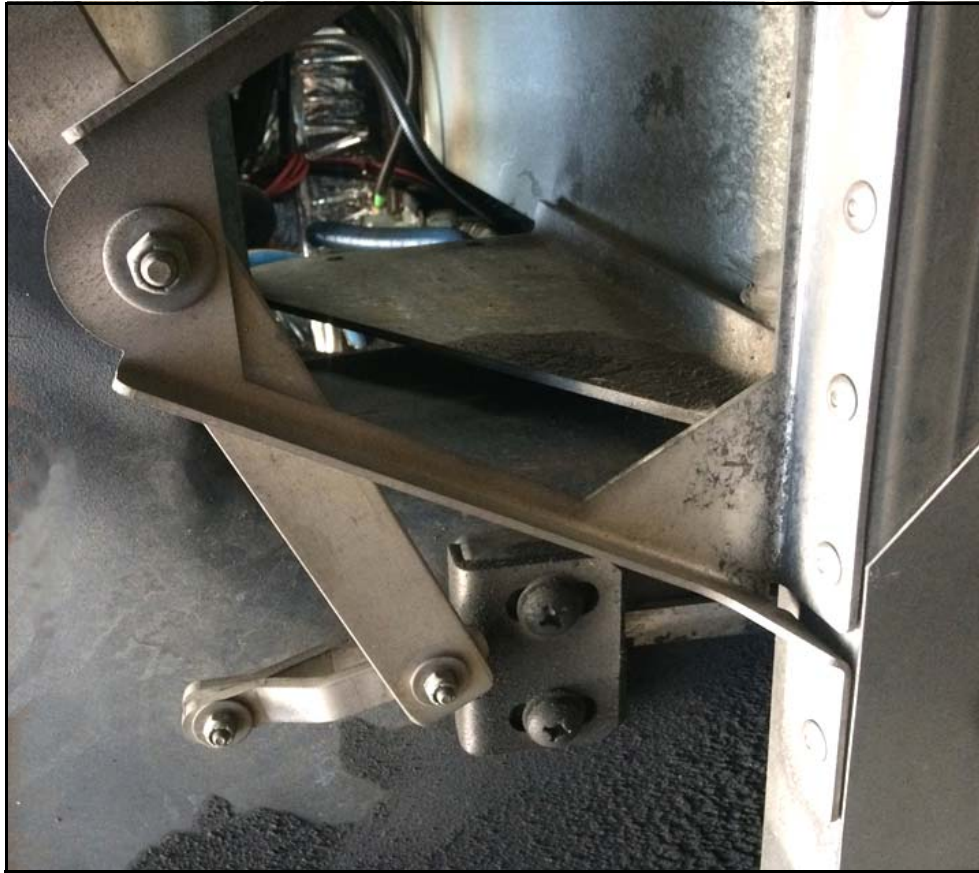
**Figure 11. Linkage.**

21. Locate the linkage positioned underneath the secondary ( lower ) lavatory tank shown in Figure 11.  
Disconnect the linkage for tank removal.

40. Re-orient the secondary ( lower ) lavatory tank back to the installation area.
41. Orient and re-connect the linkage positioned underneath the secondary ( lower ) lavatory tank shown in Figure 11.

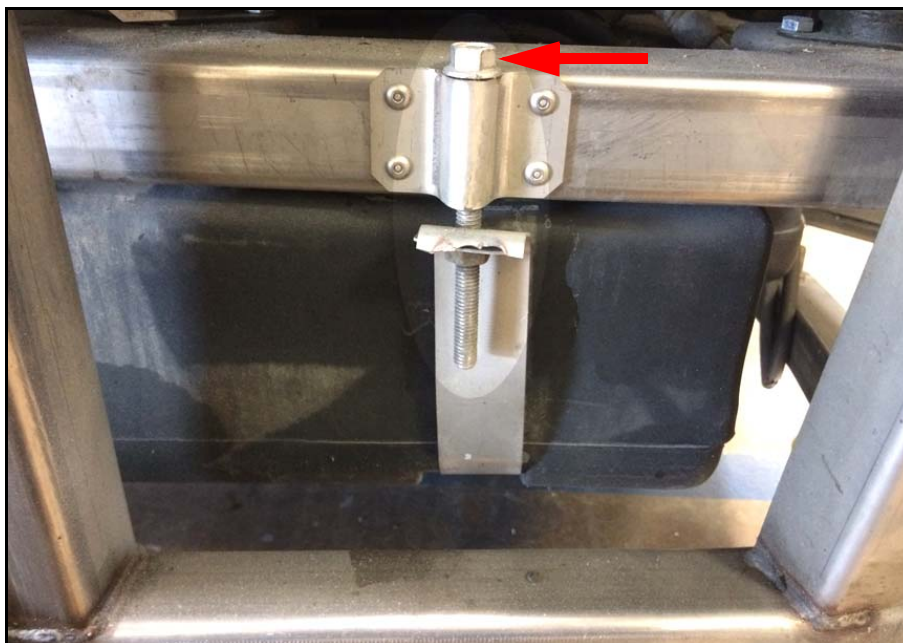
**Figure 12. Lavatory strap support capscrew.**

22. Locate the lavatory strap support capscrew shown in Figure 12. Remove and retain the lavatory strap support capscrew to be re-installed at a later step in this procedure.

42. Orient the lavatory strap support to the secondary ( lower ) lavatory tank and use the existing capscrew to secure in position and tight against the frame ( refer to Figure 12 ). Torque the capscrew to 20-23 ft-lbs.

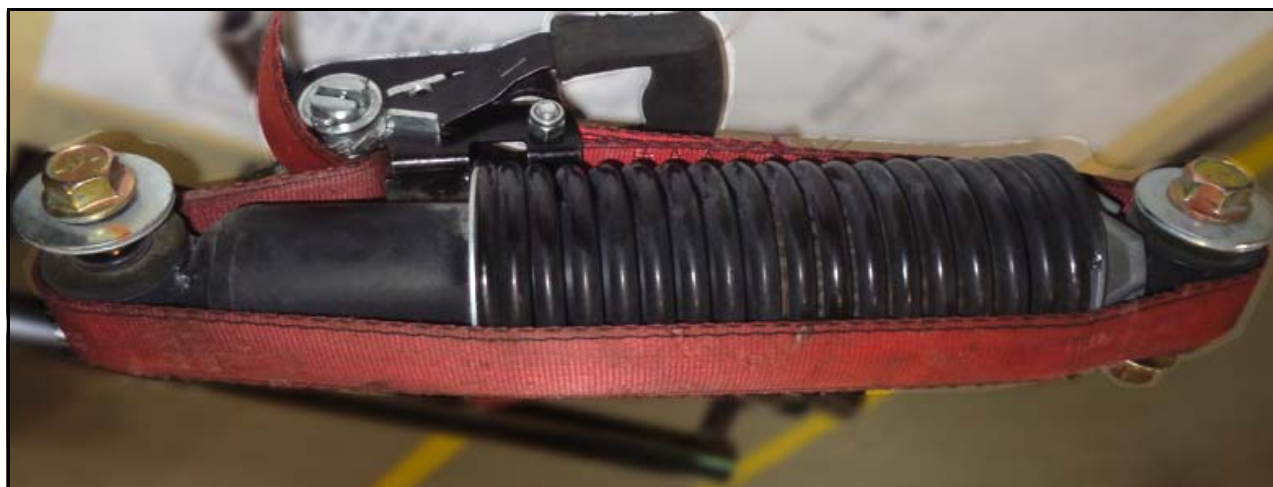
**Figure 13. Reference photo of ratchet strap compressing tensioner.**

23. Re-position the secondary ( lower ) lavatory tank away from the retrofit area.
24. Locate the A/C belt tensioner, inboard of the A/C Bitzer compressor. Carefully position a ratchet strap around the tensioner and tighten ratchet to compress, until the tension has been removed allowing removal of the mounting hardware as shown in Figure 13. Using tape and a marker, label the A/C belt tensioner ends to ensure proper orientation when re-installing.
25. Remove and retain the A/C belt tensioner and mounting hardware to be re-installed at a later step in this procedure.

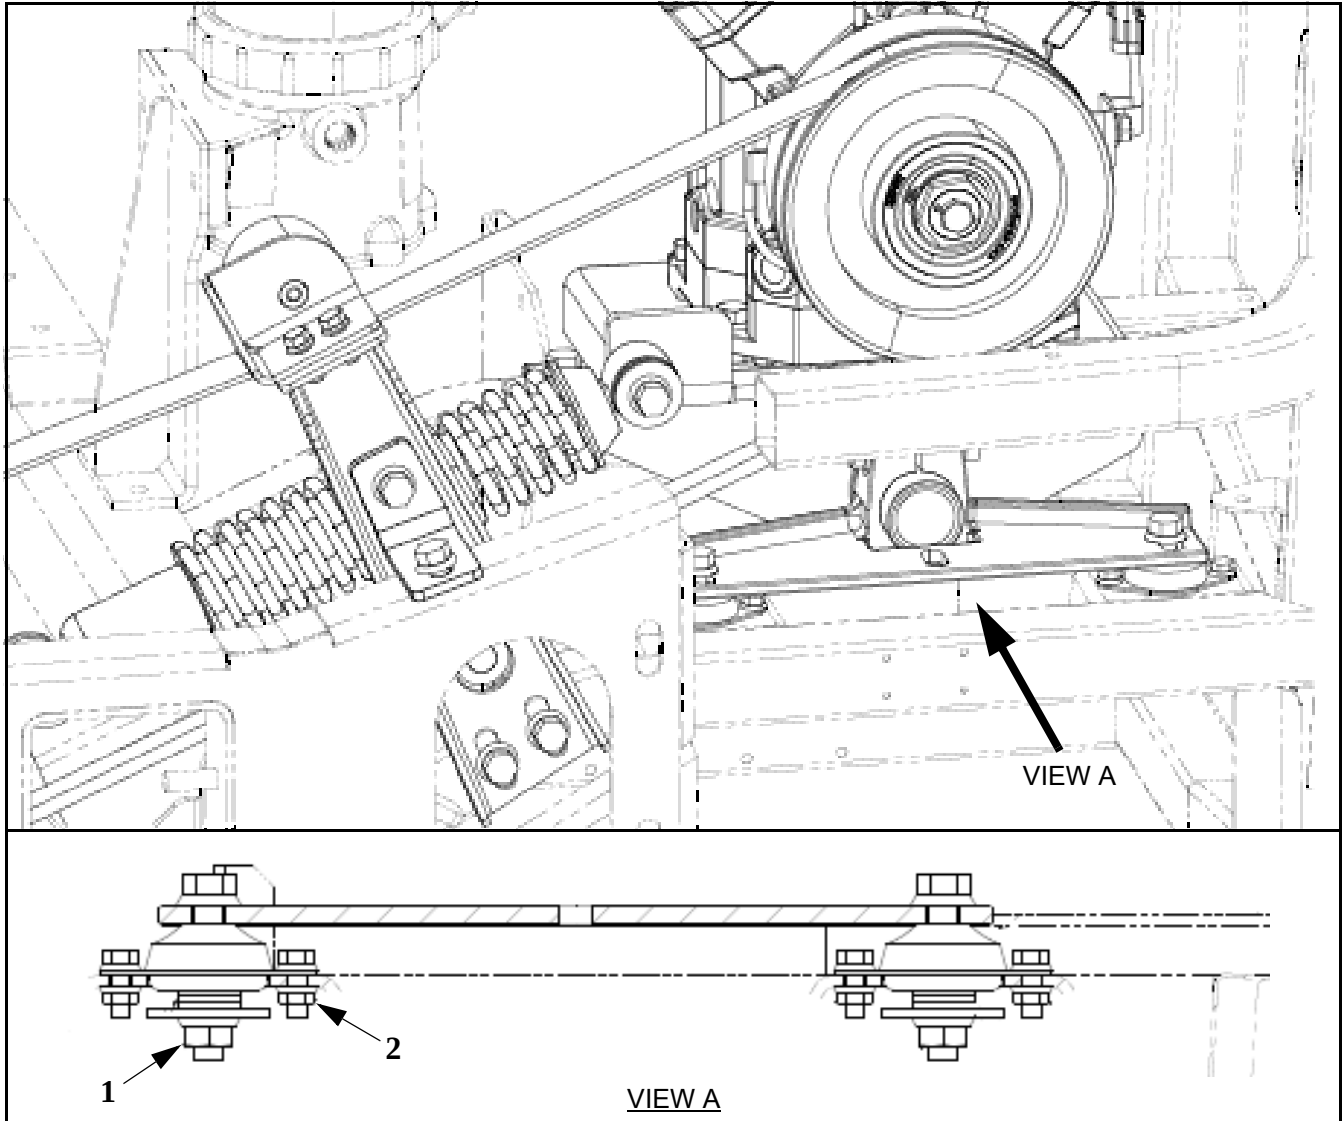
**Figure 14. A/C compressor pivot plate installation.**

| Item | Figure 14 Description |
| 1 | Two ( 2 ) nuts |
| 2 | Four ( 4 ) nuts |

26. Remove and retain the A/C compressor pivot plate mounting hardware and belt to be re-installed at a later step in this procedure. Re-position and support the A/C compressor away from the retrofit area.

| Item | Figure 17 Description |
|---|---|
| 6 | Compressor stabilizer ( pivot plate / Figure 14 ), ref p/n's 19-01-1529, 19-03-0497. Torque to 63-77 ft.-lbs |
| 7 | Stabilizer to brackets ( pivot plate / Figure 14 ), ref p/n's 19-01-1532, 19-03-0498. Torque to 14-16 ft.-lbs |

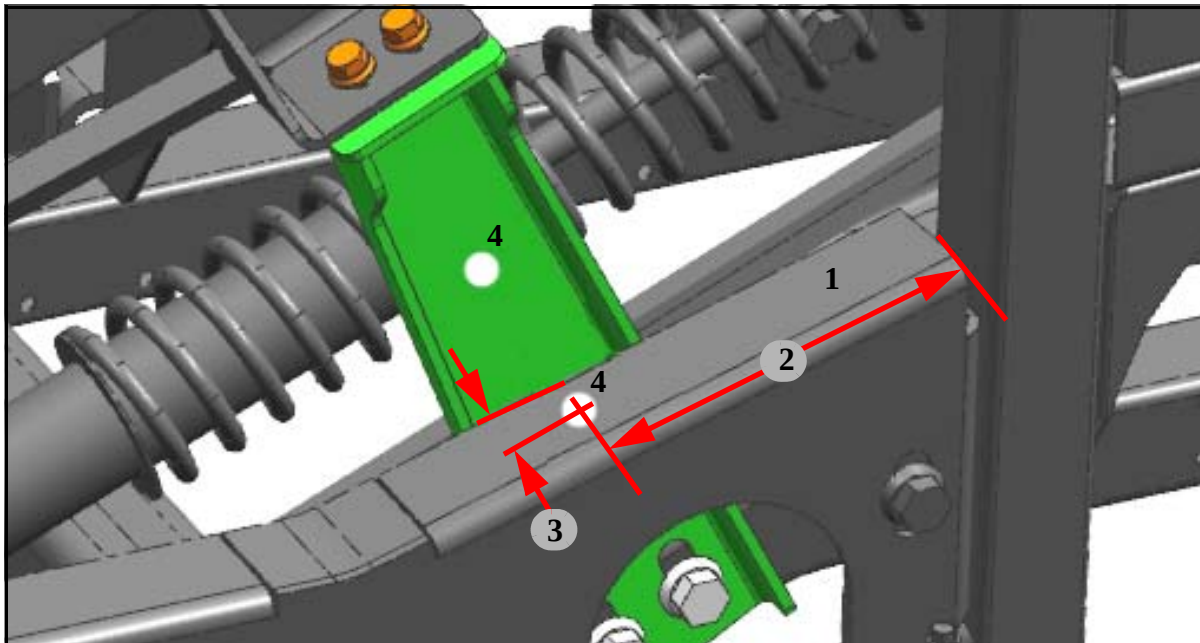
**Figure 16. Idler pulley bracket angle drilled mounting hole dimensions.**

| Item | Figure 16 Description |
| 1 | Tie bar plate |
| 2 | 6.00 inch |
| 3 | 0.87 inch |
| 4 | Mounting holes |

31. Using a 17/32 inch drill bit and a drill, drill a mounting hole in the tie bar plate per the dimensions shown in Figure 16.

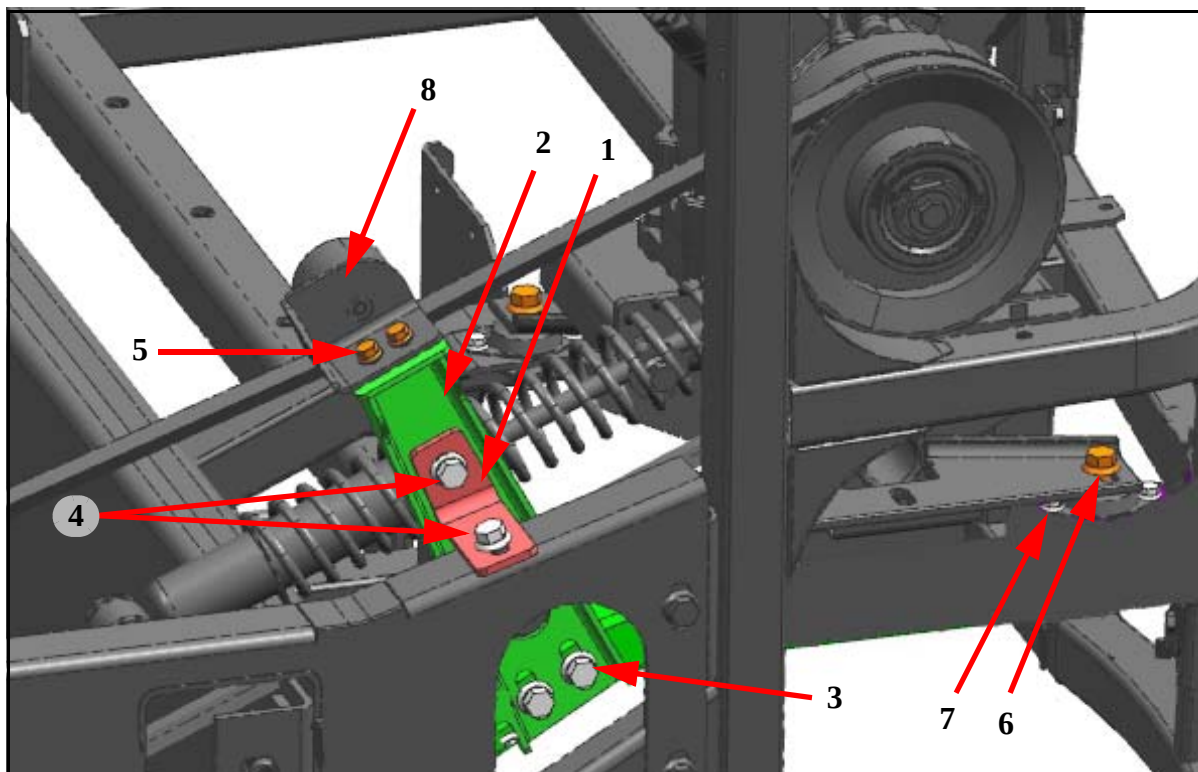
**Figure 17. Idler pulley bracket angle and snubber bracket installation.**

| Item | Figure 17 Description |
| 1 | Angle, idler pulley bracket |
| 2 | Snubber bracket |
| 3 | Snubber bracket cap screw, p/n 19-01-1526 and flange nut, p/n 19-03-0497. Torque to 77-93 ft.-lbs |
| 4 | Angle cap screw, p/n 19-01-1577 and flange nut, p/n 19-03-0497. Torque to 77-93 ft.-lbs |
| 5 | Idler pulley cap screw, p/n 19-01-1570 and lock nut, 19-03-0535. Torque to 43-47 ft.-lbs |
| 8 | Idler pulley |

32. Orient and install the new snubber bracket, p/n 08-27-1327, idler pulley bracket angle, p/n 08-27-1326, and existing idler pulley as shown in Figure 17.

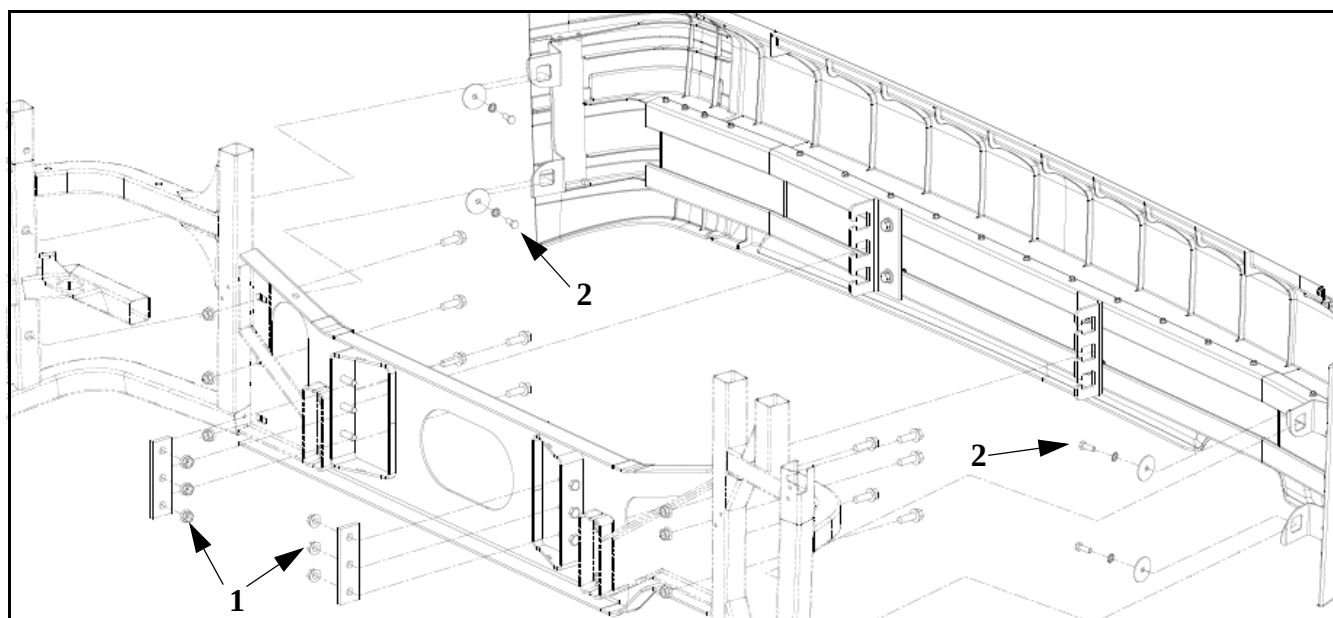
**Figure 19. Bumper installation to coach frame.**

| Item | Figure 19 Description |
| 1 | Torque six ( 6 ) nuts to 100-123 ft.-lbs. |
| 2 | Torque four ( 4 ) bolts to 18-22 ft.-lbs |

49. Align the side bumpers to follow the fender edge. Tighten the two ( 2 ) bolts to secure position. Torque to 18-22 ft-lbs. ( refer to Figure 19 ). Repeat to the opposite side of the coach.

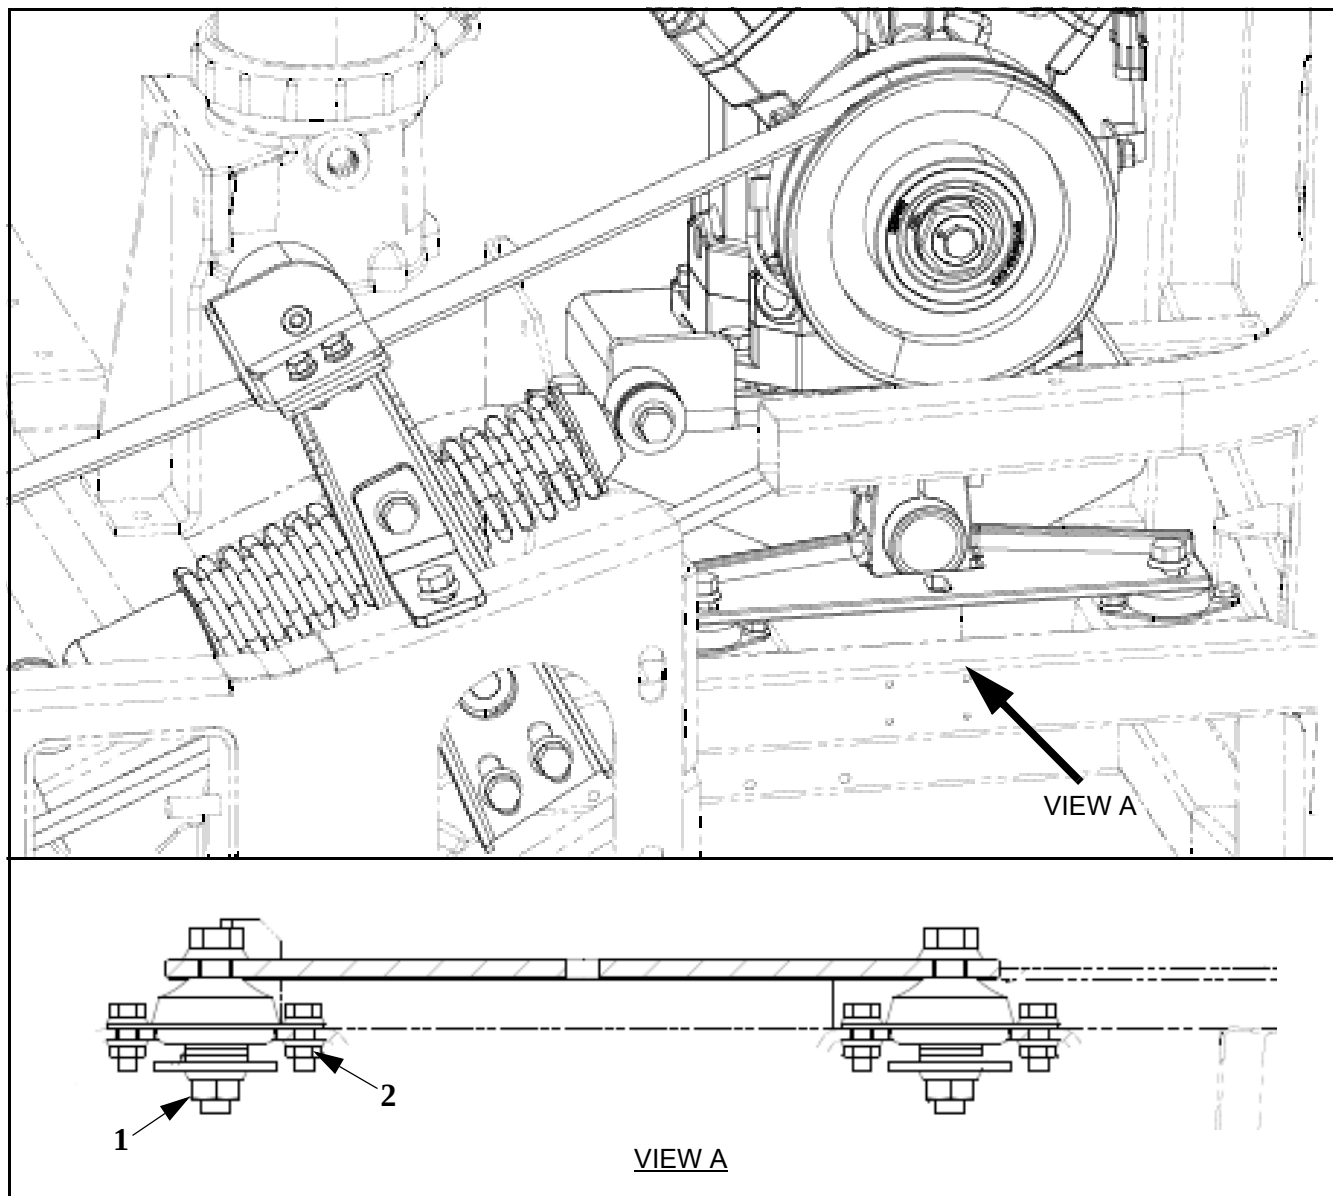
**Figure 20. A/C compressor pivot plate installation.**

| Item | Figure 20 Description |
| 1 | Torque two ( 2 ) nuts to 63-77 ft.-lbs. |
| 2 | Torque four ( 4 ) nuts to 14-16 ft.-lbs |

52. Re-orient the A/C compressor pivot plate into position. Using the existing mounting hardware, re-install the A/C compressor pivot plate as shown in Figure 20.

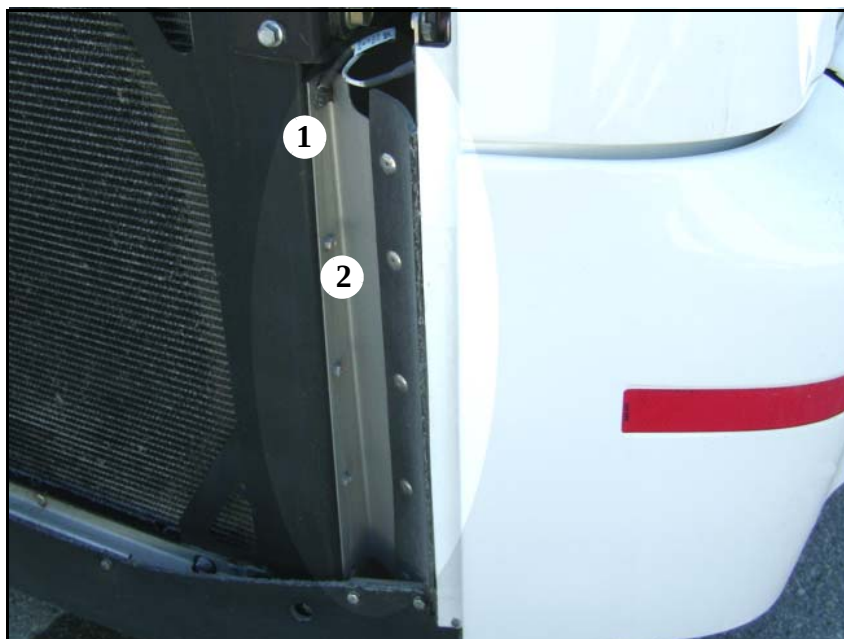
**Figure 21. Radiator closing panel strip assembly.**

| Item | Figure 21 Description |

89. Torque the six ( 6 ) center bolts to 100-123 ft-lbs. ( refer to Figure 35 ).
90. Using the existing hardware, orient and mount the radiator closing panel strip assembly and ground cable shown in Figure 21.

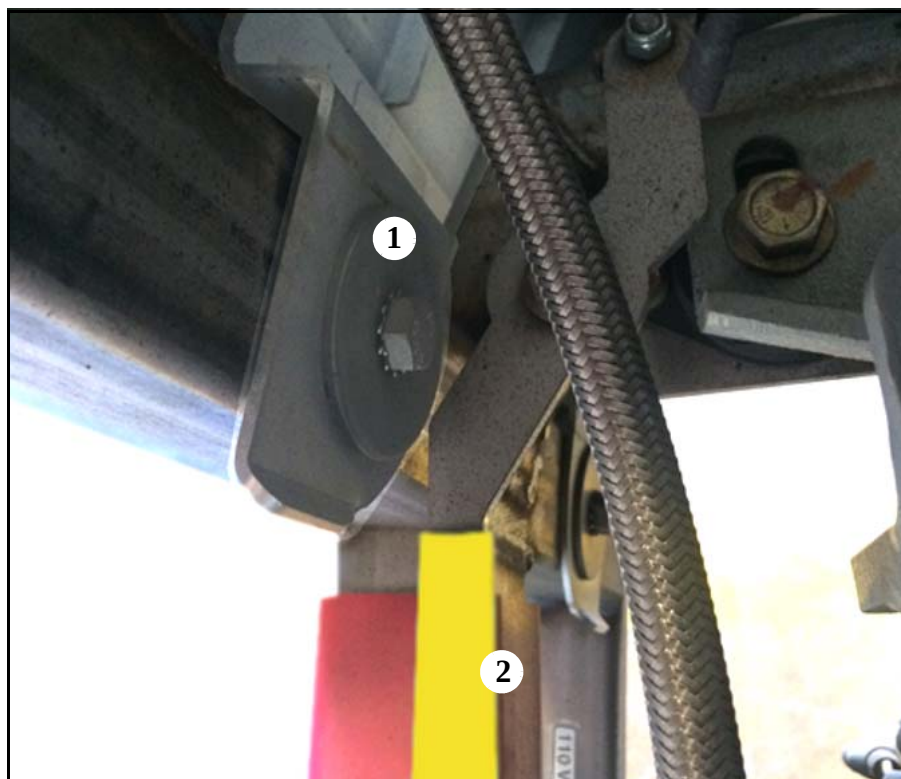
**Figure 22. Line of sight view looking straight down positioned at the curbside, rear side service compartment.**

| Item | Figure 22 Description |

56. Remove and retain the rear bumper mounting hardware ( refer to Figures 22 and 23 ). Carefully remove the bumper and place aside to be re-installed at a later step in this procedure. Using a marker and tape, label the rear bumper mounting hardware for re-installation.

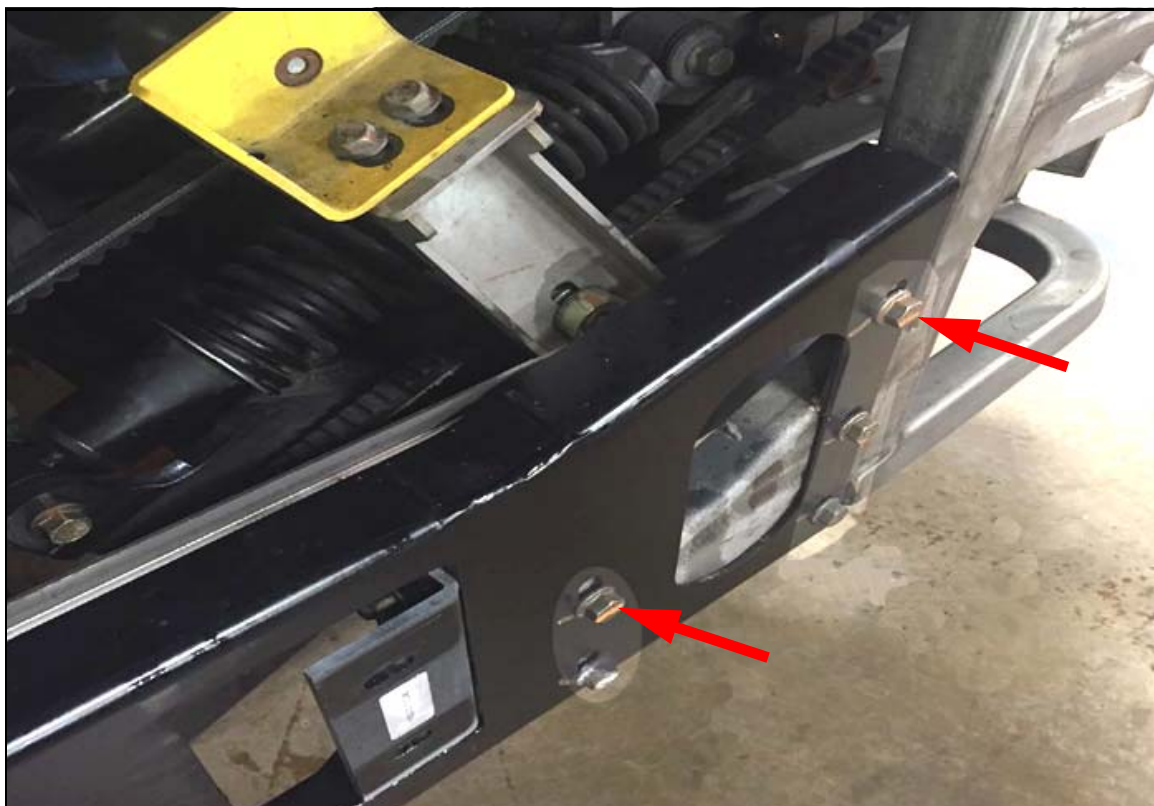
Figure 24. Tie bar plate installation.

57. Remove and retain the tie bar plate mounting hardware ( refer to Figure 24 ). Carefully remove the tie bar plate and place aside to be re-installed at a later step in this procedure. Using a marker and tape, label the tie bar plate mounting hardware, quantity of ten ( 10 ), for re-installation.

85. Using the existing hardware, orient and mount the tie bar plate to the coach frame ( refer to Figure 24 ). Torque capscrews to 100-104 ft-lbs. Apply torque seal to the capscrew heads.

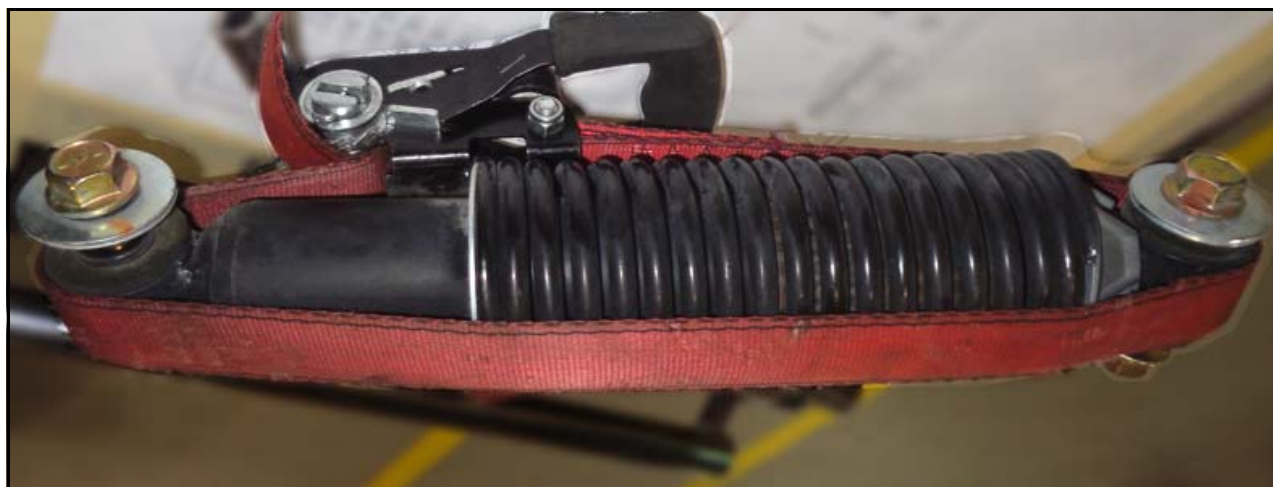
**Figure 28. Reference photo of ratchet strap compressing tensioner.**

63. Re-position the secondary ( lower ) lavatory tank away from the retrofit area.
64. Locate the A/C belt tensioner, inboard of the A/C Bitzer compressor. Carefully position a ratchet strap around the tensioner and tighten ratchet to compress until the tension has been removed allowing removal of the mounting hardware, as shown in Figure 28. Using tape and a marker, label the A/C belt tensioner ends to ensure proper orientation when re-installing.
65. Remove and retain the A/C belt tensioner and mounting hardware to be re-installed at a later step in this procedure.

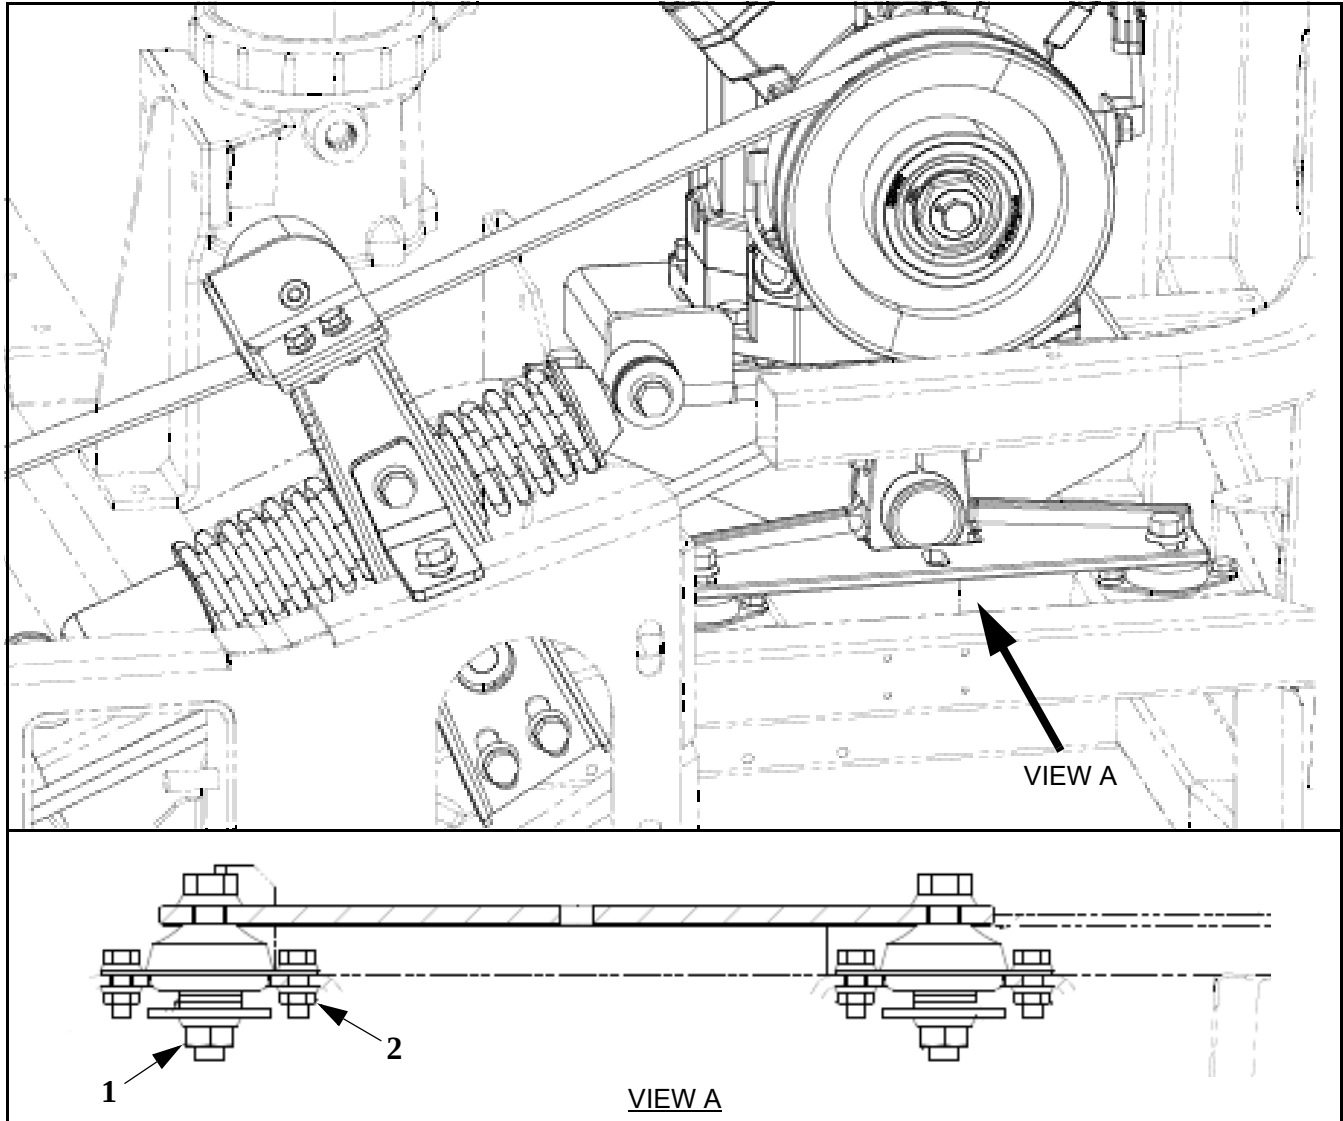
**Figure 29. A/C compressor pivot plate installation.**

| Item | Figure 29 Description |

66. Remove and retain the A/C compressor pivot plate mounting hardware and belt to be re-installed at a later step in this procedure. Re-position and support the A/C compressor away from the retrofit area.

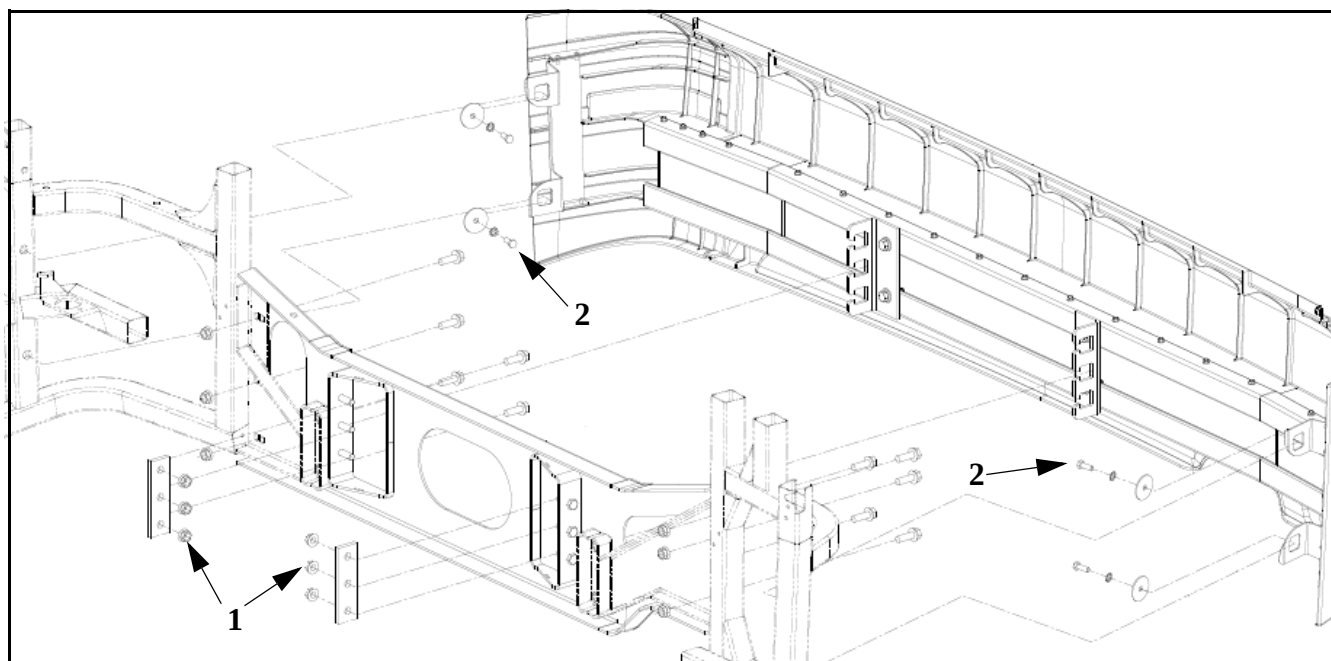
**Figure 35. Bumper installation to coach frame.**

| Item | Figure 35 Description |
| 2 | Torque four ( 4 ) bolts to 18-22 ft.-lbs |

88. Align the side bumpers to follow the fender edge. Tighten the two ( 2 ) bolts to secure position. Torque to 18-22 ft-lbs. ( refer to Figure 35 ). Repeat to the opposite side of the coach.

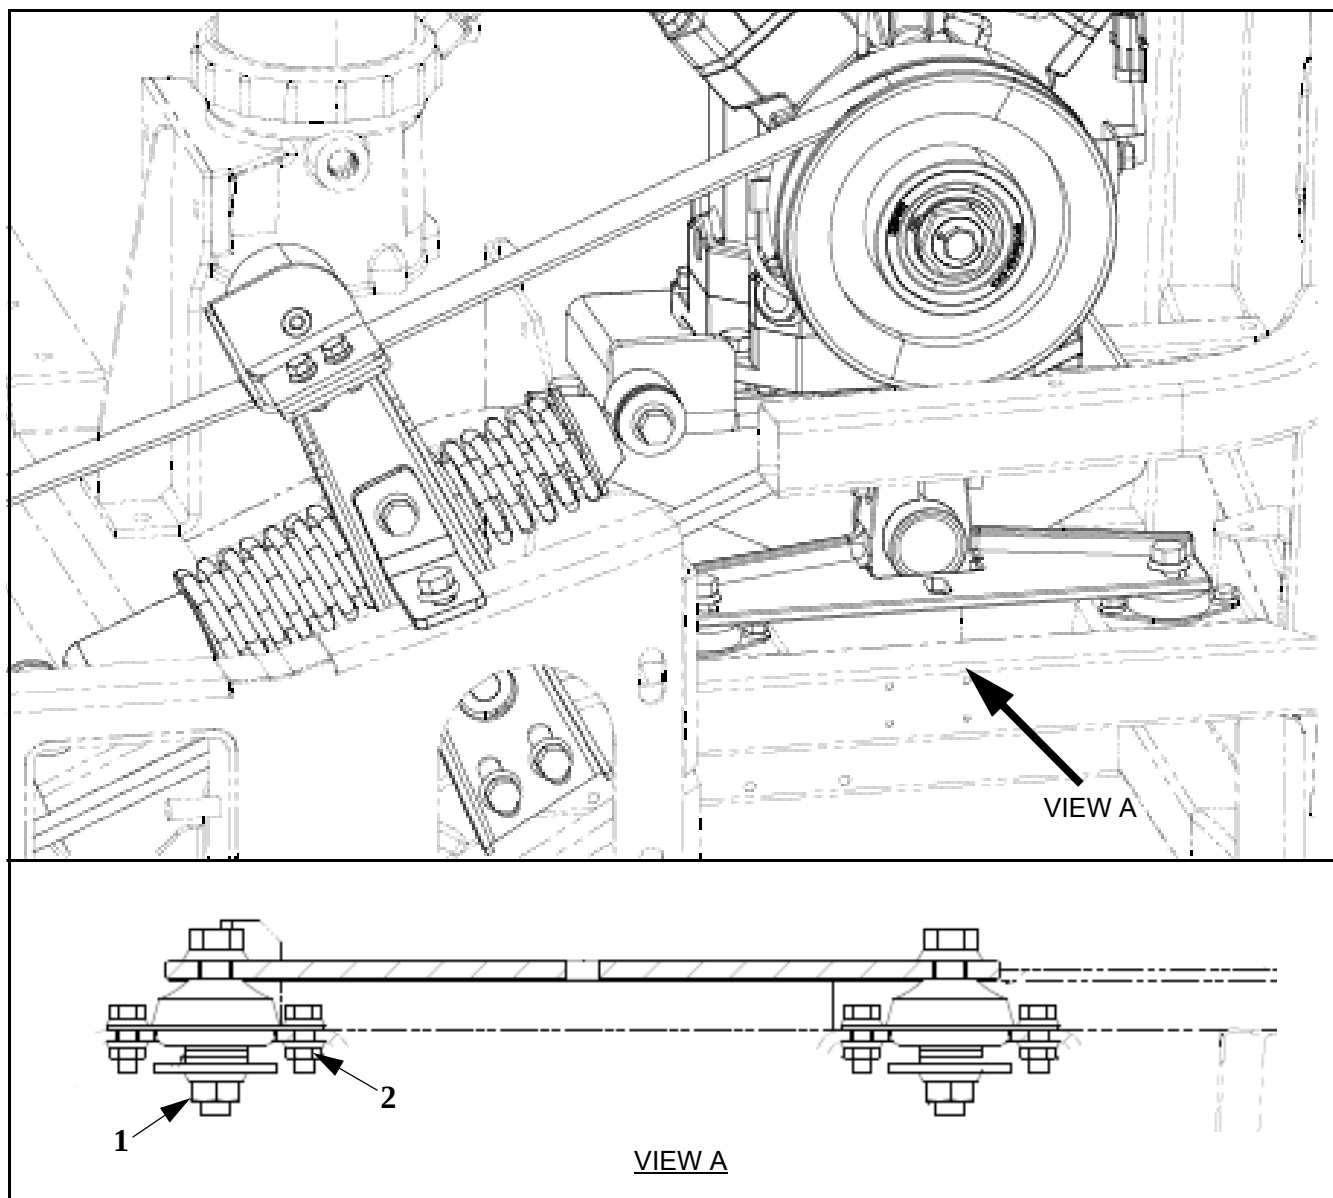
**Figure 36. A/C compressor pivot plate installation.**

| Item | Figure 36 Description |

91. Re-orient the A/C compressor pivot plate into position. Using the existing mounting hardware, re-install the A/C compressor pivot plate as shown in Figure 36.
