NEWMAR CORPORATION

RECALL SERVICE BULLETIN

Recall Service Bulletin

NHTSA/TC Id: **17V-160**

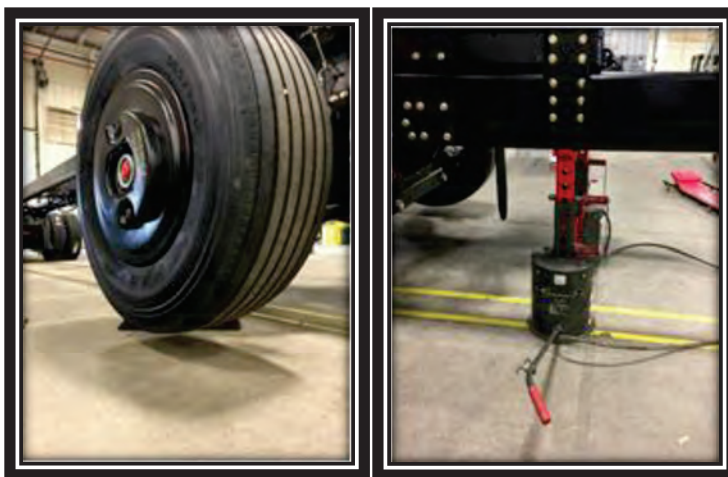
1. Ensure park brake is set and place wheel chocks behind rear wheels.
2. Lift front of vehicle until front wheels are off of the ground. Properly support vehicle with 10t – 12t jack stands.

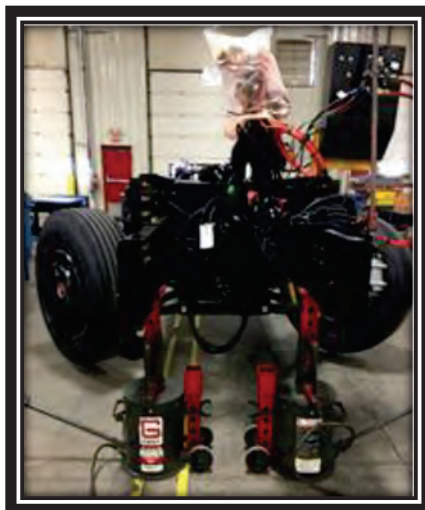
3. Steer wheels completely to the left.

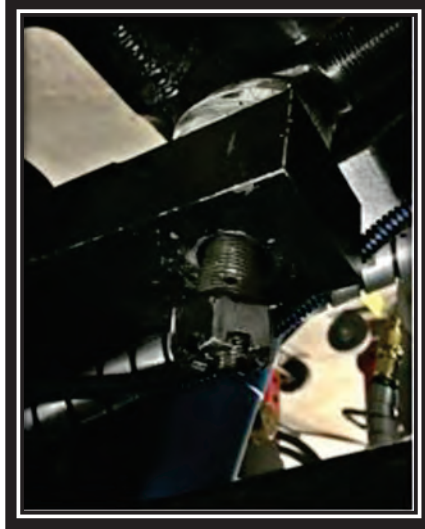
4. Beginning on the right side of the vehicle, remove castle nut from tie rod end that is connected to the relay rod.

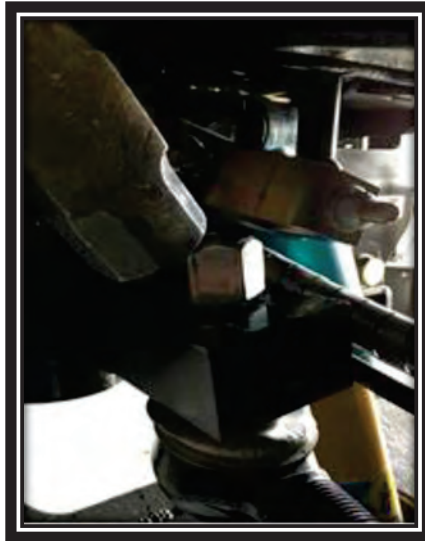
5. Place sacrificial 7/8"-14 nut on rod end stud and strike with hammer to un-seat tapered connection.

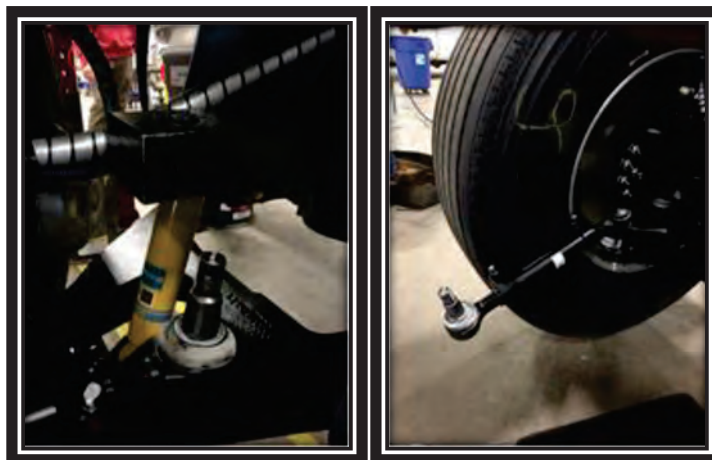
6. Remove tie rod end from relay rod assembly and position tie rod against wheel.

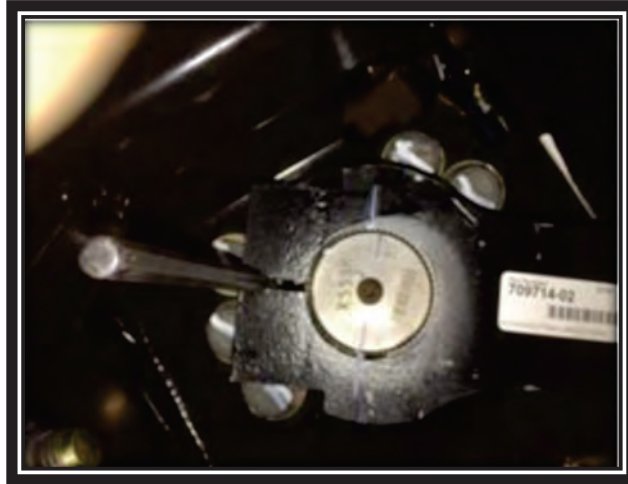
11. Remove pinch bolt from pitman arm.

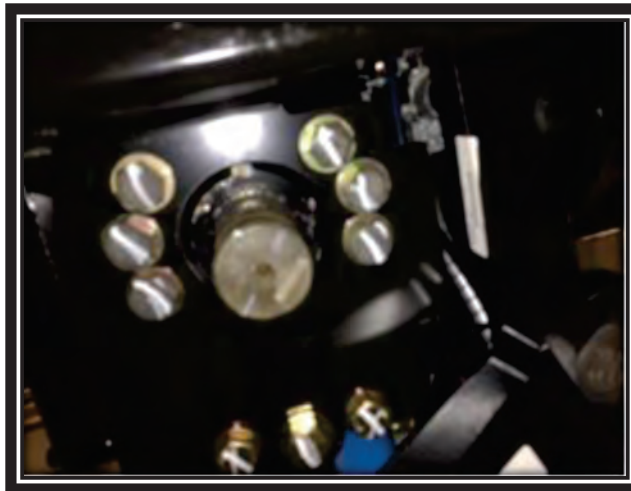
12. Lower pitman arm and position arm to where it is parallel with the relay rod.

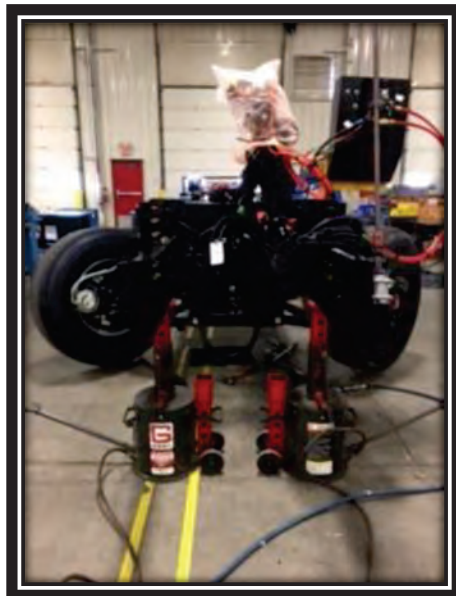
13. Slowly steer wheels completely to the right.

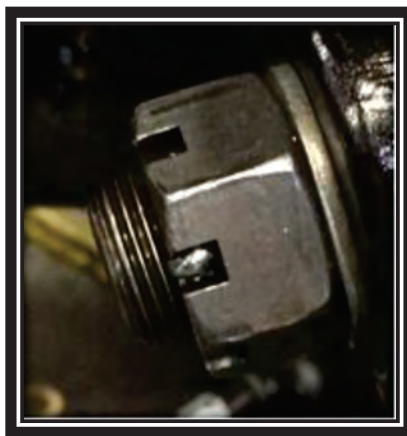
16. Remove the cotter pin from the ball joint stud.

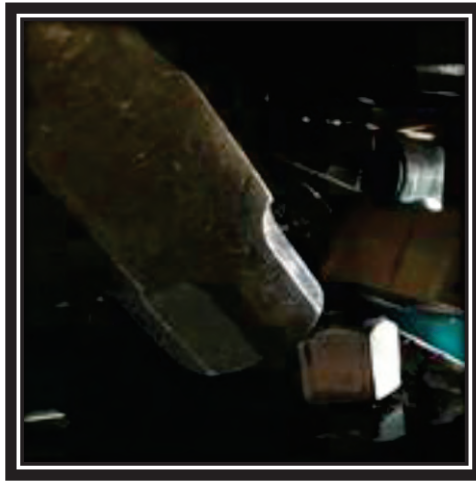
17. Remove the castle nut from the ball joint stud, retain for reinstallation. Ensure all washers found under castle nuts are re-installed in their original position.
18. Place sacrificial M20 1.5 nut on ball joint stud. Roll assembly over so sacrificial nut is on bottom resting on a solid surface. Strike relay rod downward with hammer to un-seat tapered connection.

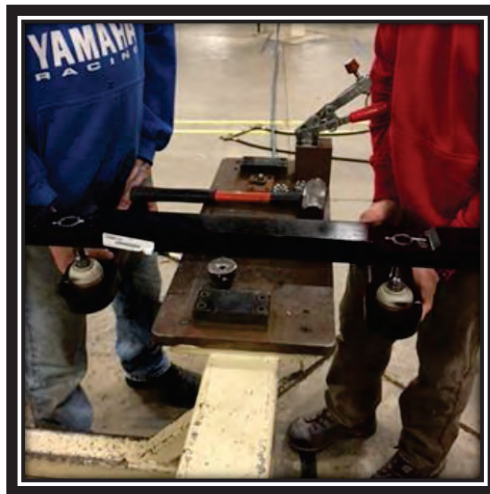
19. Remove ball joints from the relay rod.

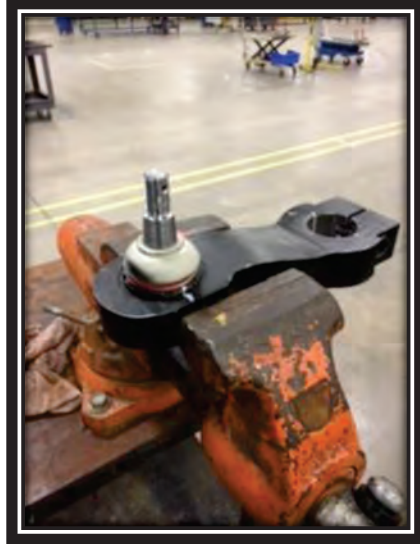
20. Place pitman arm (or idler/bell crank) assembly in a vice.

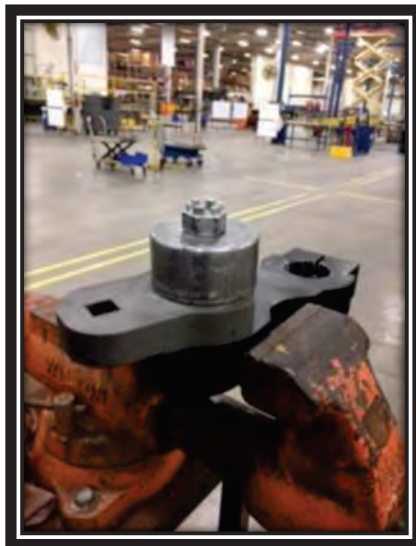
21. Using 40 mm ball joint tool and castle nut, place over ball joint.

USE CAUTION TO NOT TEAR BOOT

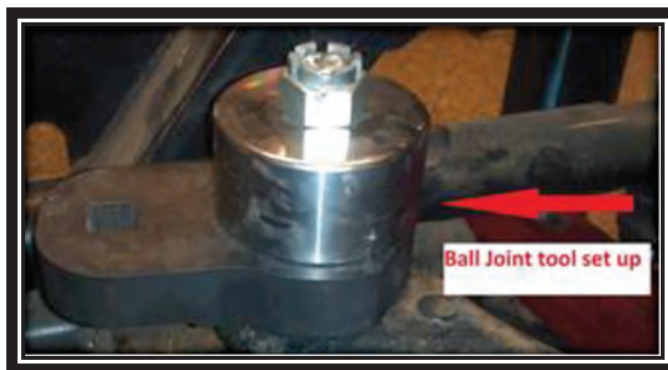
22. For each ball joint, run castle nut down, leaving castle nut slightly loose. **DO NOT RUN DOWN TIGHT**

Note: Tool 708116-05 is used with castle nut to hold tool 708116-02 loosely on the ball joints. Be sure that tooling set up is not binding when loosening, castle nut should come off freely after ball joint is loose.

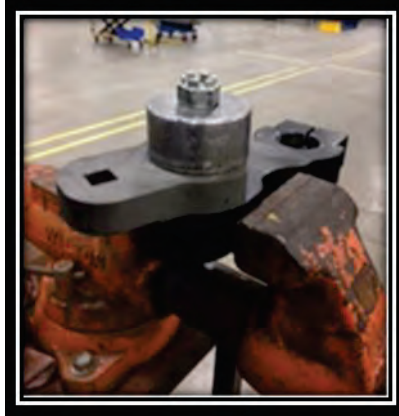
30. Using 50 mm ball joint tool and castle nut placed over ball joint (Use caution to not tear boot) torque the ball joint to 350 lbf-ft.

31. Be sure that tooling set up is not binding when tightening.
32. Castle nut should come off freely after ball joint is torqued.
33. Ensure that the ball joint is fully seated into the pitman arm.
34. Reinstall the relay rod to the front suspension in reverse order to removal using new cotter pins and the following torque specs:
 - Tie rod castle nut – 90-100 lbf-ft.**
 - Ball joint castle nut – 155-170 lbf-ft.**
 - Pitman arm attachment bolt – 295-315 lbf-ft.**
 - If applicable the drag link castle nut – 90 - 100 lbf-ft.**
35. When tightening castle nuts ensure specified torque is achieved. Advance the nut to align the castle slot with the thru hole to allow cotter pin to be installed. **DO NOT BACK CASTLE NUTS OFF TO INSTALL COTTER PINS.**
