SERVICE BULLETIN

Classification: FA15-003c	Reference: NTB15-062c	Date: June 2, 2017
------------------------------	--------------------------	-----------------------

2014-2016 ROGUE; POPPING NOISE FROM FRONT SUSPENSION WHEN TURNING

APPLIED VEHICLE: 2014-2016 Rogue (T32)

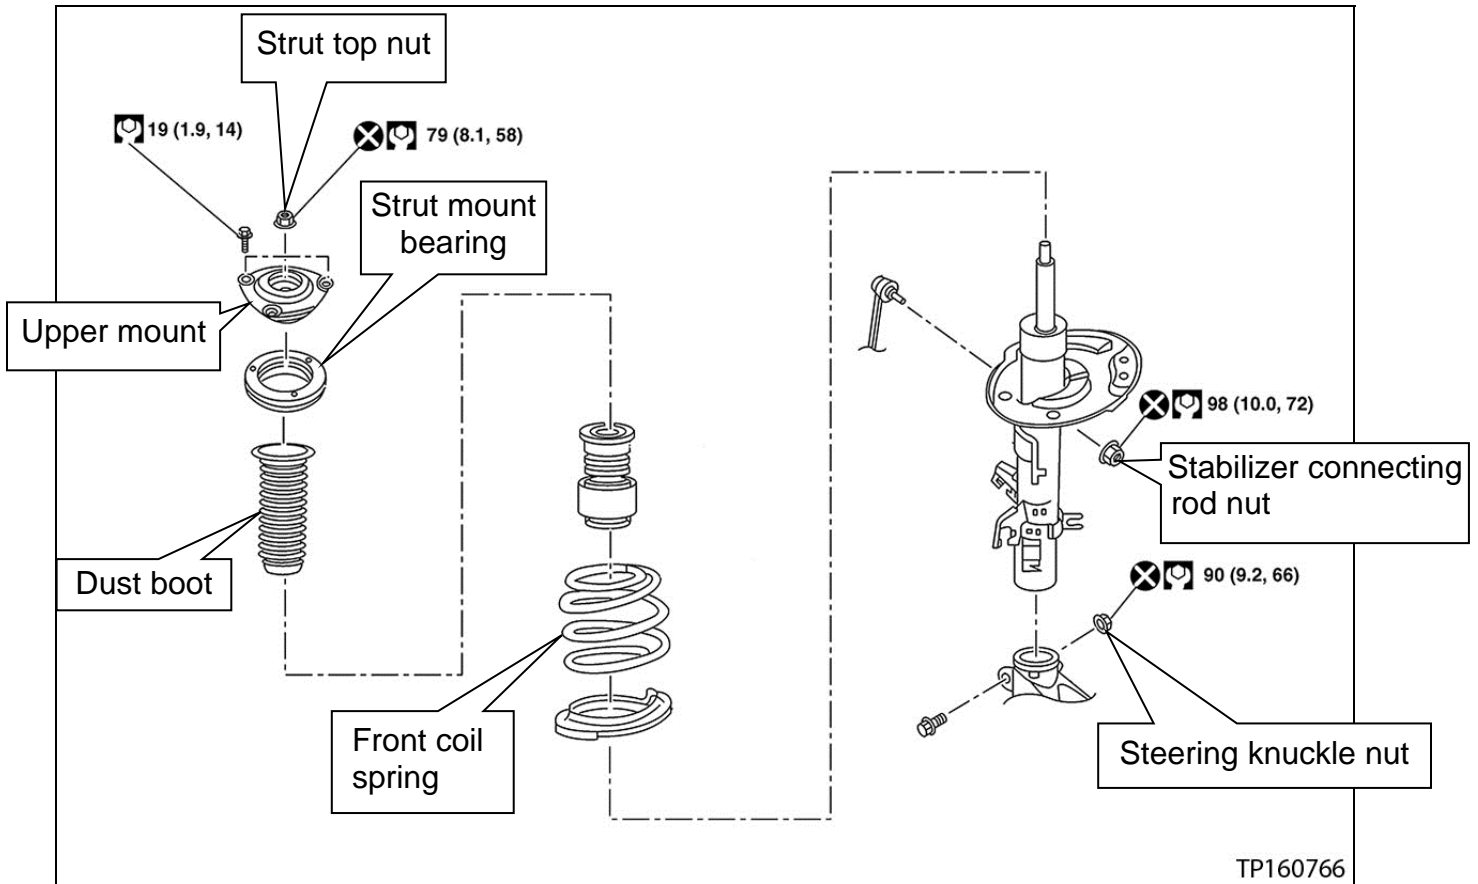
- For an effective repair, all parts called out in Figure 1 must be replaced on both front strut assemblies. These parts are also listed in the Parts Information.
- The incident noise may return if all listed parts are not replaced.

DESCRIPTION	PART #	QUANTITY
Front Coil Spring (FWD vehicles)	54010-9TA0D	2
Front Coil Spring (AWD vehicles)	54010-9TA1C	2
BEARING-STRUT (strut mount bearing)	54325-8271R	2
INSUL STRT MNTG (upper mount)	54320-4BA0C	2
SEAT-RUBBER, FRNT SPRING (dust boot)	54034-4BA0C	2
NUT (steering knuckle nut)	01223-N2011	2
NUT (strut top nut)	54588-JA005	2
NUT (stabilizer connecting rod nut)		2

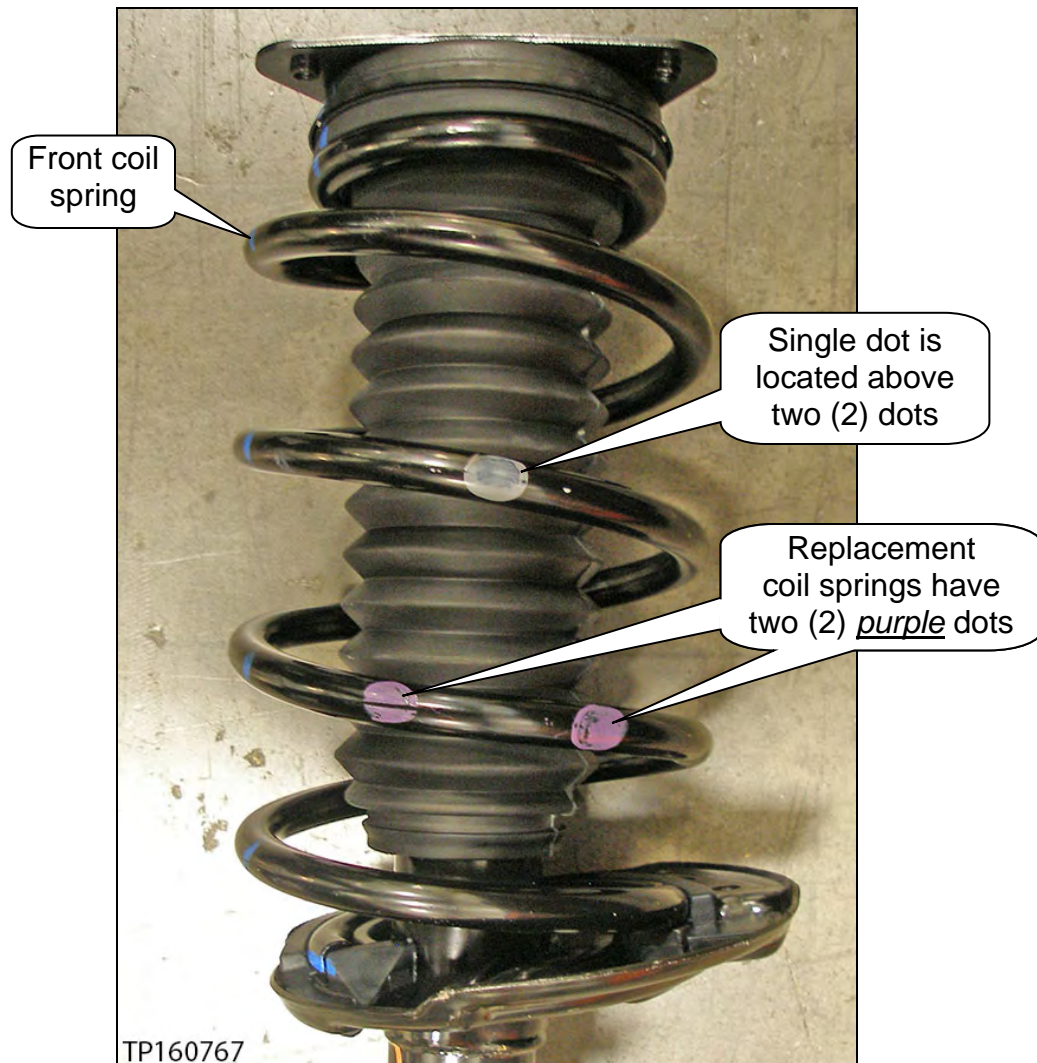
Figure 4

- With the coil spring installed, the single dot must be ABOVE the two dots (see Figure 4).

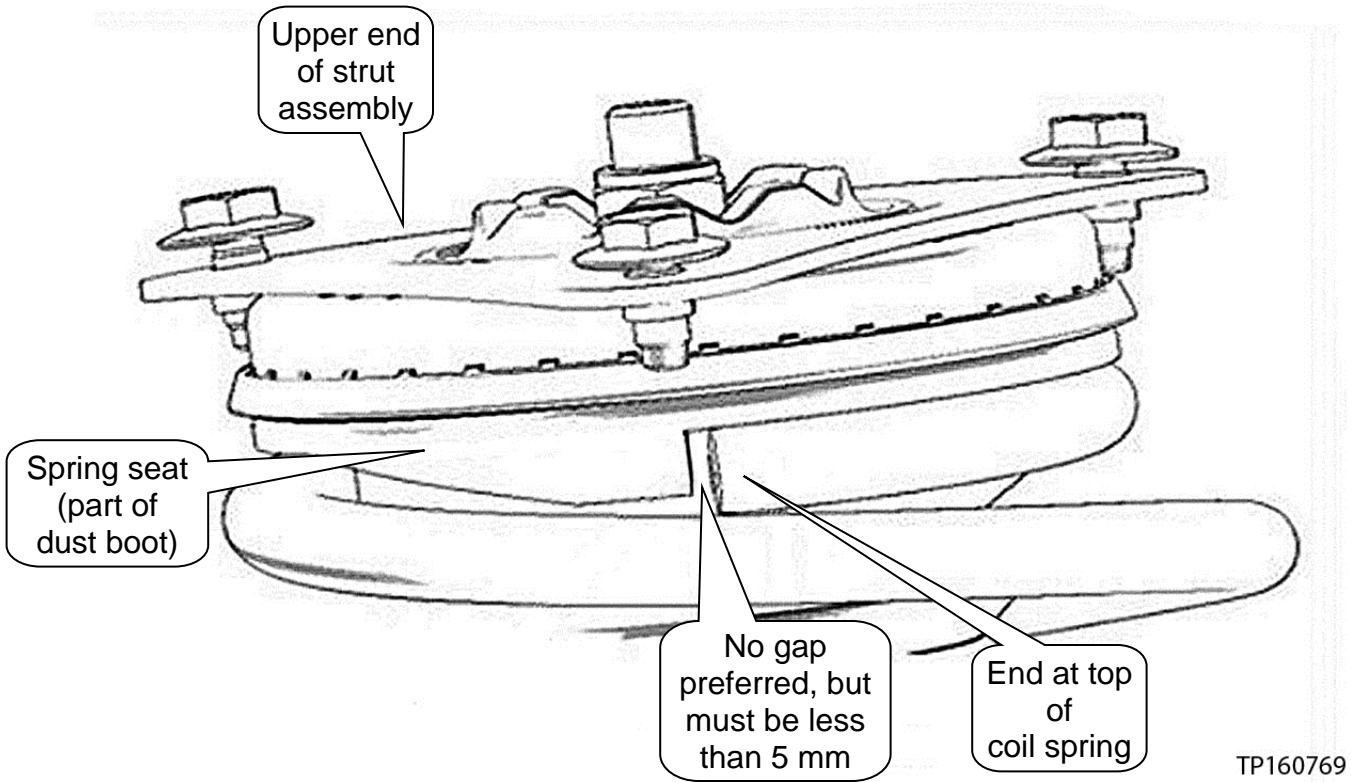
Figure 5

Coil Spring Installation Guidelines (continued)

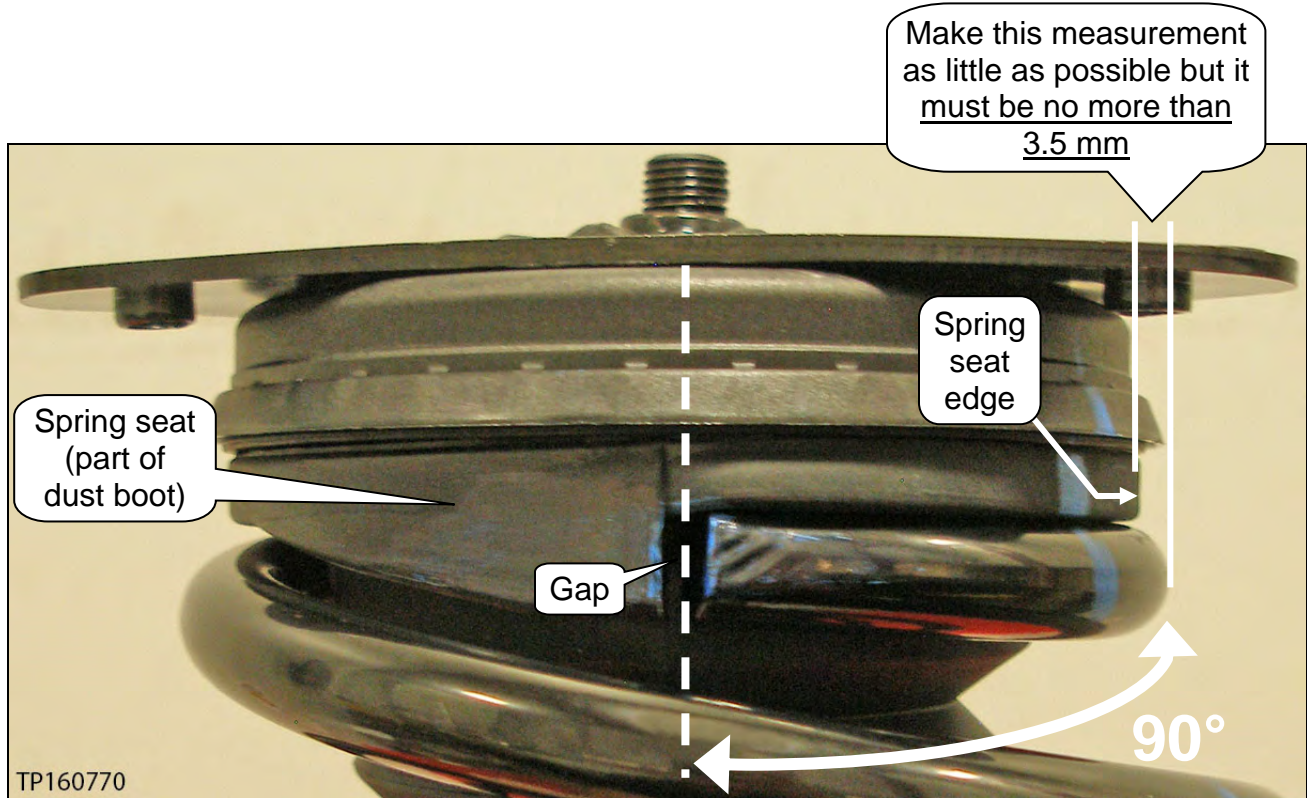
Figure 7

- The side edge of the upper coil spring, located 90° counter clockwise from the gap, needs to be as little as possible but it must be no more than 3.5 mm from the edge of the spring seat (see Figure 7).
- If the measurement is greater than 3.5 mm, rotate the coil spring into the spring seat (close the gap).
