C15 & C58 CONNECTOR BYPASS

Prevost vehicles

On the vehicles affected by this bulletin, on the HVAC system wiring, remove selected wires from C15 and C58 and place them in new connectors C15B and C58B. New connectors have a higher amp rating.

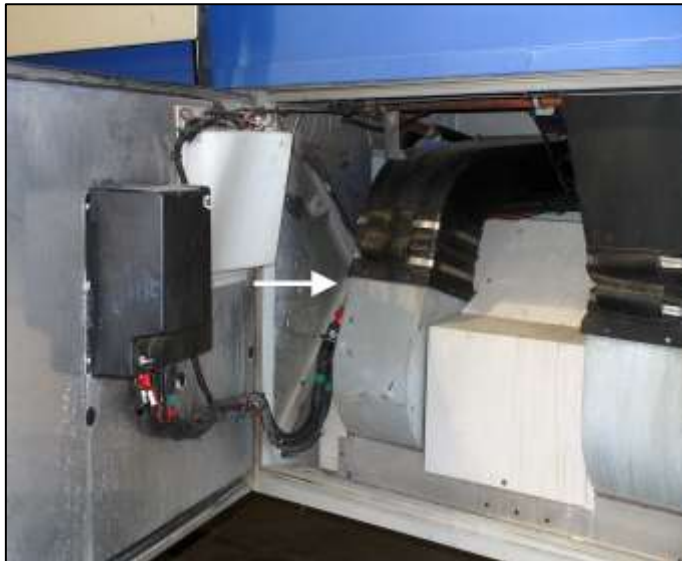
**Figure 10**

1. Locate connector C15 in the evaporator compartment.
2. Harness and connector is attached along the left side of the evaporator fan enclosure.(Figure 10)

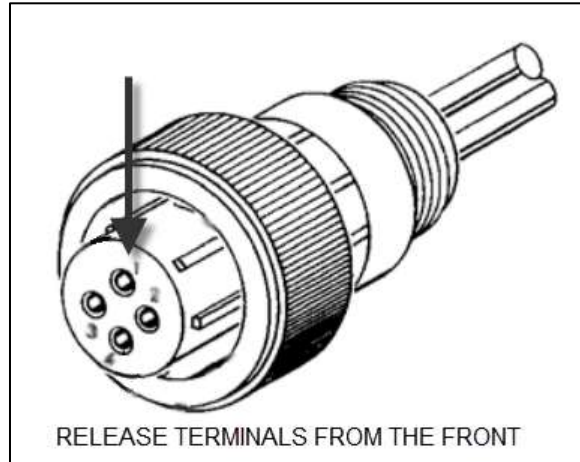
7. C15 is an AMP CPC type 1 connector, use tool 681598 to release the pins. This is done from the front of the connector. (

Figure 12: C15 Amp CPC type 1 Contact Release

8. On each wire, remove terminals, strip and crimp new terminals 564563 pin / 564564 socket. Insert the wires in the new C15B connector cavities.

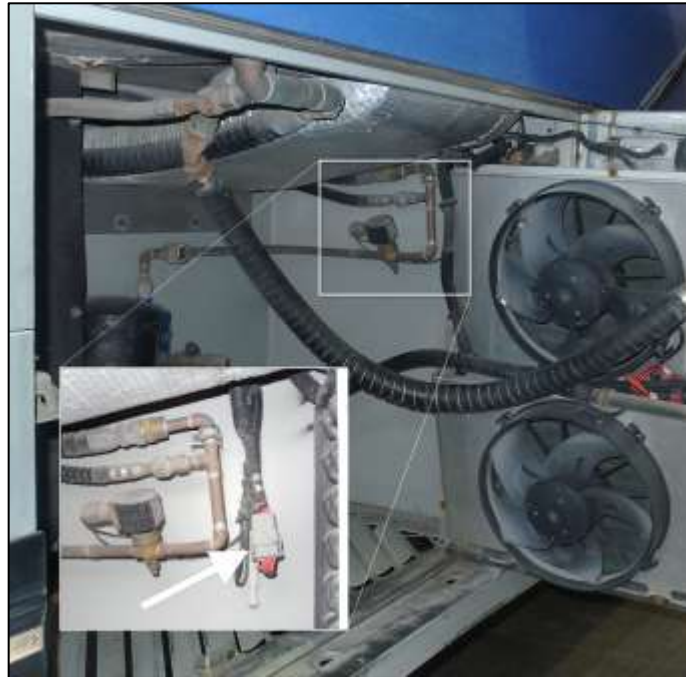
Figure 13

12. Harness is located along the top of the right wall of the condenser compartment. (Figure 13, Figure 14)

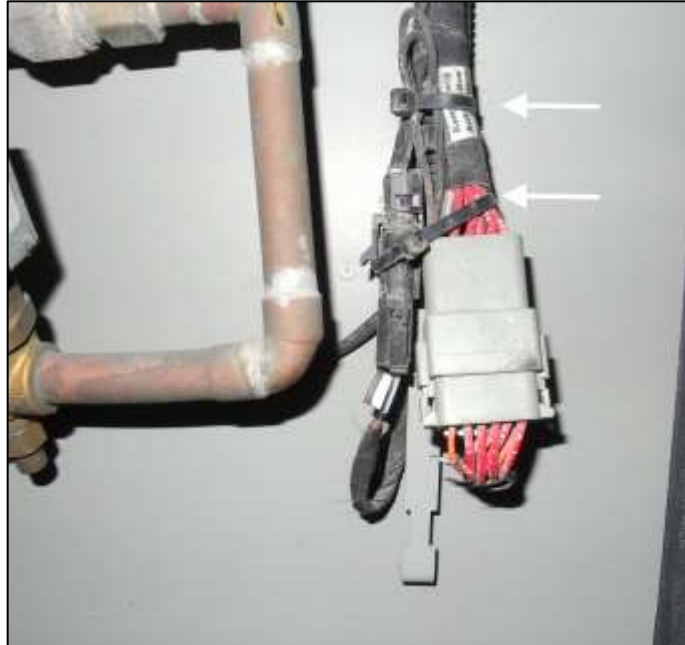
Figure 15: C58

13. Remove cable ties to free harness and connector.(Figure 15)

14. Inspect C58 connector for heat damage. Replace connector and pins if required.
