NYCT DOOR LATCH PINS REPLACEMENT

Prevost vehicles

On the vehicles affected by this bulletin, it is necessary to replace the two engine door latch pins and the compressor door latch pin by new units made of sturdier material.

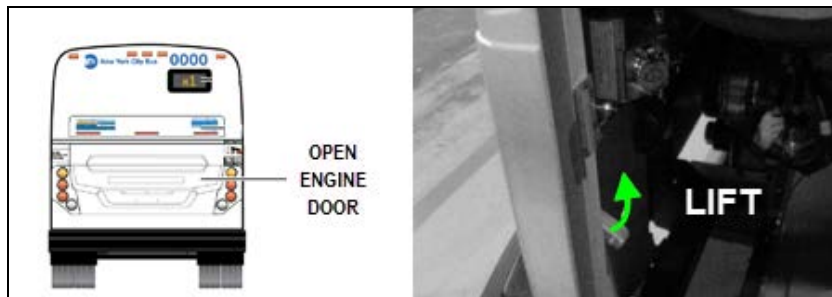
FIG.1 REAR ENGINE DOOR

1. Open the vehicle rear engine door (Fig.1).

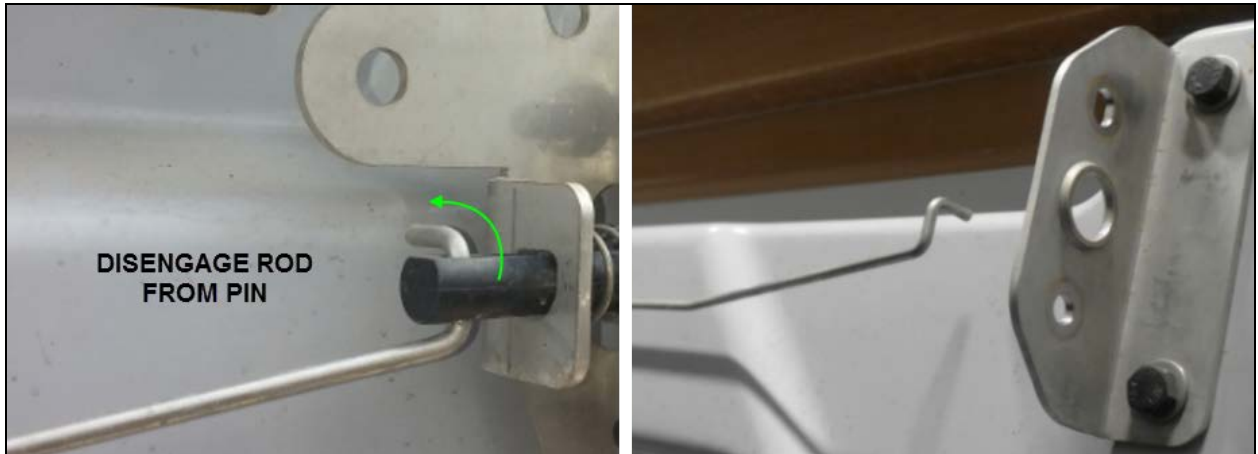
FIG.13 DISENGAGING ACTUATING ROD FROM LATCH PIN

12. Disengage the actuating rod from the latch pin slot to free (& discard) the pin (Fig.13).
