PREVOST

**WARRANTY
BULLETIN**

WB17-10A

DATE :	June 2017	SECTION :	26 SLIDE-OUT
EXPIRATION:	June 2019		
SUBJECT :	SLIDE-OUT RAIL BOLT INSPECTION

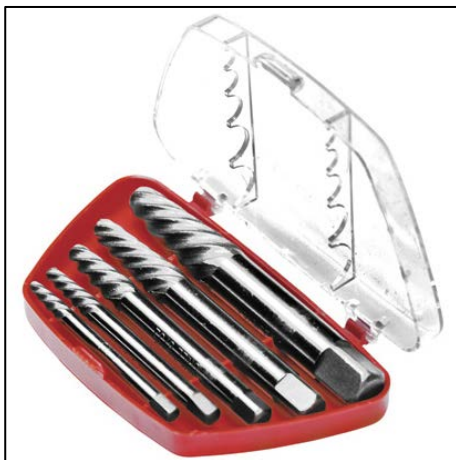
Figure 1 : SCREW EXTRACTOR KIT (INCLUDING M14 SIZE)

6. If the screw head is broken, use a bolt extractor kit to remove the bolt. Closely follow kit instructions.
7. Replace with a new 5001617 screw (Fig. 4). Tighten to **90-100 lb-ft (122-136 Nm)**.

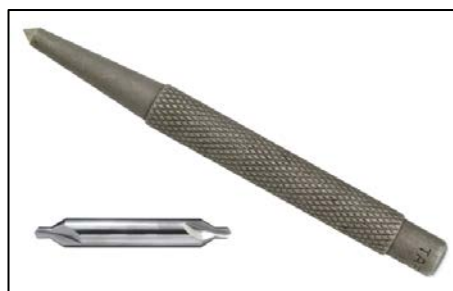
Figure 2 : Centering punch and drill

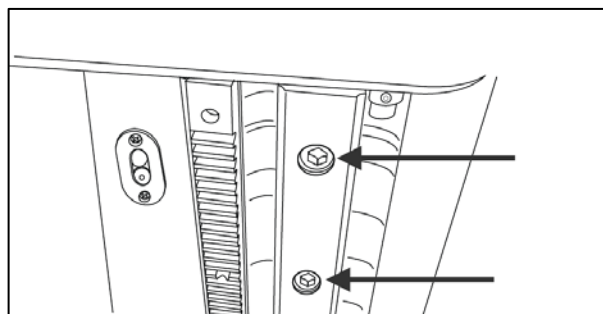
Figure 3

1. Extend the slide-out room.
2. Set the ignition switch to the OFF position and trip the main circuit breakers equipped with a trip button.
3. From under the slide-out, locate the slide out rail socket head screws. (Fig. 3)
4. Remove the protecting cap.

5. Re-torque to **90-100 lb-ft (122-136 Nm)**.

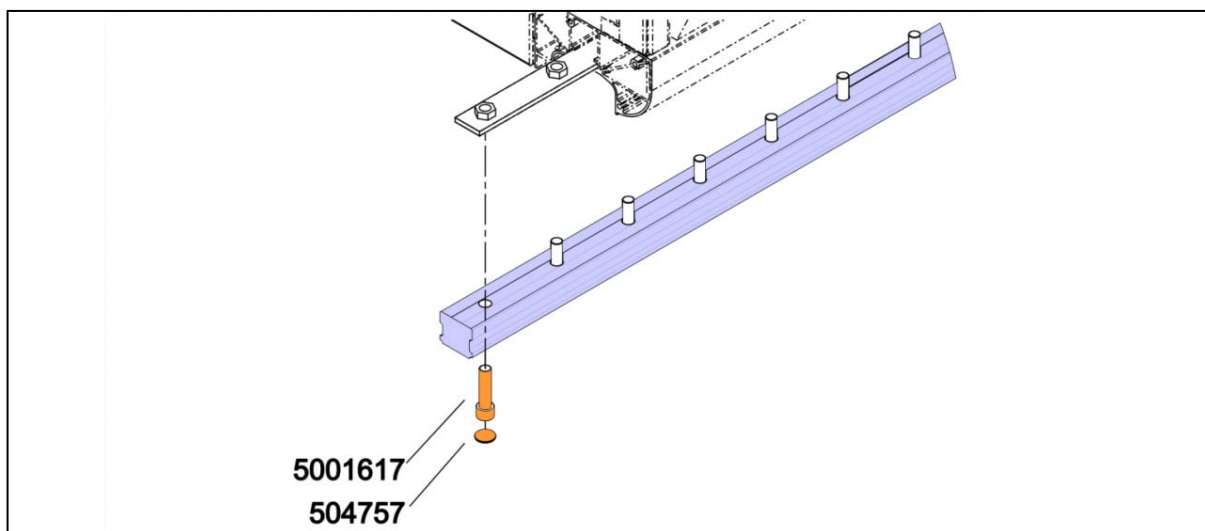
Figure 4

8. Replace any missing or damaged finishing plugs with replacement plugs #504757 supplied in the kit.(Fig. 4)
9. Finishing plug should be mounted flush with rail surface to avoid inflatable seal damage.
10. Set breakers and ignition switch back on.
11. Confirm proper slide operation.
