# Service Bulletin

**Subject:** Poor Engine Performance in Extremely Cold Weather Conditions, PCV Bypass Hose and Charge Air Cooler Icing - Malfunction Indicator Lamp (MIL) Illuminated, DTC P0299, P0236, P2227, P00C7 Set

Brand:	Model:	Model Year:		VIN:		Engine:	Transmission:
		from	to	from	to		
Buick	Encore	2013	2017			1.4L (LUV)	
Chevrolet	Trax

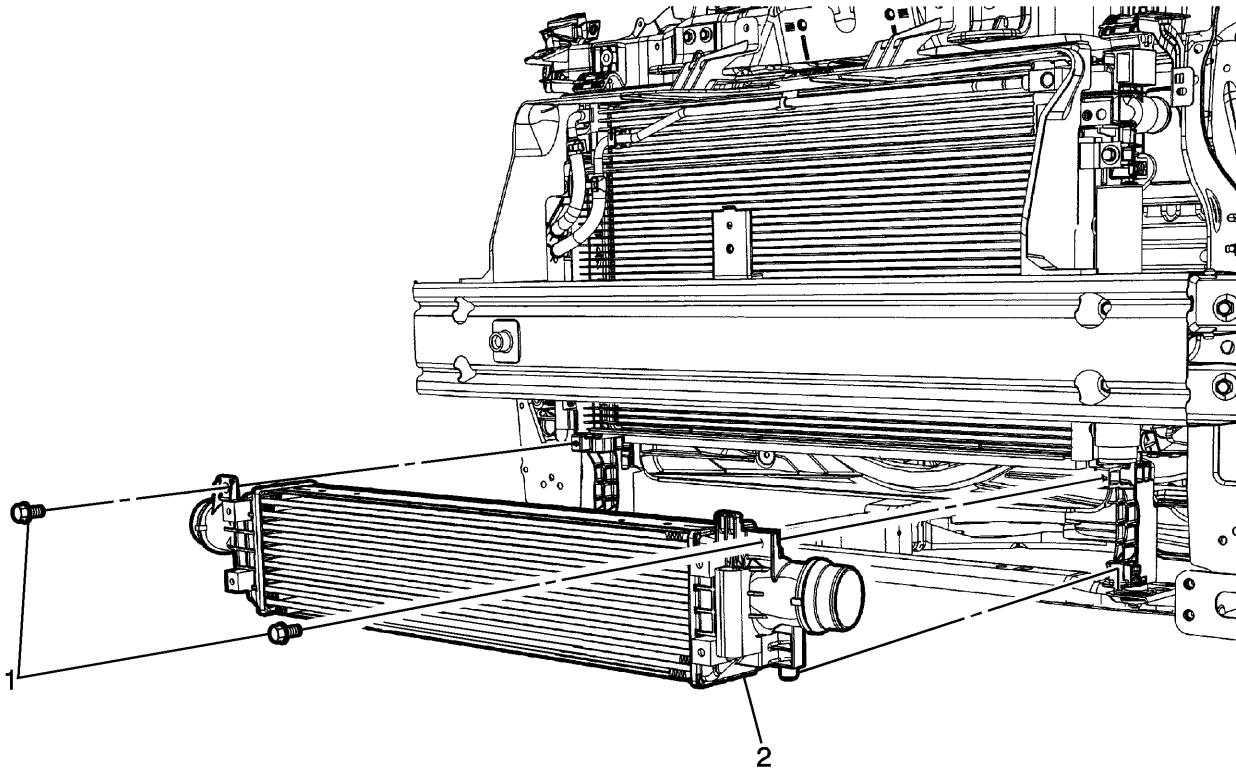
- Plugged Crank Case Vent tube from ice forming in the tube during very cold weather conditions.
- Ice accumulation in the charge air cooler restricting air flow to the throttle body.

27. Remove the Charge Air Cooler (CAC) (2), refer to Charge Air Cooler Replacement in SI.
28. Drain water moisture from the CAC.
29. Install the CAC.
