Service Bulletin

Subject: Rear Roof Weatherstrip Sticks Out After Installing Removable Roof

Brand:	Model:	Model Year:		VIN:		Engine:	Transmission:
		from	to	from	to		
Chevrolet	Corvette	2014	2017

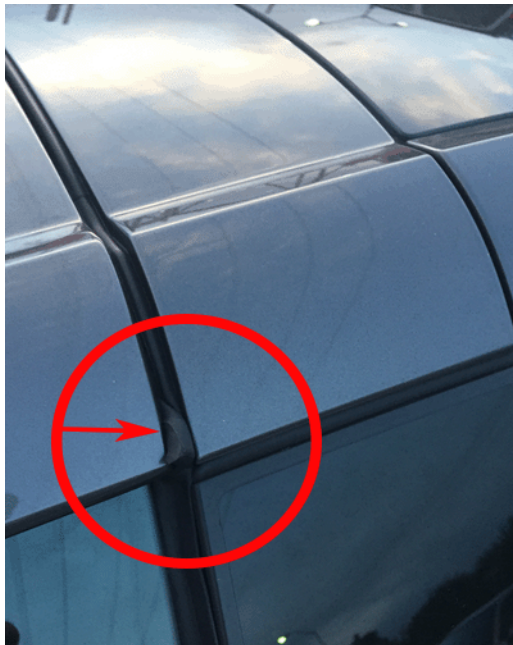
<p>Some customers may comment that the rear roof weatherstrip sticks out from the removable roof when the roof is reinstalled.</p>
Cause	This condition may be due to the profile of the roof weatherstrip.

Replace the rear roof weatherstrip and both (RH and LH) removable roof weatherstrips with the latest design.

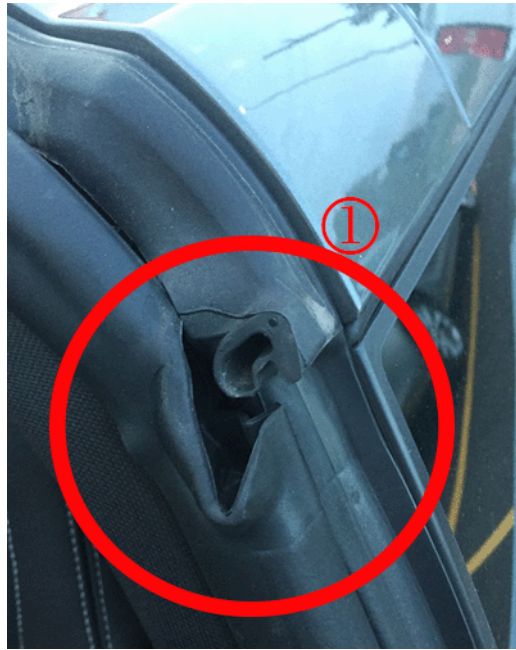
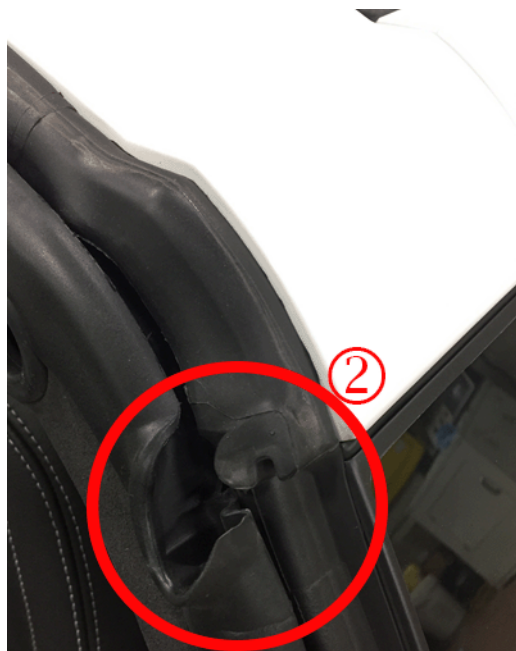
Note: Shown in the illustrations above are examples of the old design (1) and the latest design (2) removable roof weatherstrip.
