Preliminary Information

PIP5395B Ticking Rattle Or Buzz Noise Heard The Best In The Passenger Compartment

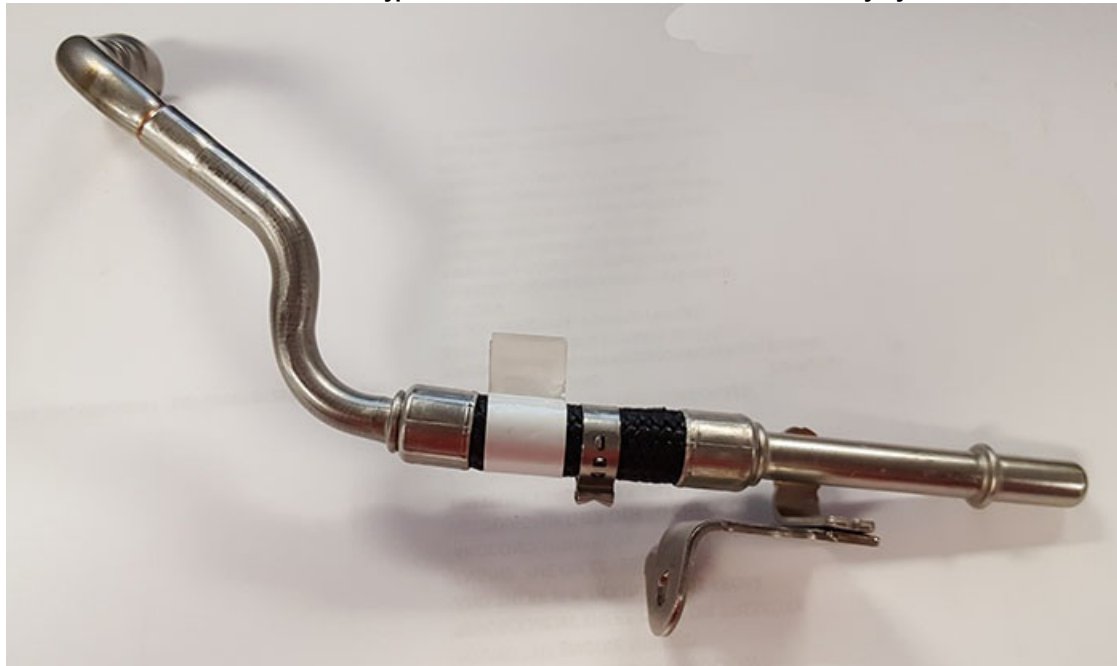
The line above is the fuel feed pipe for Corvette, truck and SUV.
This line connects the chassis fuel line to the high pressure fuel pump.

Listen to the fuel line connection at the left side of the engine.
If the noise is heard best at the fuel line (this sound will be real loud with a stethoscope).
The fuel feed line between the high pressure fuel pump and chassis fuel line could be the cause allowing high pressure pulsation back to the low side of the fuel system. There is not a good way to test the check valve, the line will need to be replaced.
On pickups and SUVs, a vibration in the fuel line at the fuel tank may also be observed.
Reevaluate the concern.
There are two different fuel line types that contain this check valve and vary by model.

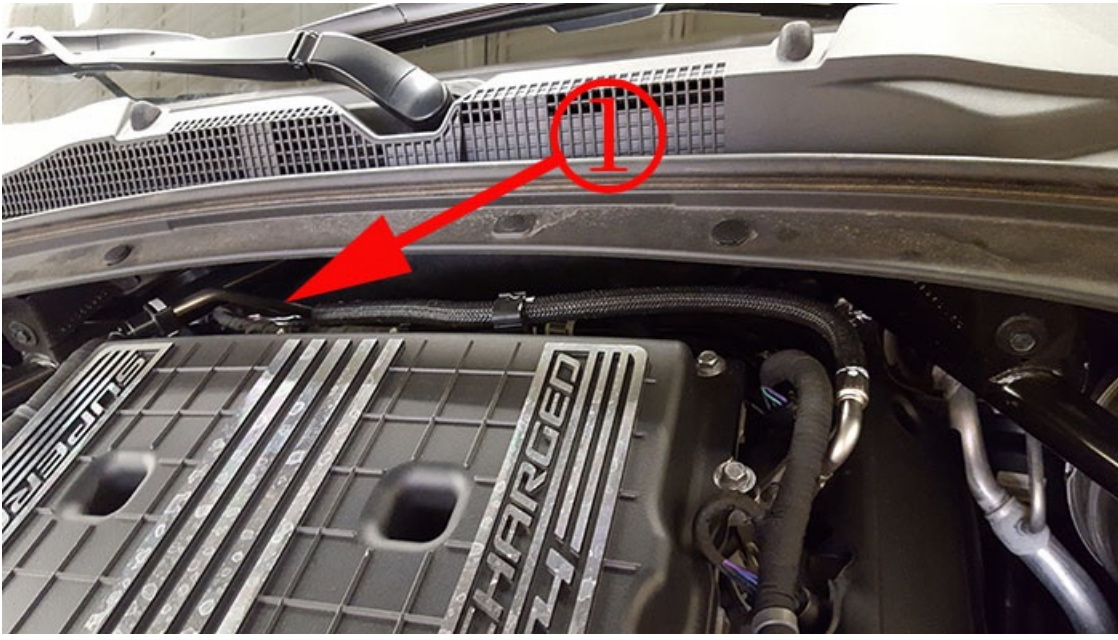
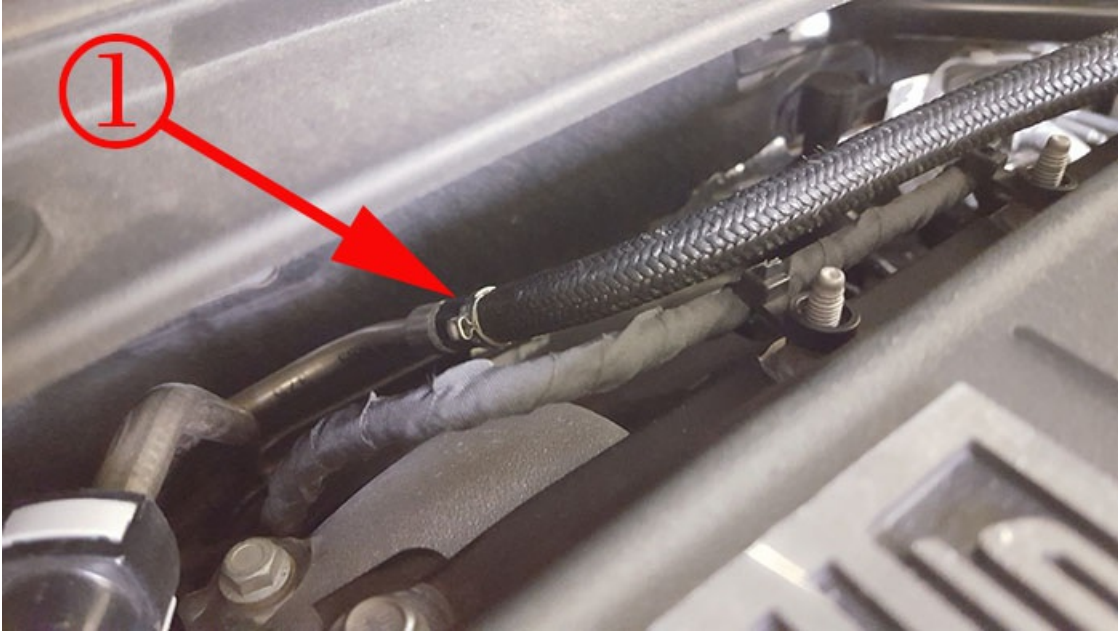
These pictures above shows the chassis fuel feed pipe for the LT4 supercharged ZL1 Camaro. On LT1 Camaro and LT4 CTS-V this line would have a jumper line with quick disconnects at both ends. One end will connect to the chassis line and the other to the high pressure pump feed line.
