# ***Airstream Service Bulletin***

**Bulletin Number: #171**  
**Product Line: Airstream Basecamp**  
**Subject: Refrigerator Compartment Leaks**

2017 Airstream Basecamp Travel Trailers built between 9/08/2016- 3/31/17

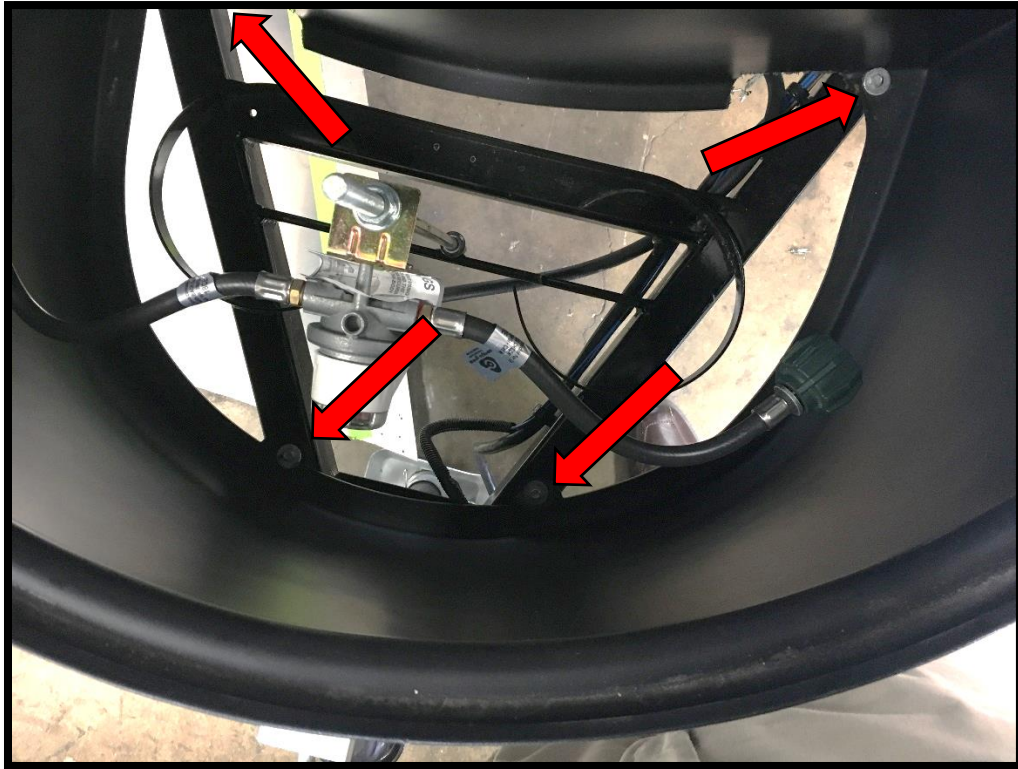
**Step 1:** Turn off gas, remove LP bottles and LP bottle cover. To remove the cover, remove the 4 self-tapping bolts with a 3/8" socket or nut driver.

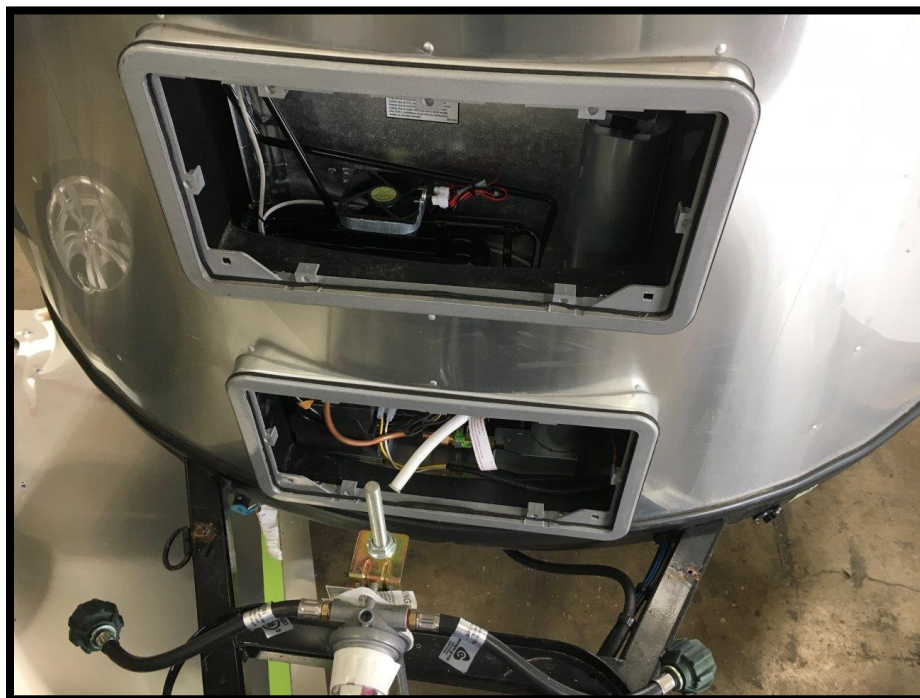
**Step 2:** Using a flat head screw driver, turn the locking tabs in the corners of the refrigerator access doors. This will allow you to remove the refrigerator access doors.

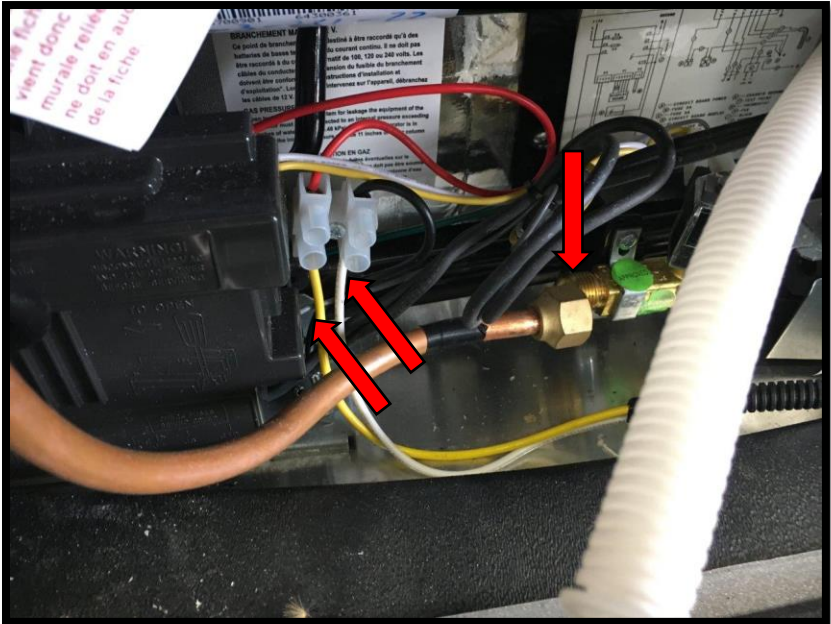
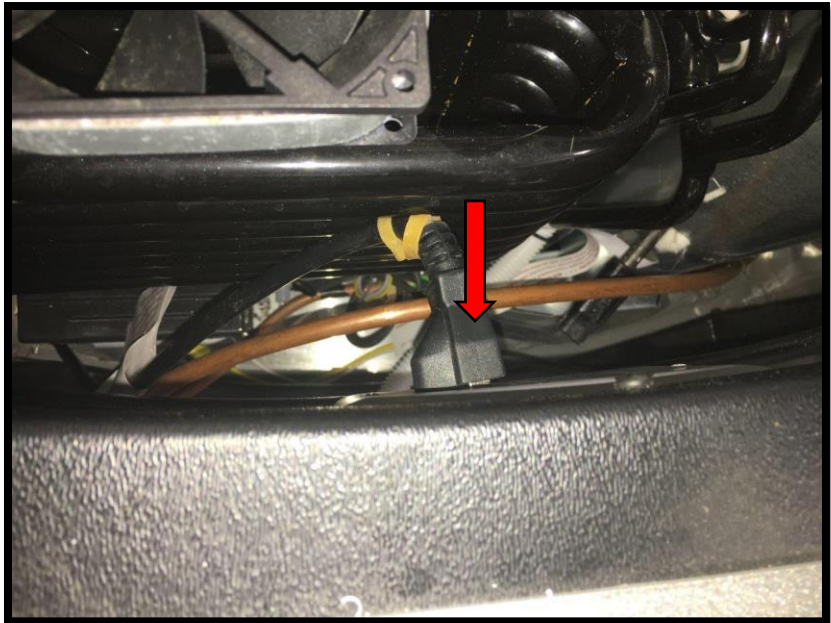
**Step 3:** Disconnect the LP line, 12 volt power wires and 110 volt power plug for the refrigerator.

**Note:** You may need to loosen and move the fridge to get the 110V power disconnected. See step 4 for refrigerator removal process.

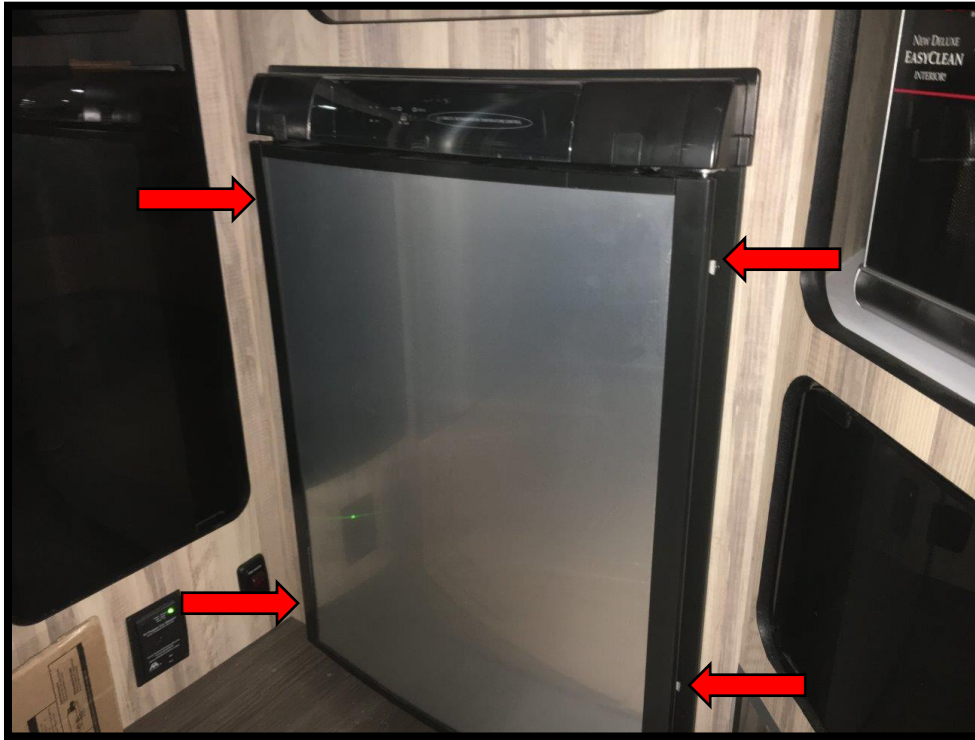
**Step 4:** Remove the refrigerator. To do this, remove the screw caps on the left and right side of the refrigerator and remove the 4 phillips-head screws. You should also put down some kind of protective cover on the floor to avoid damage when removing the refrigerator.

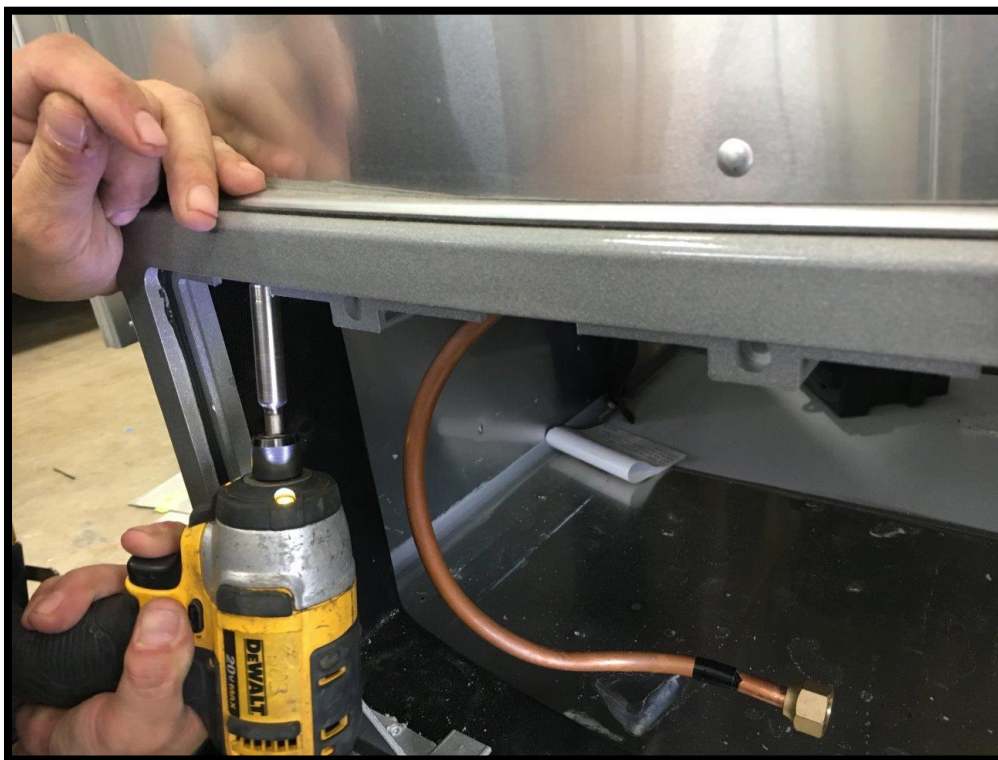
**Step 5 :** Using a battery drill and phillips-head bit, remove the 4 screws holding the upper and lower refrigerator access door frames and remove the frames.

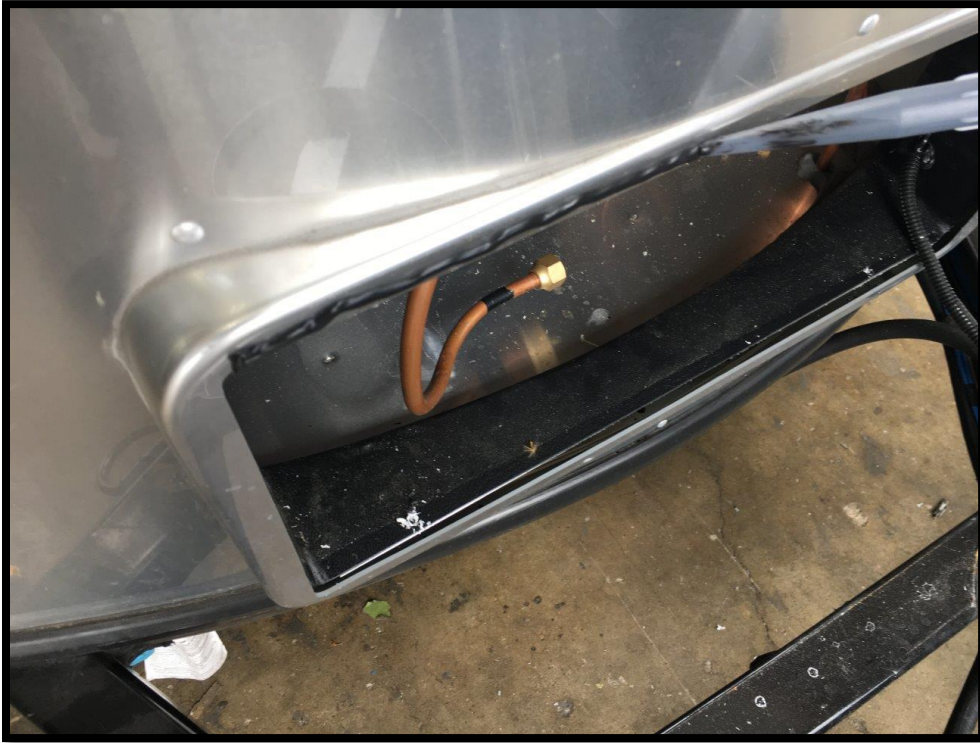
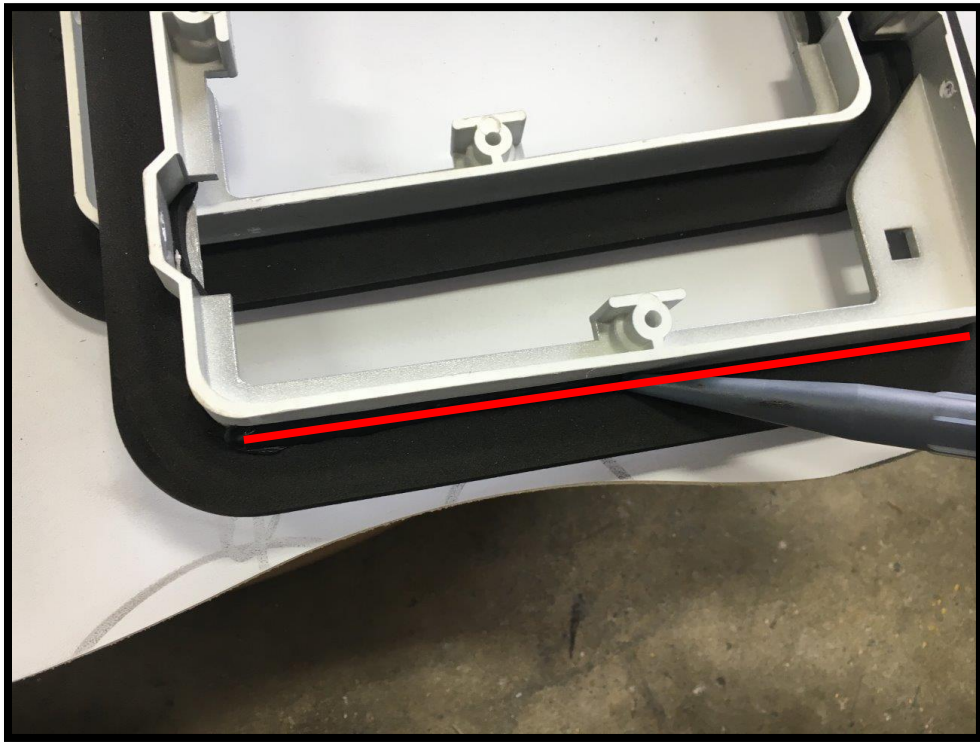
**Step 6:** Using black Ad Seal (part # 365330-04), put a bead of sealant around both upper and lower exterior frames attached to the trailer. Also, put a bead of sealant all the way around the interior side the frame that was removed, like pictured below.

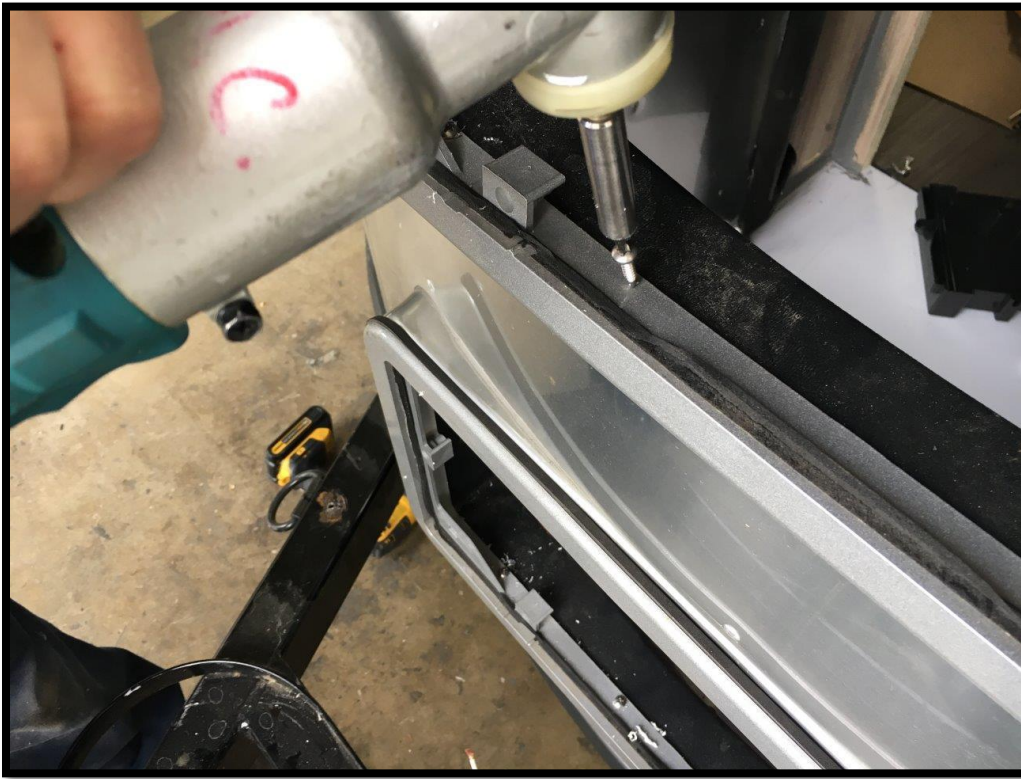
**Step 7:** Re-install the frames. Using a #30 drill bit, pre drill 2 holes on the top of bottom of each frame near the center. Add screws and angle the screws in order to catch the interior aluminum frame. Clean any excess sealant.

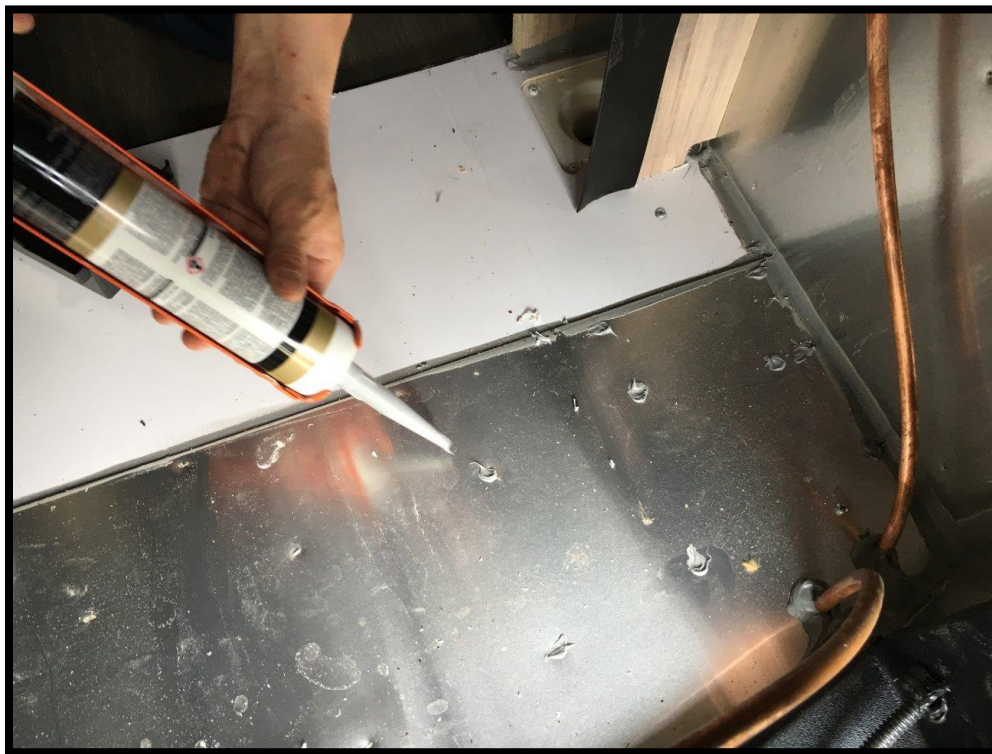
**Step 8:** Inside the refrigerator compartment, using gray Ad Seal (part # 365330-03), seal any penetrations.

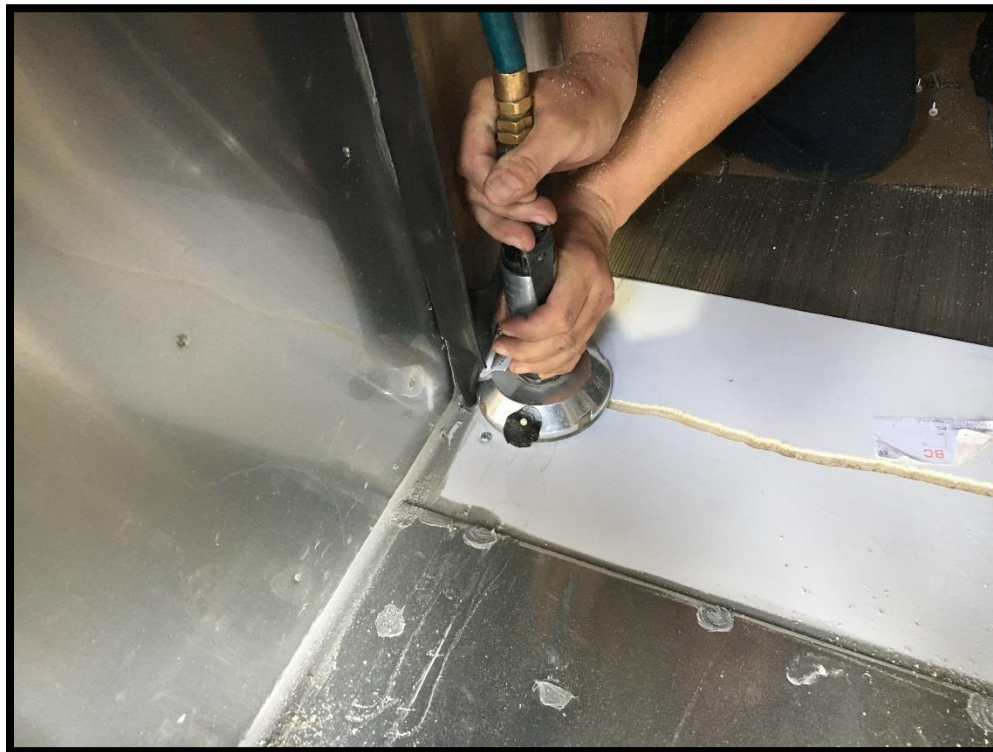
**Step 10:** Using a router, with the cutting bit set at 1/2" cut a channel from the drain area across to the other side of the cabinet. This will allow any excess water to be channeled into the drain.

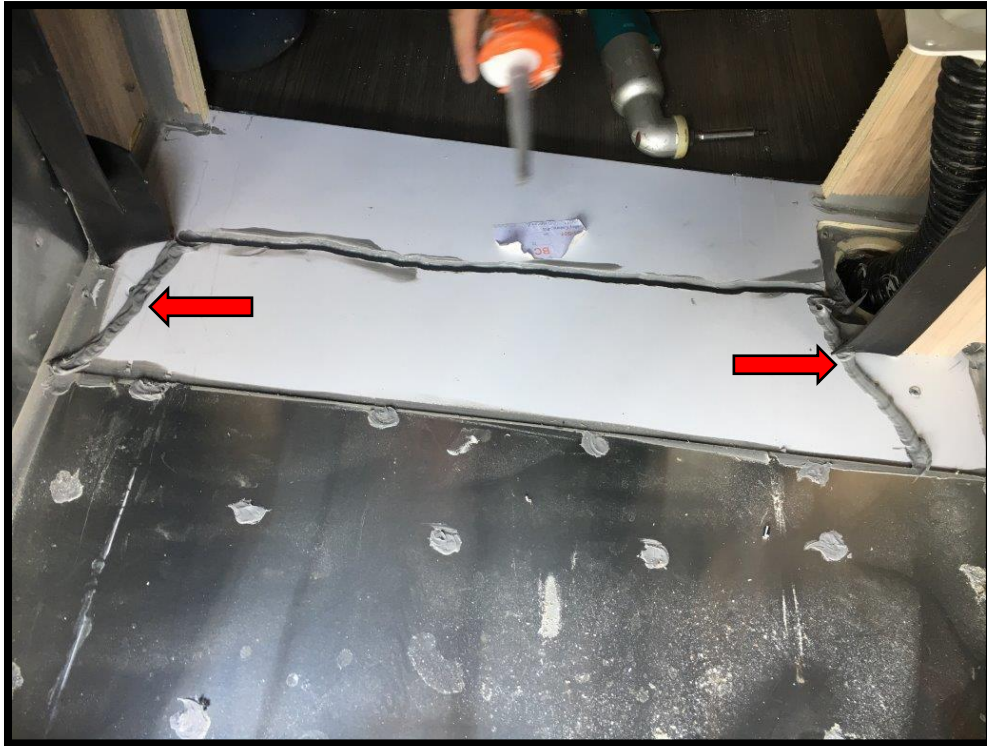
**Step 11:** Using the gray Ad Seal, lay a thick bead of sealant from the metal edge of the refrigerator cabinet to the channel, as pictured below. This will allow any excess water to be directed into the routed channel and into the drain, protecting the wood of the refrigerator cabinet.

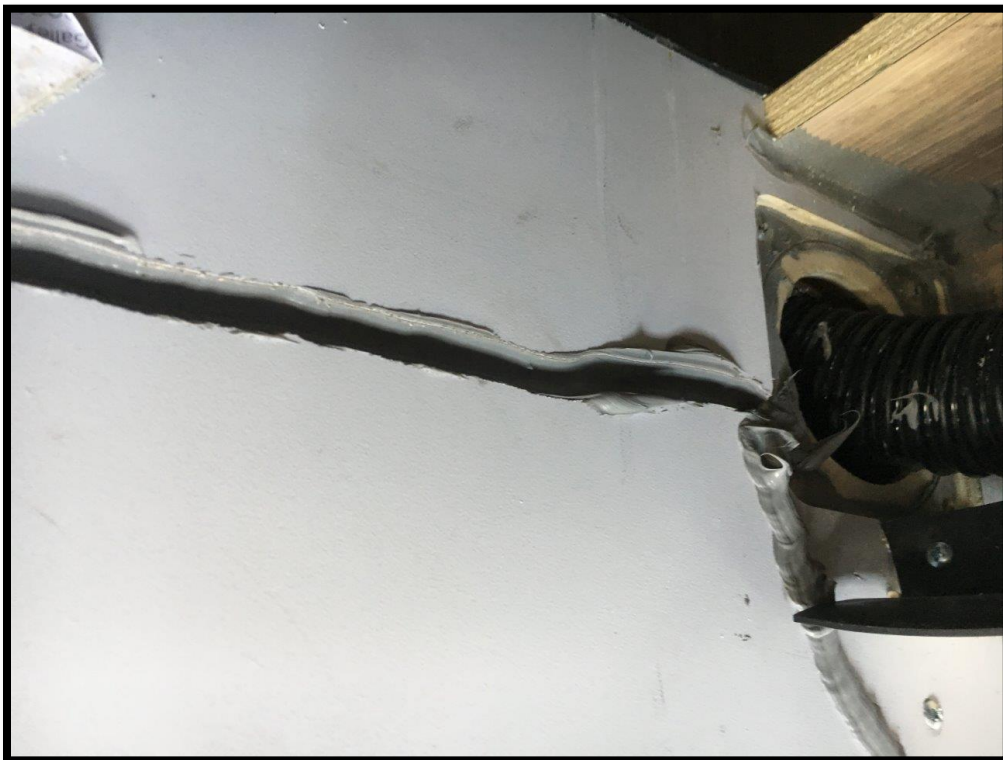
**Step 12:** Lay another thick bead of sealant into the channel. Smooth with your finger to make sure that all sides of the channel are covered. Also seal around the area under the drain and re-install the drain.

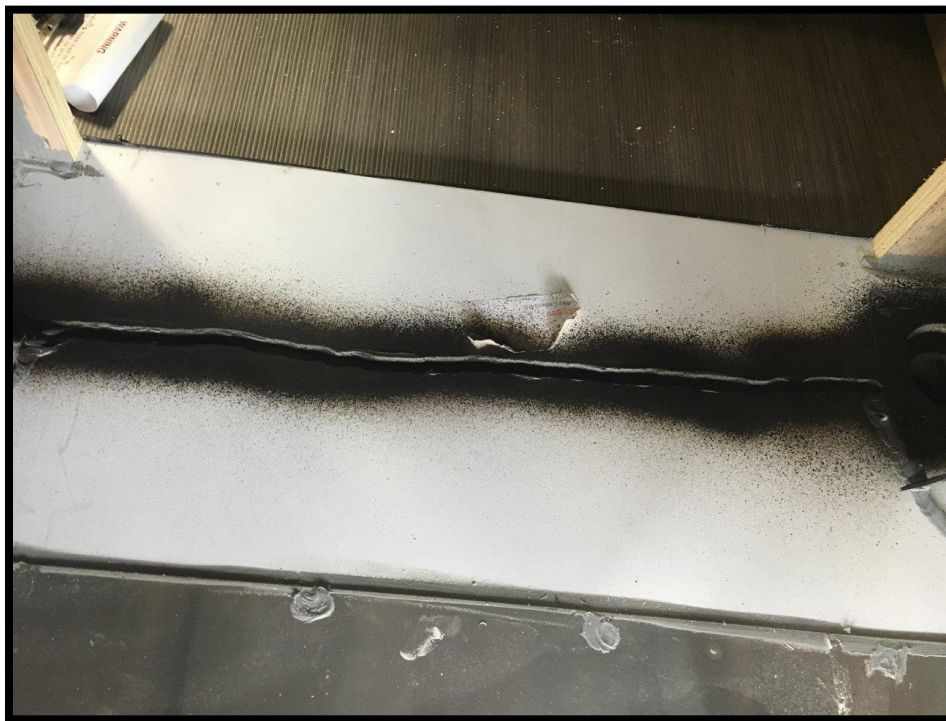
**Step 13:** Using spray anti-wick or undercoating, spray the channel and the drain to seal any remaining areas. You can now re-install the refrigerator. Make sure to plug in the 110V power plug, the 12V power wires and reconnect the LP gas line.

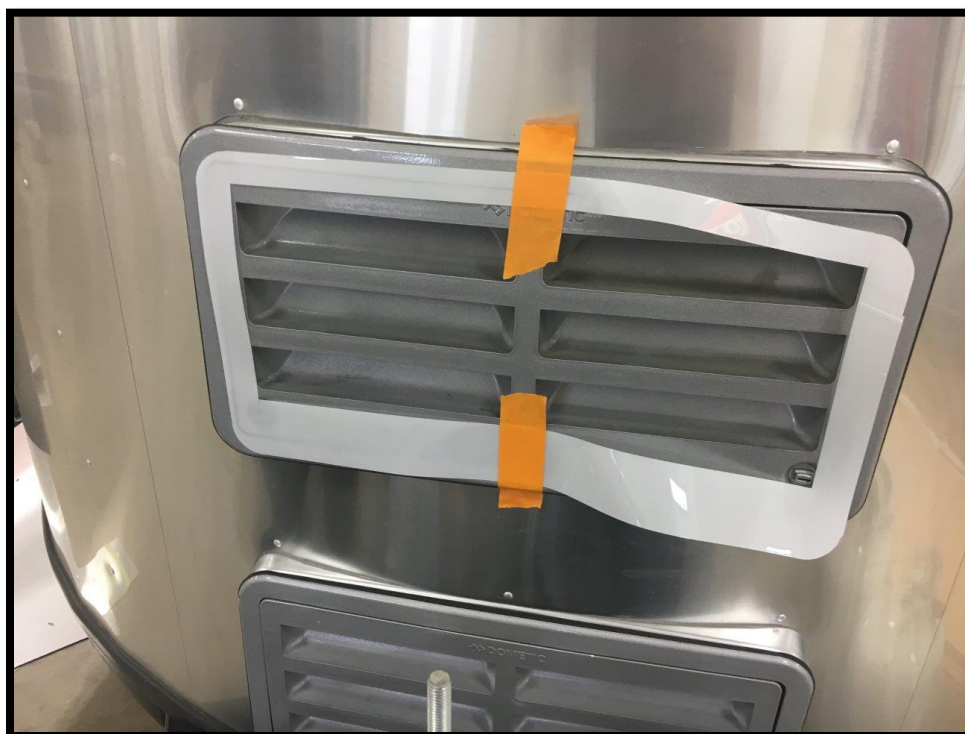
**Step 14:** Re-install the refrigerator access doors. Using the die-cut 3M film (part #203988 ), line up the film to cover the area where the door meets the frame. Tape the film in the middle to hold it in place, remove the backing and stick to the door. Smooth out any air bubbles. Repeat on lower door.

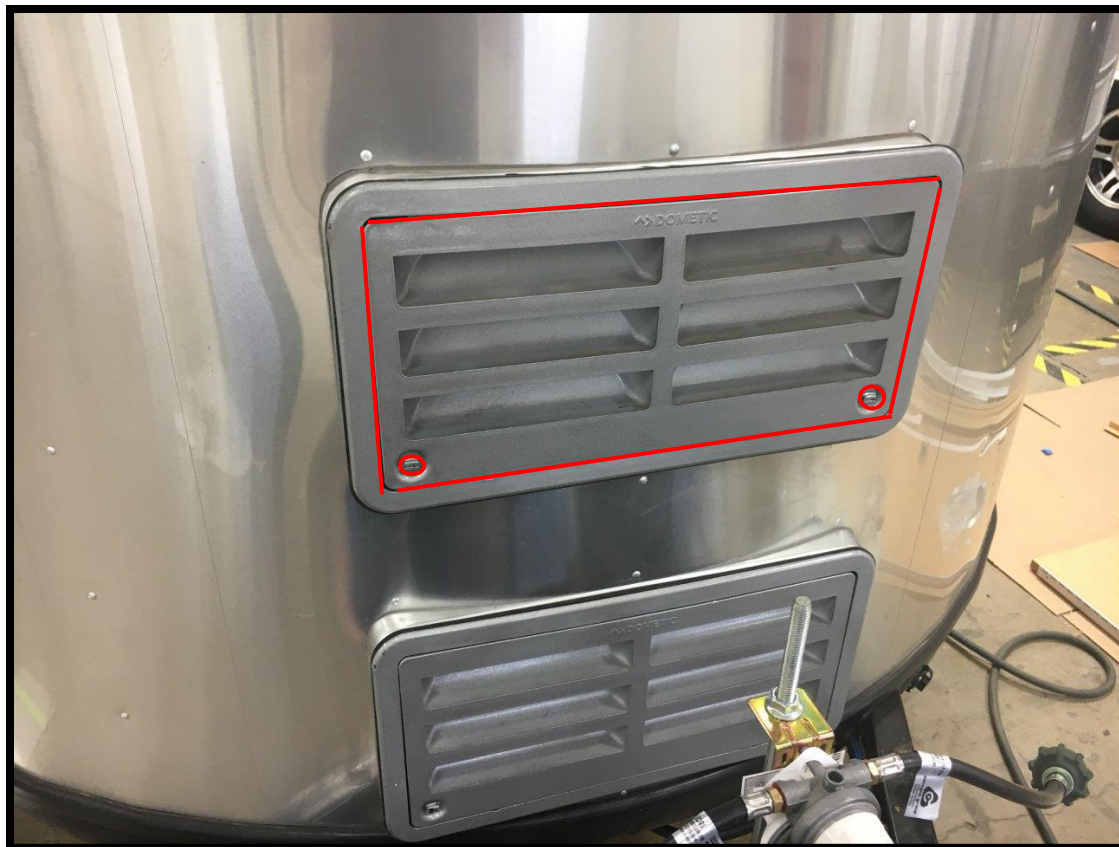
***Note:*** When the refrigerator needs to be accessed in the future, the film will have to be cut around the door frame and latches (see below). New film will need to be installed.
