**August 25, 2017**

07255 Version 2

## Warranty Extension: Transmission Chirps During 3-4 Shift, Poor Shift Quality, or Engine Overheats Because of Defective ATF Warmer

Supersedes 17-035, *Warranty Extension: 2016 Pilot Chirps During Shifting, Poor Shift Quality, or Engine Overheats Because of Defective ATF Warmer*, dated August 4, 2017, to revise the information highlighted in yellow

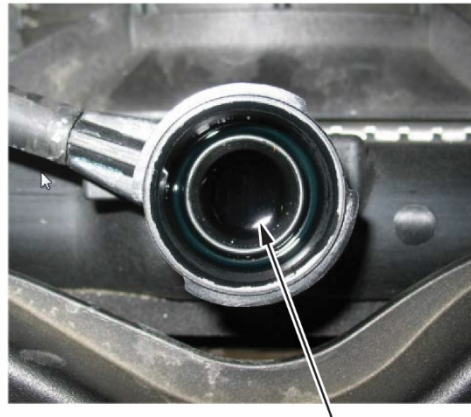
ATF IN THE COOLING SYSTEM

Remove the radiator cap and inspect for ATF in the coolant. If there is coolant contamination, the coolant will look brown.

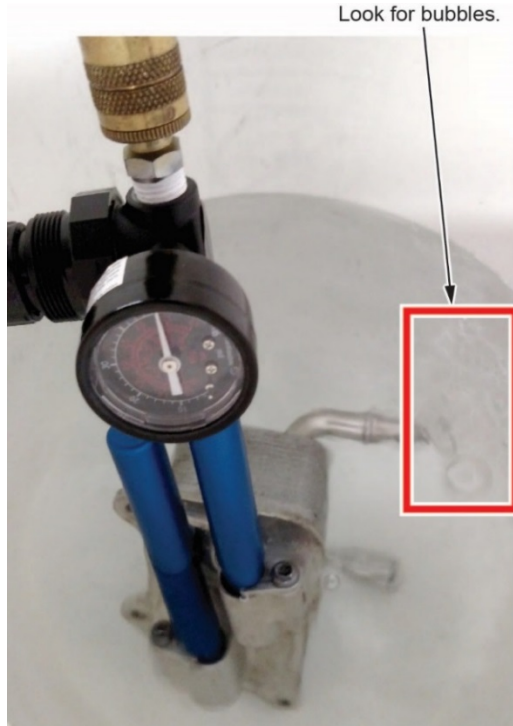
14. Check the transmission warmer for leaks by submerging the warmer completely under the water and watching for bubbles.

NOTE: Some bubbles are normal when the transmission warmer is first submerged and will come to a stop. If there is a leak, there will be a steady stream of bubbles coming from the transmission warmer.

- **If there are no bubbles** coming from the warmer, the 9-speed transmission warmer is OK. **Go to step 15 to install the original warmer** with new O-rings and Jiffy-Tite fittings (if equipped with an accessory cooler.) Submit a claim for the warmer inspection only, then continue with normal troubleshooting to resolve the original customer complaint.
- **If the transmission is going to be replaced for another problem reuse the O-rings when reinstalling the warmer.**
- **If there are bubbles**, take photos (see Photos) and check to see if the vehicle also overheated by checking the customer responses on the RO.
  - If the transmission warmer leaks, but the vehicle did not overheat, go to [REPAIR PROCEDURE A](#).
  - If the transmission warmer leaks, and the vehicle did overheat, go to [REPAIR PROCEDURE B](#).

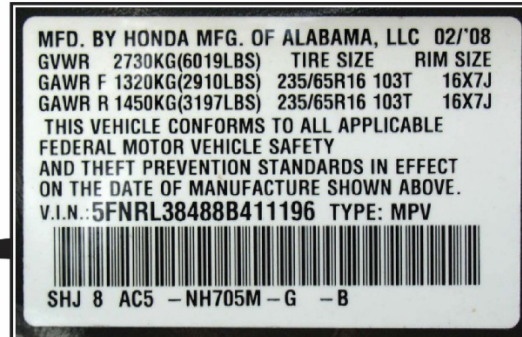
VIN LABEL

- VIN

*Take this photo:*

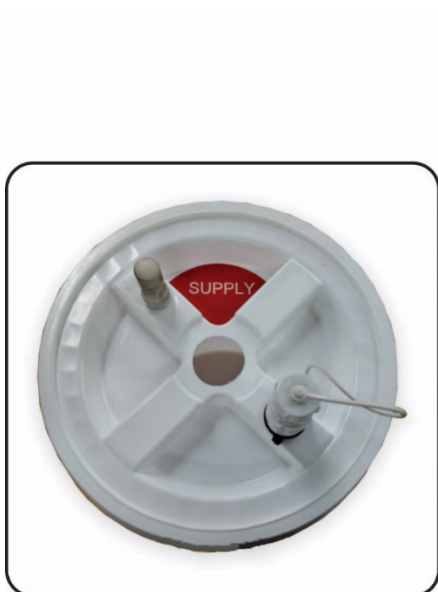
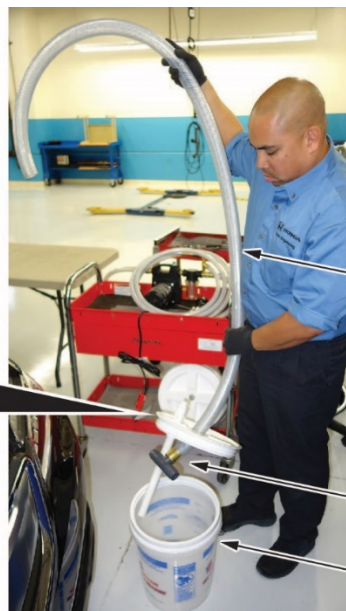
11. From the bucket marked SUPPLY, remove the lid and install the large (1.5 in.) return hose with the T-fitting through the hole in the lid as shown.

ENGINE RETURN HOSE

T-FITTING

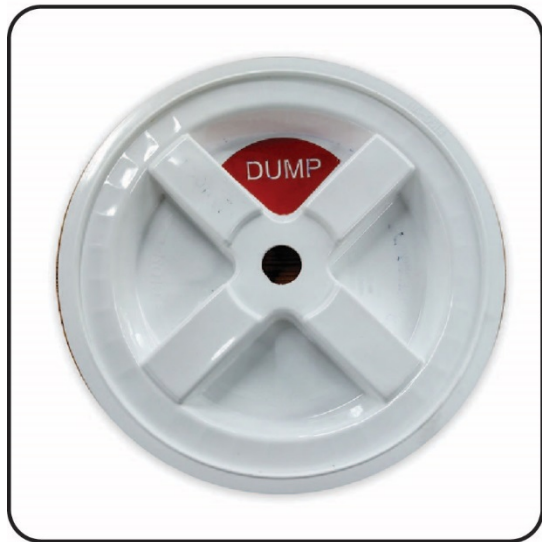
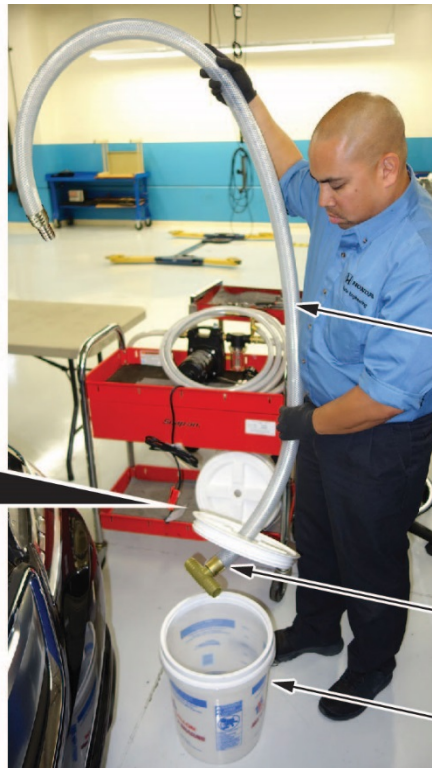
23. Install the heater core return hose through the DUMP bucket lid.

HEATER CORE RETURN HOSE

T-FITTING

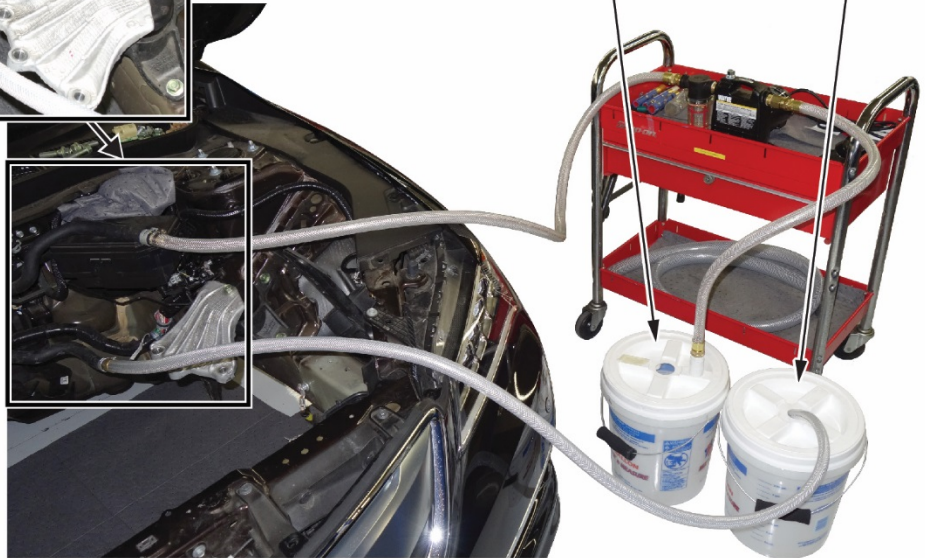
**SUPPLY BUCKET**  
Fill with water and run the pump until bucket is empty.

**DUMP BUCKET**  
Empty into waste coolant container.

FLUSH 4 TIMES TOTAL.

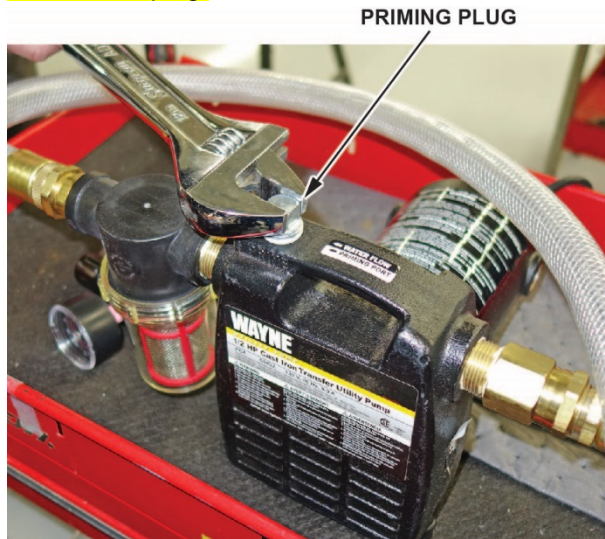
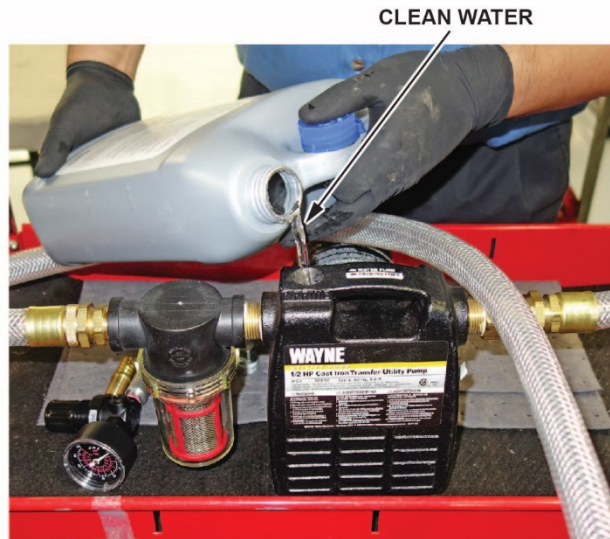
**NOTE:** If this is the first time using the pump, remove the priming plug, and fill the pump with clean water, then reinstall the plug.

PRIMING PLUG

CLEAN WATER
