Remove Rear Seat Protective Coverings Carefully at PDI

AFFECTED VEHICLES

2017 Clarity Electric

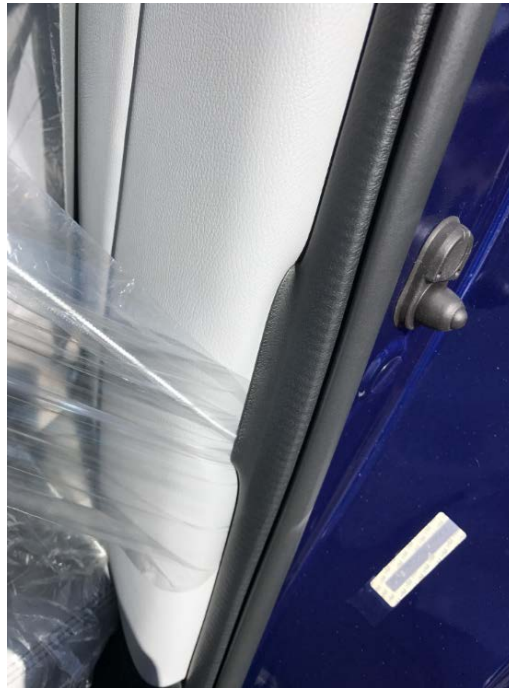
At PDI, be careful when pulling off the protective coverings from the rear seats. If you're not, you could dislodge the rear door opening seal, like you see here.

If it goes unnoticed, over time, that dislodged seal could be permanently deformed, requiring complete rear door opening seal replacement.

If you happen to dislodge the rear door opening seal, it's an easy fix. Just push it back into place with your hands.
