# Procedure 7-135

## ALLISON TRANSMISSION HARNESS CONNECTOR PLUG CAVITY

MCI has prepared a procedure to insert plugs in the transmission harness connector open cavities on the J4500 series coaches listed below. This procedure is in conjunction with transmission harness retrofit outlined in MCI FCP Bulletin 445.

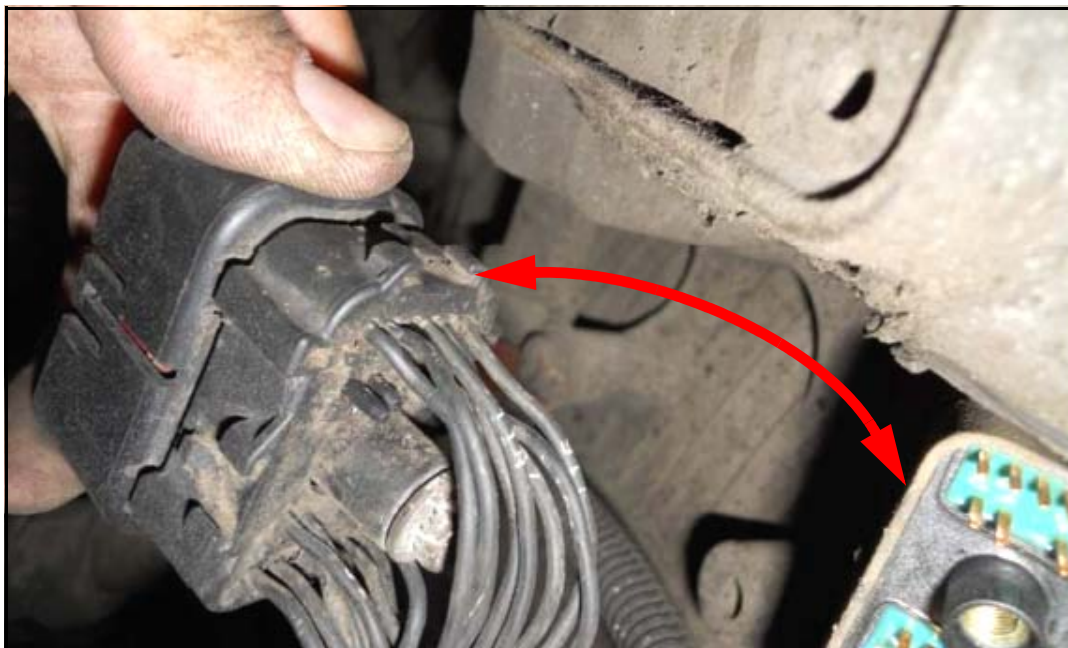
**Figure 4. Transmission harness connector removed from the interface port.**

4. At the forward section of the transmission, locate the transmission harness connector shown in Figure 3.
5. Using a 8 mm socket, loosen the mounting screw from the face of the transmission harness connector. Carefully pull to disconnect the transmission harness connector ( refer to Figure 4 ).

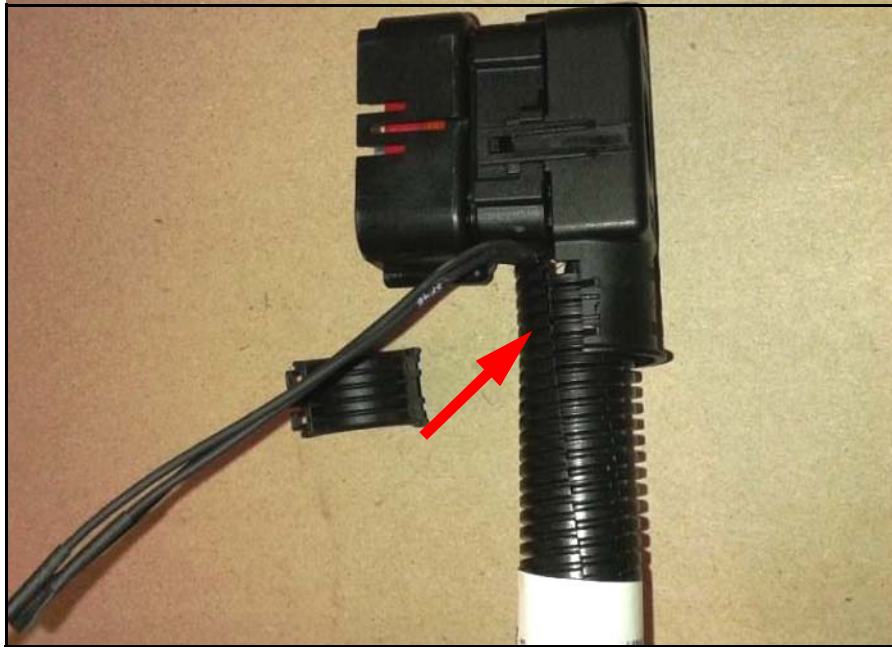
**Figure 5.**

6. Remove and discard the tape from the spare wires and the loom clamp as shown in Figure 5.

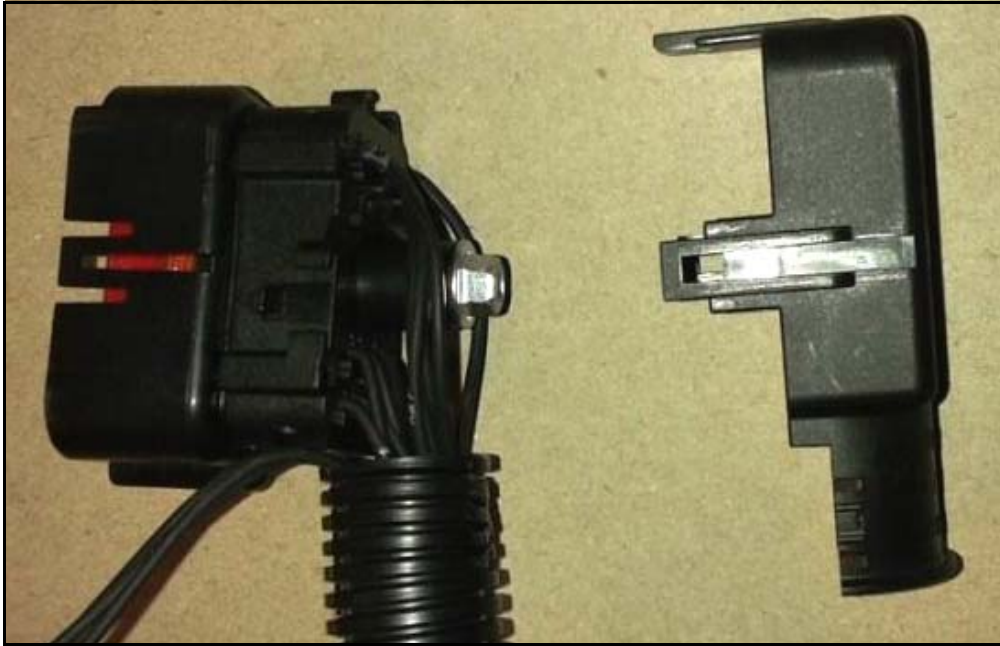
**Figure 7. Back cover removed.**

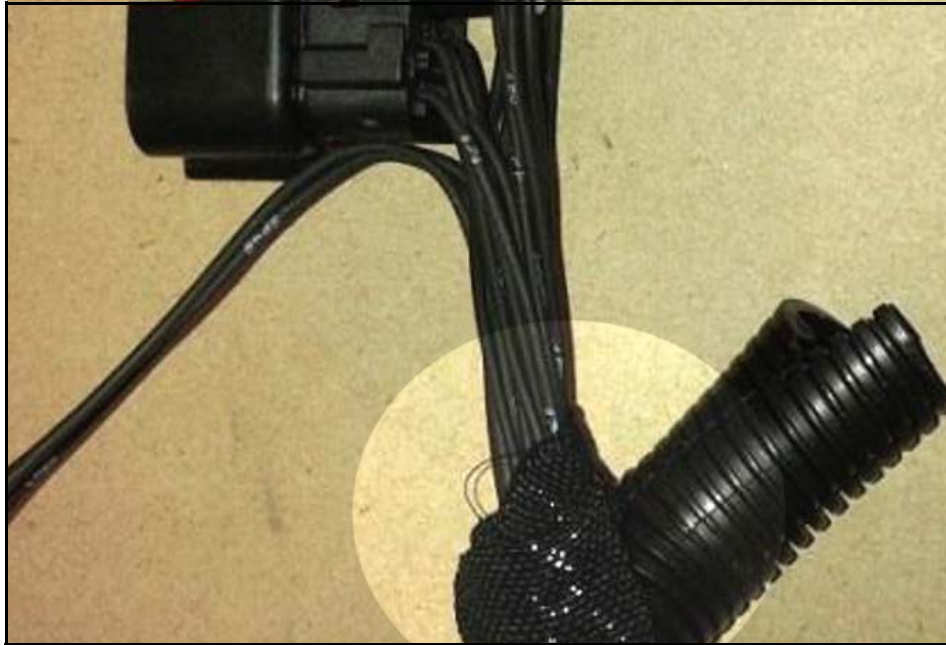
**Figure 8.**

8. Using controlled force, carefully open and pull back the loom as far as possible ( refer to Figure 8 ).
9. Using controlled force, carefully pull back the roundit 200 cover as far as possible ( refer to Figure 8 ).

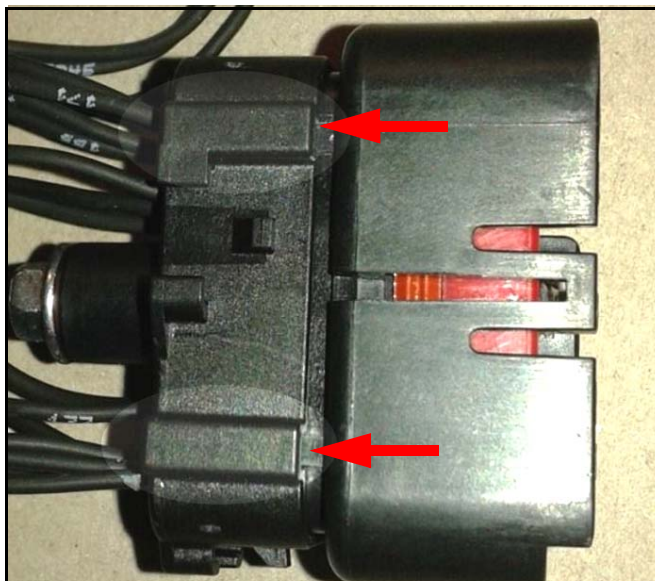
Figure 10.

11. Using a narrow, flathead screwdriver, gently pry on the four (4) locking tabs to release the terminal lock (refer to Figure 10).

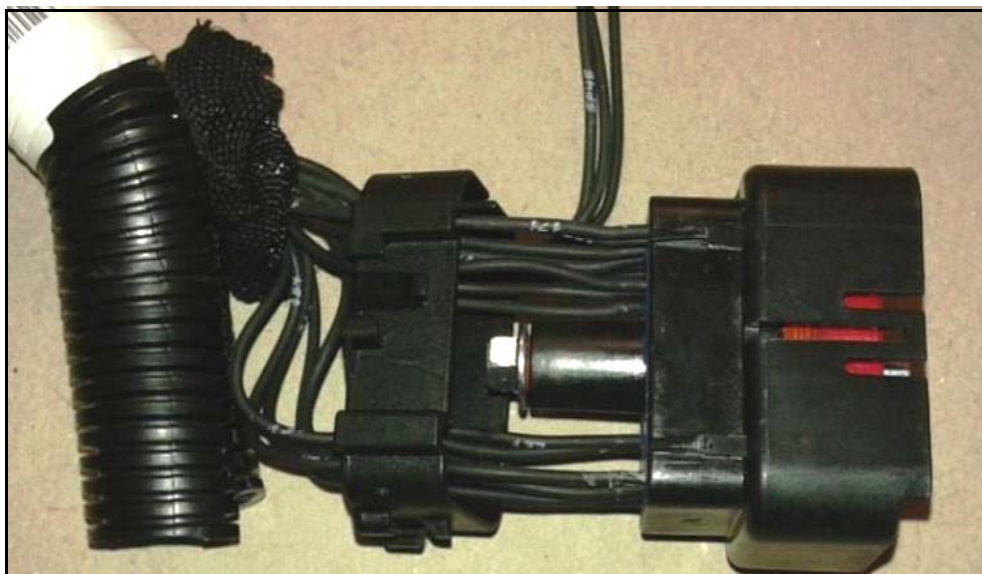
Figure 11.

12. Carefully, and in controlled stages, slide back the terminal lock as far as possible as shown in Figure 11, to access the terminal lock seal pins.

*To avoid damage to the wires, ensure that all wires are straight and parallel to the holes in the terminal lock.*

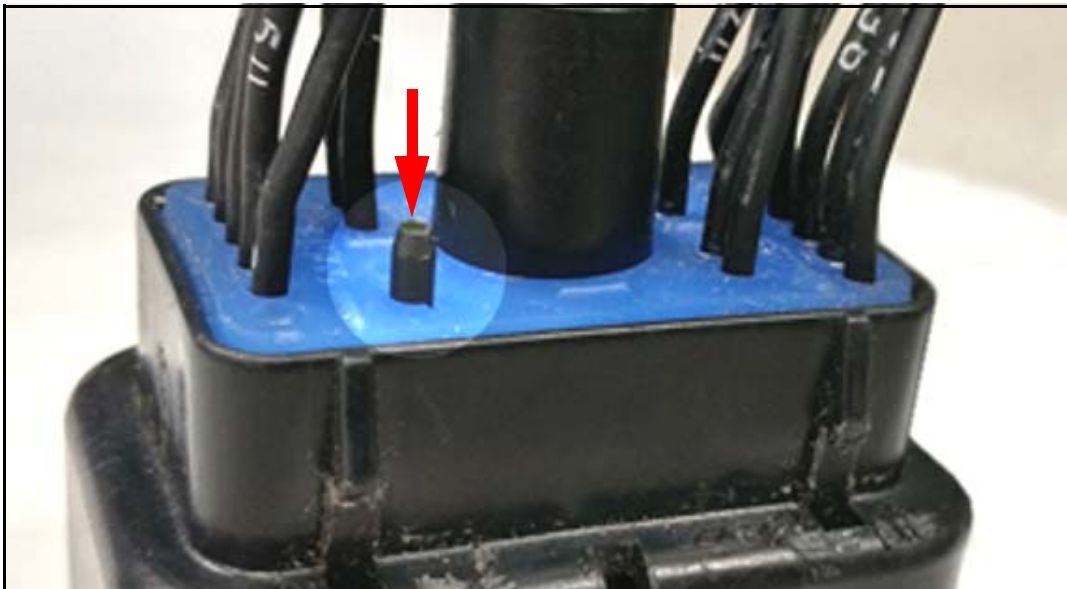
14. Orient and press to secure the four cavity plugs, p/n 19-11-1845, into the open terminal lock cavities from the removed four ( 4 ) black molded pins as shown in Figure 13.

*The cavity plug must be completely pressed down and bottomed out as shown in Figure 13 to achieve a water-tight seal.*

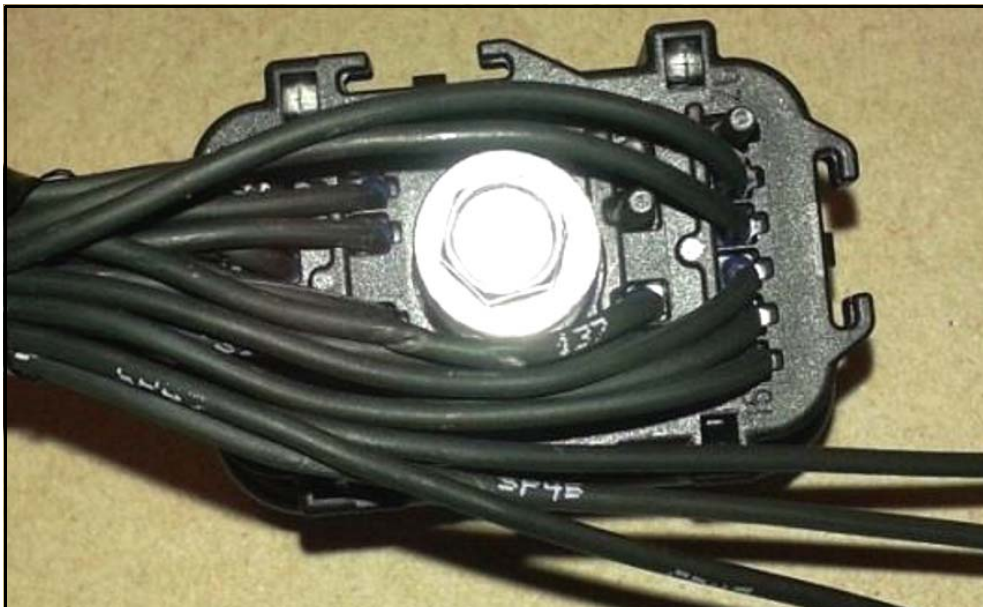
**Figure 14.**

15. Carefully, and in controlled stages, slide the terminal lock on the connector body. Apply force to snap the terminal lock into the connector body.
16. Orient and route the wires around the center bolt as shown in Figure 14.
17. Tie back the spare wires to the wire bundle. Orient and wrap the roundit 200 cover back on the wire bundle. Apply electrical tape to secure.

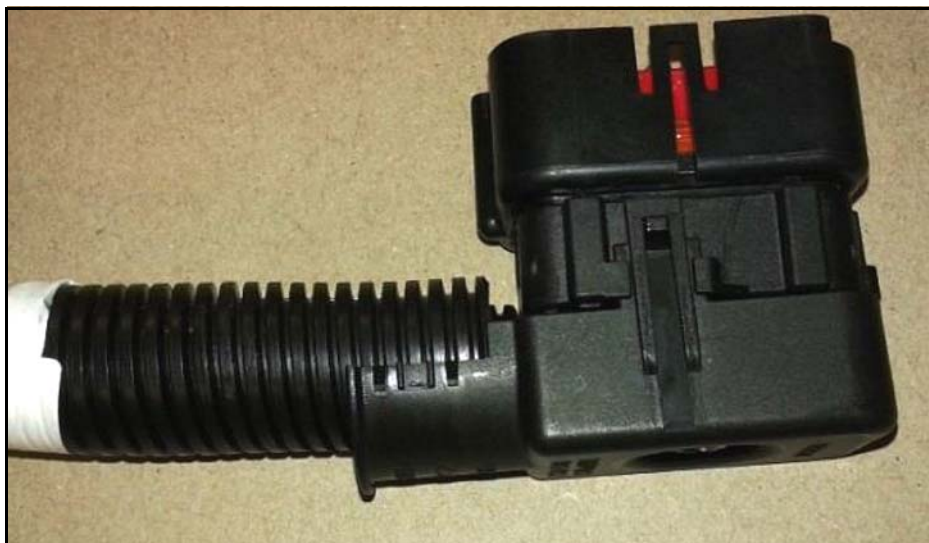
**Figure 15.**

18. Orient and apply pressure to snap the back cover on the transmission harness connector.

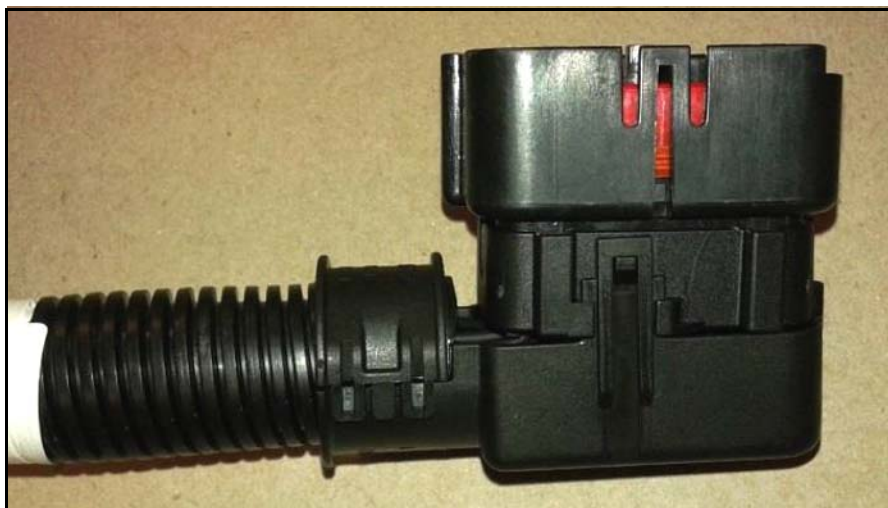
**Figure 16.**

19. Orient and apply pressure to snap the loom clamp on the transmission harness connector
