INSTRUCTION TO SERVICE

ITS: 6623	
SECTION:	204 Rear Suspension
WRITTEN BY:	Tyler Omichinski
SUBJECT:	Inspect Rear Axle Hub Spindle Nuts

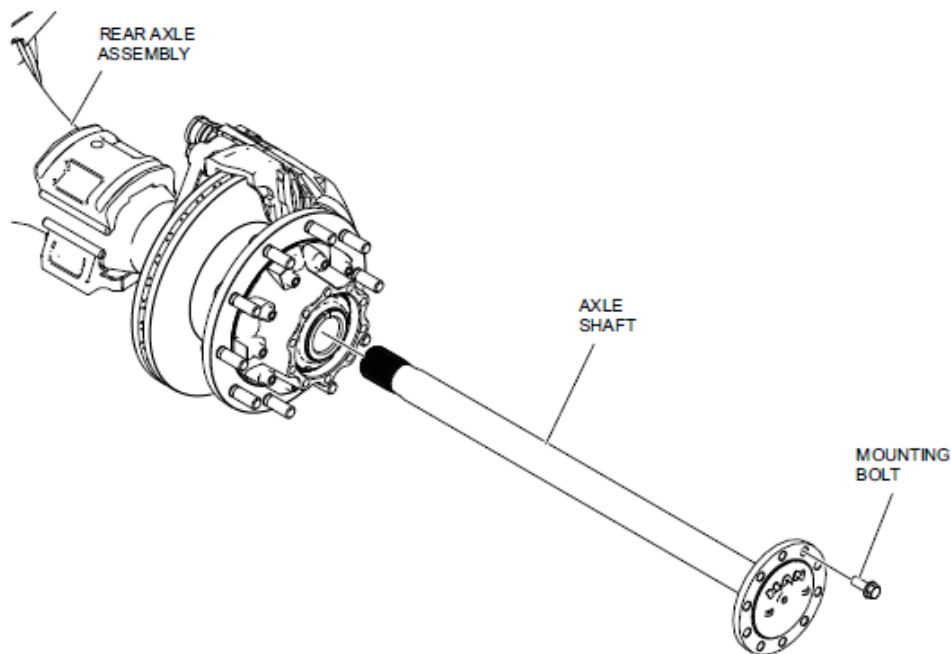
Figure 1: Rear axle shaft and mounting bolts

4. To aid in reassembly, on the rear wheel hub, mark the orientation of the axle shaft flange relative to the wheel hub housing with a torque stripe or similar mark.
5. Remove and discard the 10 bolts which hold the axle flange to the hub. Remove the axle shaft. Use absorptive pads or similar to control gear oil spills as required. Refer to Fig. 1.

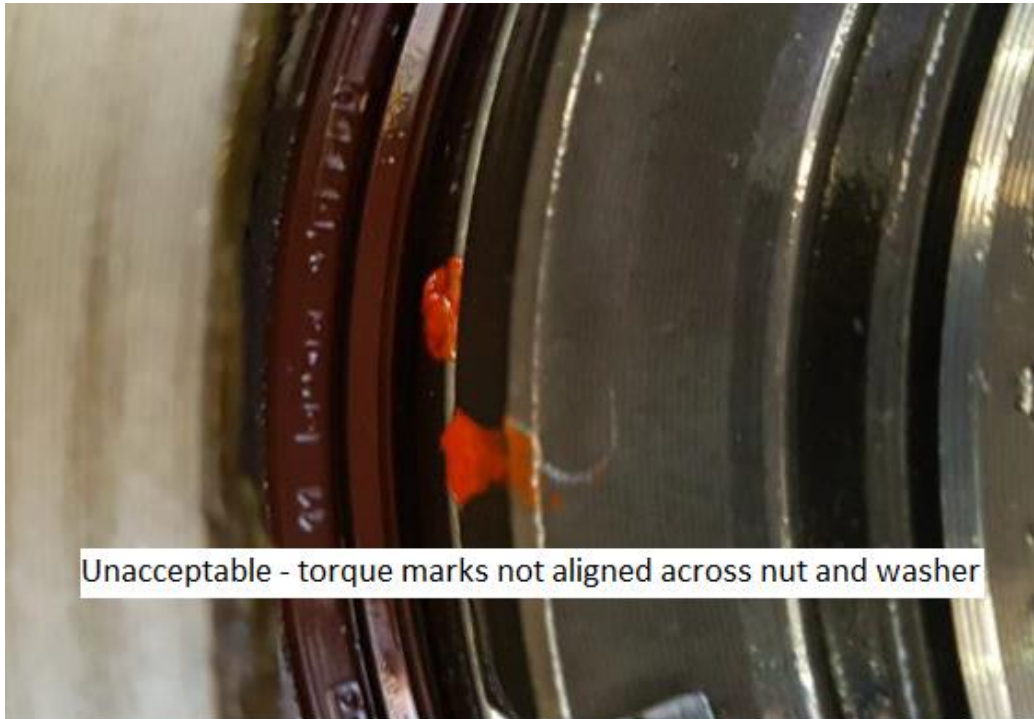
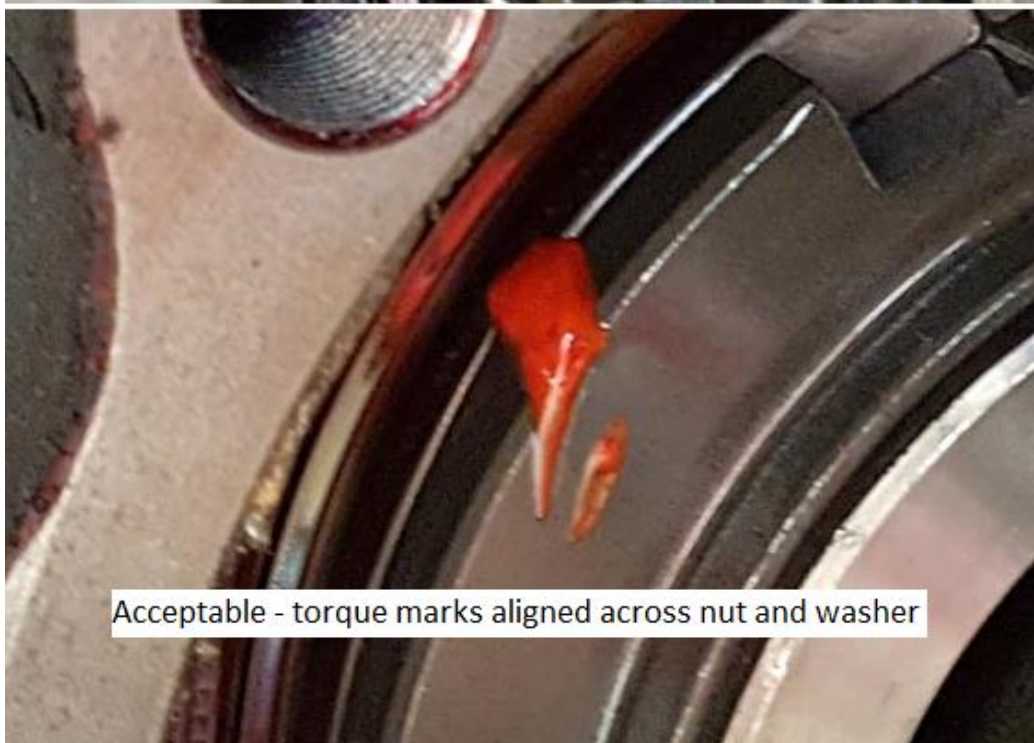
Figure 2: Exemplar spindle nut torque marks

6. Inspect the rear axle spindle nut and washer and locate the torque marks. Note if the torque marks extended from the spindle nut to the washer are misaligned. Record the results on the inspection sheet. Refer to Fig. 2 for examples of unacceptable and acceptable torque marks.

- NOTE:** Once all inspections are complete, review the results for each wheel. If the original torque marks were found misaligned, the spindle nut must be replaced; proceed to Part B: Replacing Spindle Nut. If the original torque marks are aligned, the axle shaft can be reinstalled; proceed to Part C: Reinstalling Axle Shaft.

14. Stake the spindle nut in accordance to the standard shown in Fig. 2 using a blunt chisel. Ensure the staking mark would engage the spindle threads if the nut were to rotate. Avoid staking the nut too deeply so that the spindle threads are not damaged.

19. If the spindle nut is not already sufficiently staked, use a rounded chisel to stake the spindle nut collar to specification. Refer to Fig. 2.
20. Remove all sealant from the axle hub and axle flange mating faces using a razor blade, scraper, or abrasive pad.
21. Apply a thin coat of Loctite 518 sealant (NF P/N 6357944) to the mating face of the hub.
22. Install the axle shaft into the rear axle. If the hub nut has not been replaced in Part B, use the alignment mark applied in Step 5 as a guide for reassembly.
23. Install 10 new mounting bolts (NF P/N 6407909) in the axle flange. Torque the bolts to 360 N.m. (266 ft-lb.). Apply a torque stripe to all bolts.
24. Turn the main battery disconnect switch to the "ON" position.
25. Forward the completed inspection sheet to your New Flyer Regional Product Support Manager.

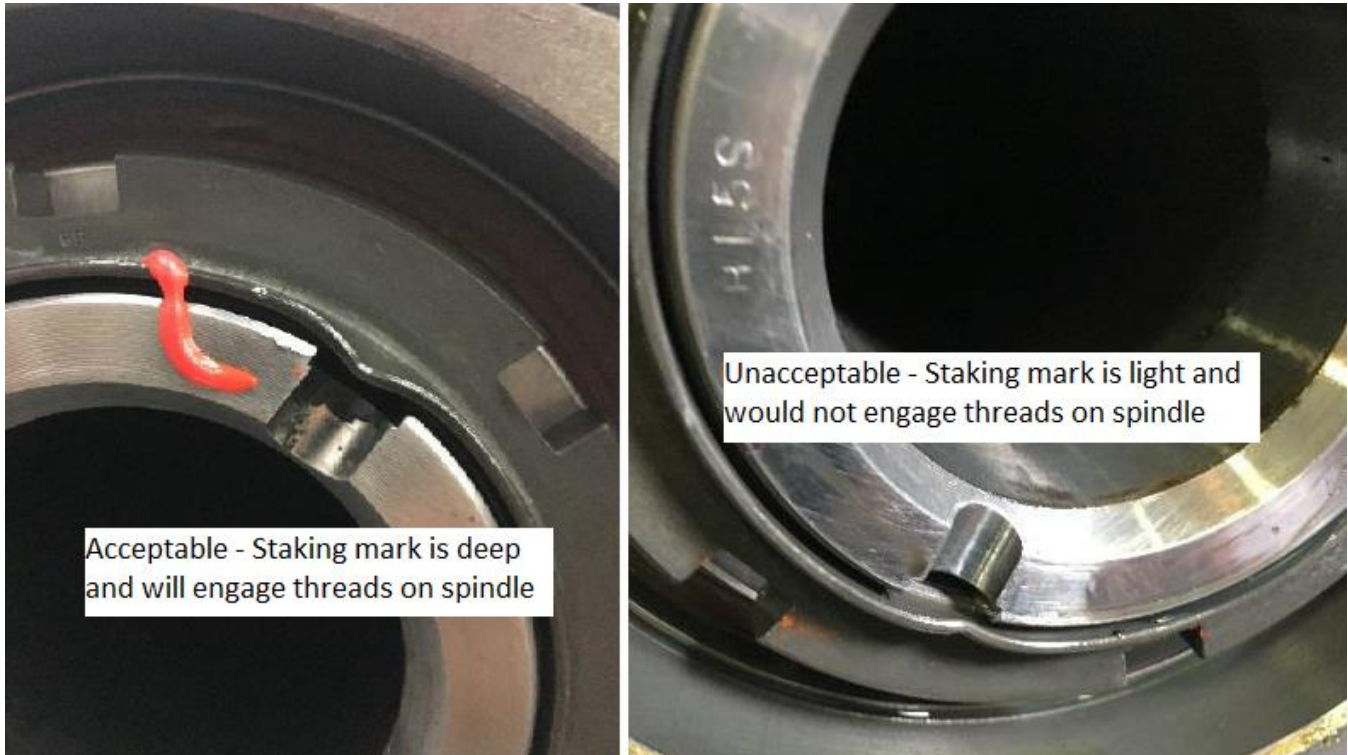
Figure 3: Exemplar staking marks

7. Inspect the staking mark on the spindle nut. The staking mark should extend into the spindle groove so that it will engage the spindle threads if the nut becomes loose. Record the results on the inspection sheet. Refer to Fig. 3 for unacceptable and acceptable staking marks.

10. Ensure the wheel hub can spin freely by hand.
 11. Use a round punch to knock out the existing staking mark so that the spindle threads are not damaged when the spindle nut is removed.

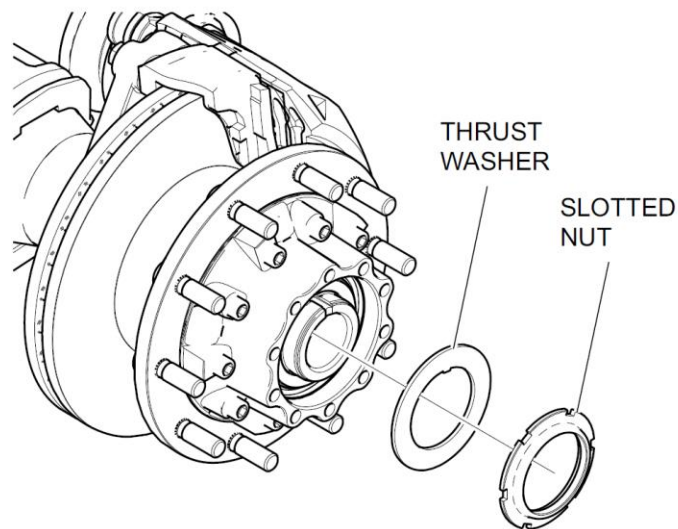
Figure 4: Rear wheel hub spindle nut installation

15. Apply a new torque stripe across the spindle nut and washer shown in Fig. 4.

13. Install a new spindle nut (NF P/N 6392549) using appropriate tooling. Torque the nut to 1200 N.m. (885 ft-lbs). Spin the hub as torque is applied.
