Customer Satisfaction Campaign

CC-17-20-07

MODEL: Karma Revero

TITLE: PTC Heater Replacement

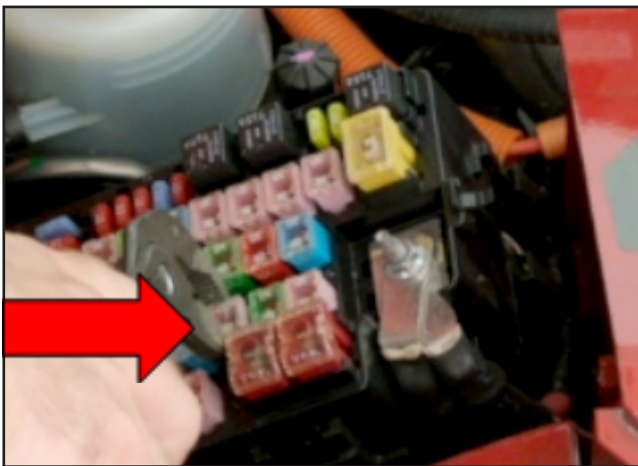
fig.1a

1. Isolate the 12V battery
 - a. Note- have vehicle unlocked, open all the windows before disconnecting
 - b. Remove the 10A solar panel fuse as shown (fig.1a)
 - c. Disconnect the 12V harness as shown (fig.1b).

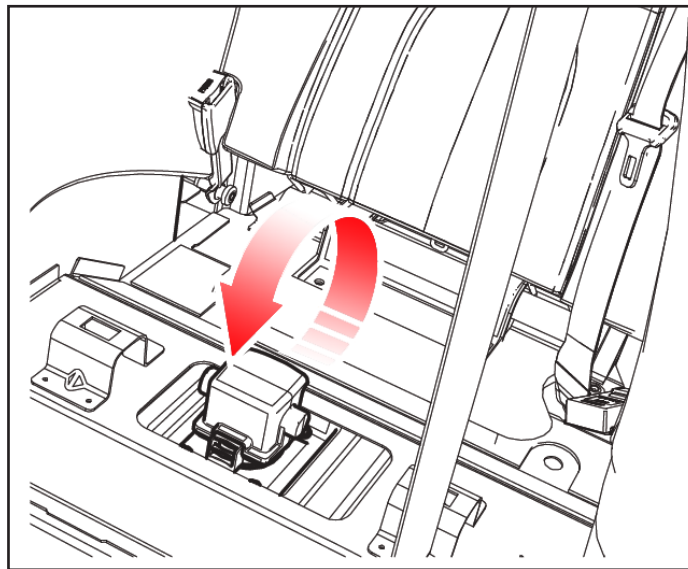
fig.3a

2.1.1 Release the latch pin from the MSD latch (fig.3a,3b,and 3c). Lift cover for access, release clip and remove the MSD from the HV battery

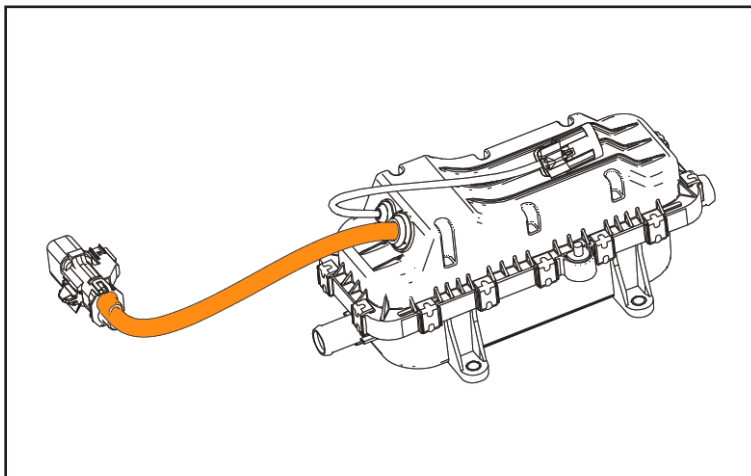
9. Raise PTC heater and disconnect the orange high voltage connector and low voltage harness connectors (fig. 6)
