August 31, 2017

07159 Version 1

## Fuel or Engine-Type Smell While Driving or at Idle

| Year | Model | Trim | VIN Range |
|---|---|---|---|
| 2015–16 | CR-V | ALL | ALL |

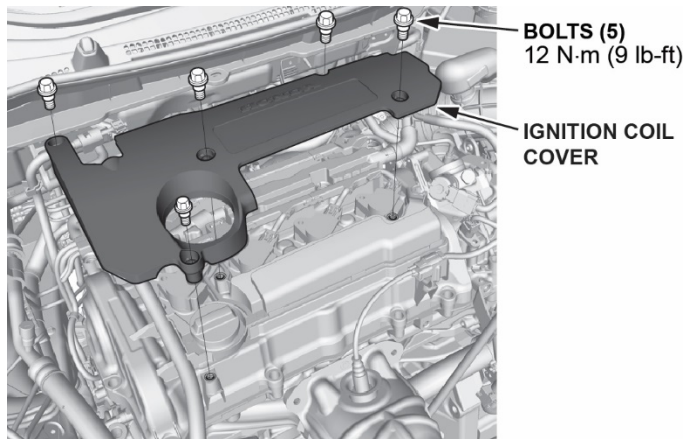
1. Visually check that there are no oil or other fluid leaks.
  - If there are no visible leaks, go to step 2.
  - If there are any visible leaks, repair them first and clean up the fluid. If the smell persists, then go to step 2 to replace the PCV hose.
2. Remove the ignition coil cover.

18. Install the harness holder, then reinstall the ignition coil cover. Torque the bolts to **12 N·m (9 lb-ft)**.

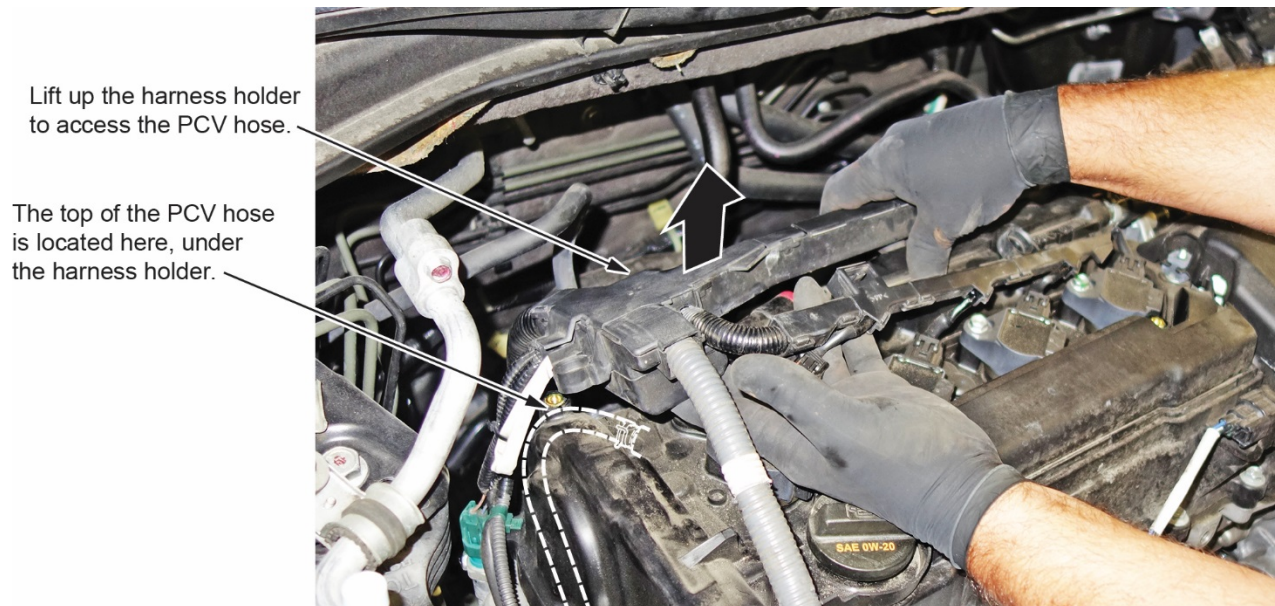
3. Lift up the harness holder, and move it so you can disconnect the PCV hose.

NOTE: You do not need to disconnect the harness or its connectors.

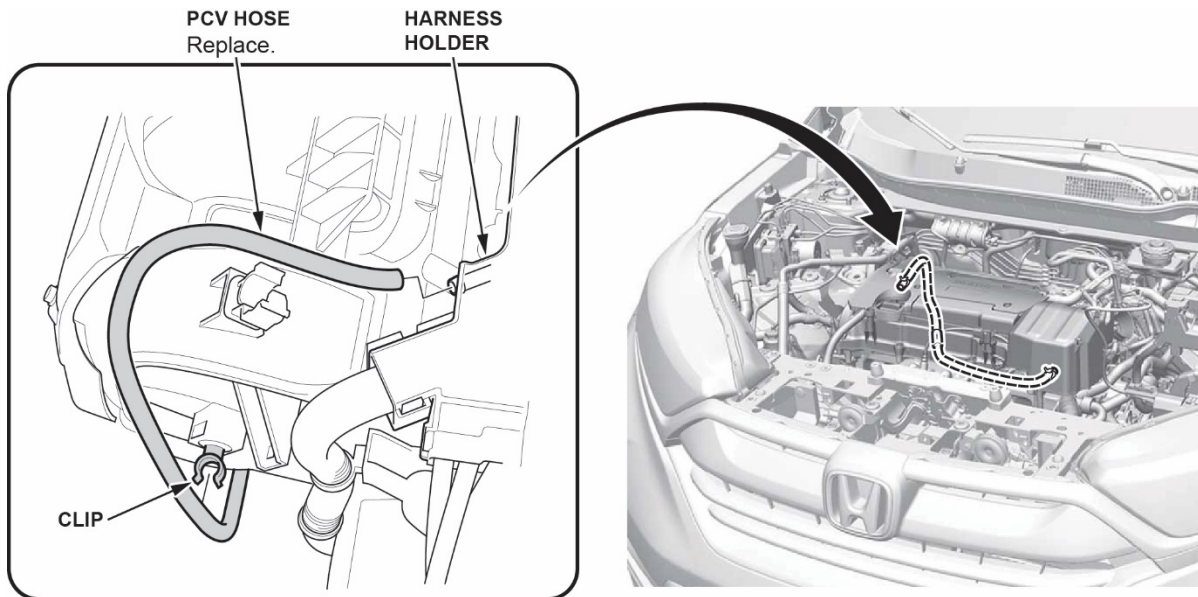
4. Disconnect the upper part of the PCV hose, and remove the hose from the clip.

13. Install the hose into the clip.
14. Raise the vehicle, and install the lower part of the hose onto the intake manifold.

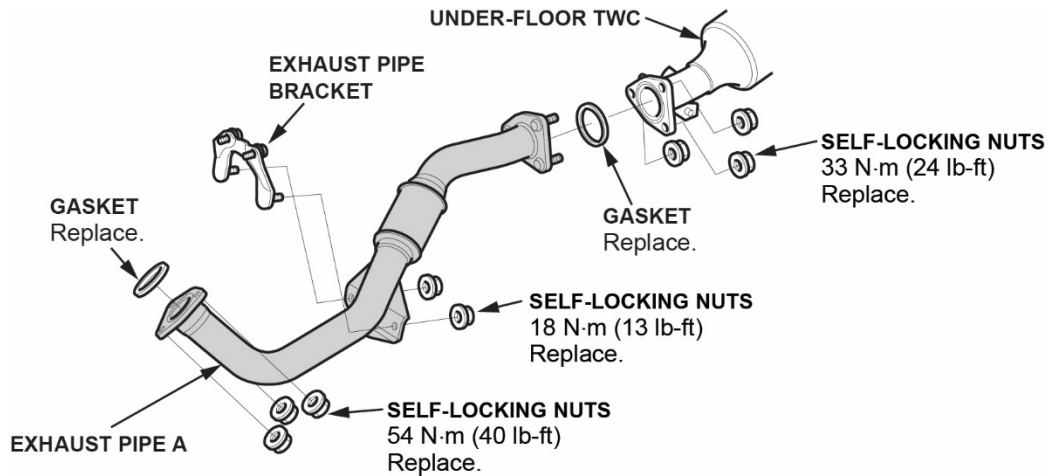
5. Raise the vehicle, and remove the splash shield.  
6. Remove exhaust pipe A.

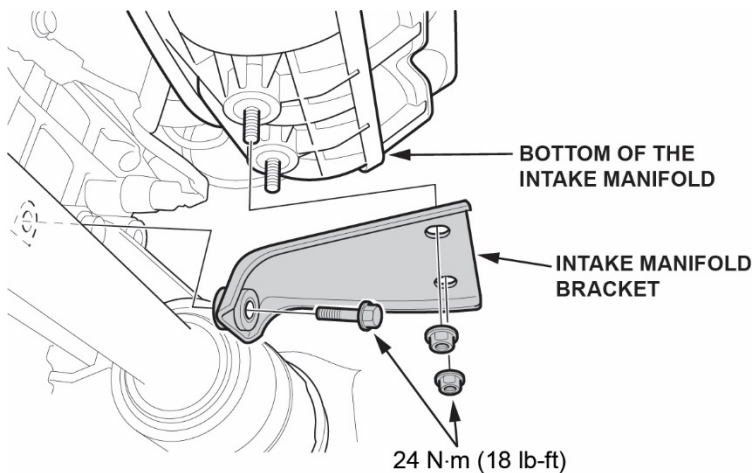
7. Raise the vehicle, and remove the front wheel on the passenger's side.  
8. Remove the intake manifold bracket.

15. Install the intake manifold bracket. Torque the bolts to **24 N·m (18 lb-ft)**.

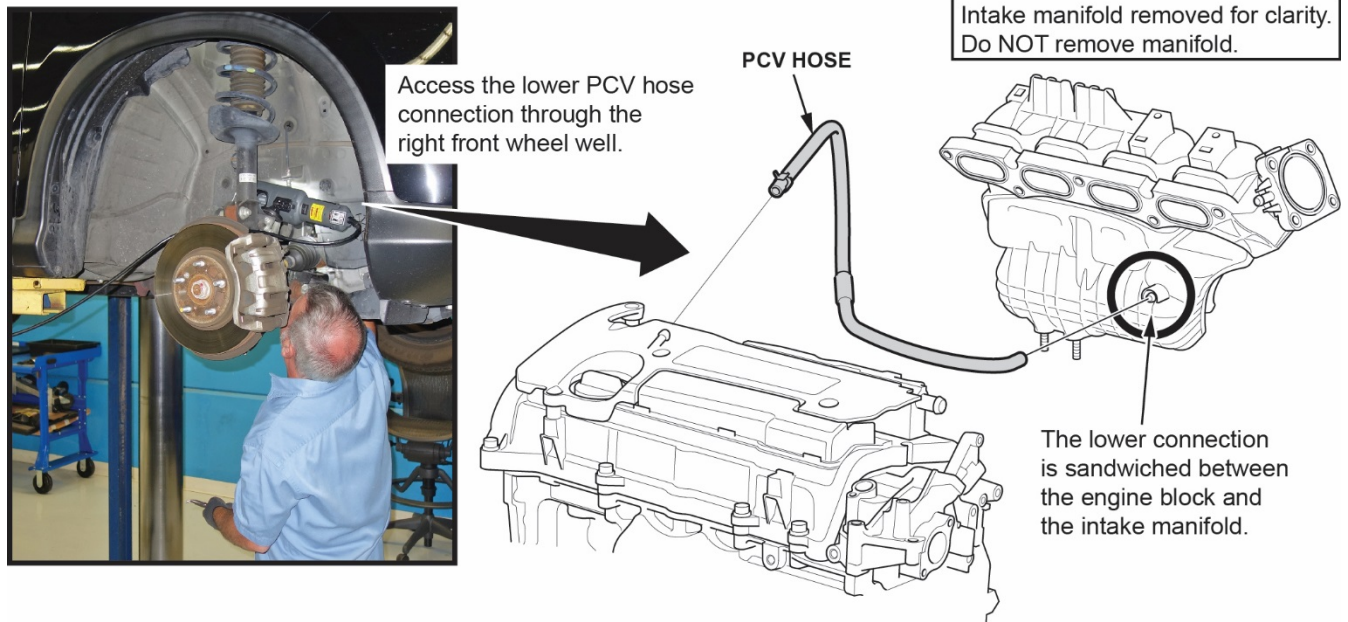
9. Disconnect the lower part of the PCV hose by reaching through the right front wheel well.

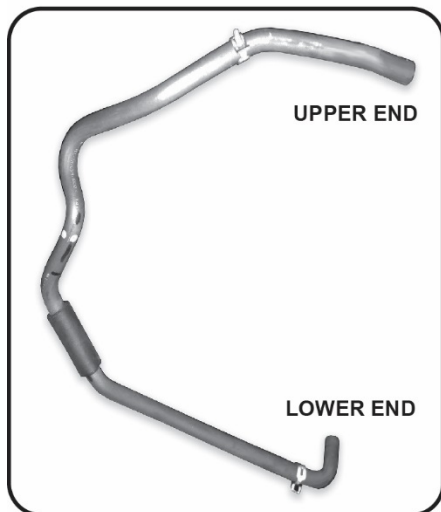
NEW PCV HOSE

10. Carefully remove the PCV hose.
11. Transfer the hose clamps from the original PCV hose to the new one.
12. Install the PCV hose by inserting it through the top part of the engine and connecting the upper part of the hose to the engine.

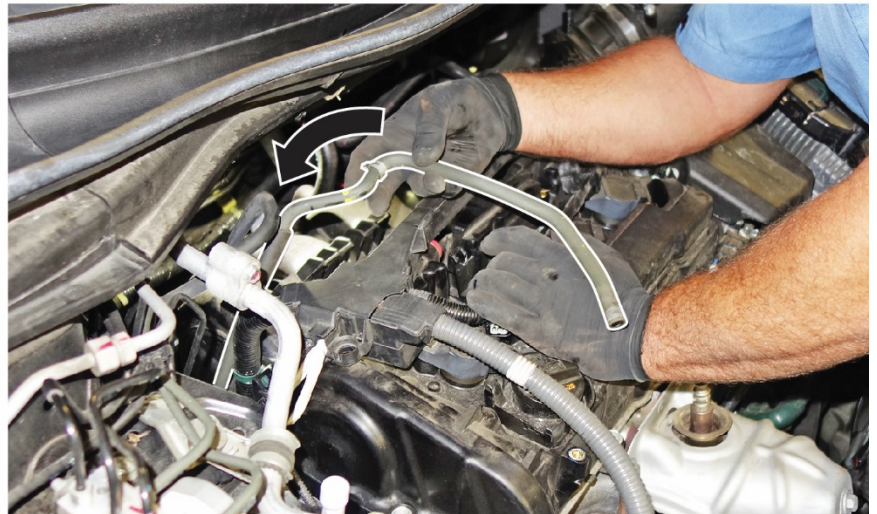
Feed the new PCV hose in from above.

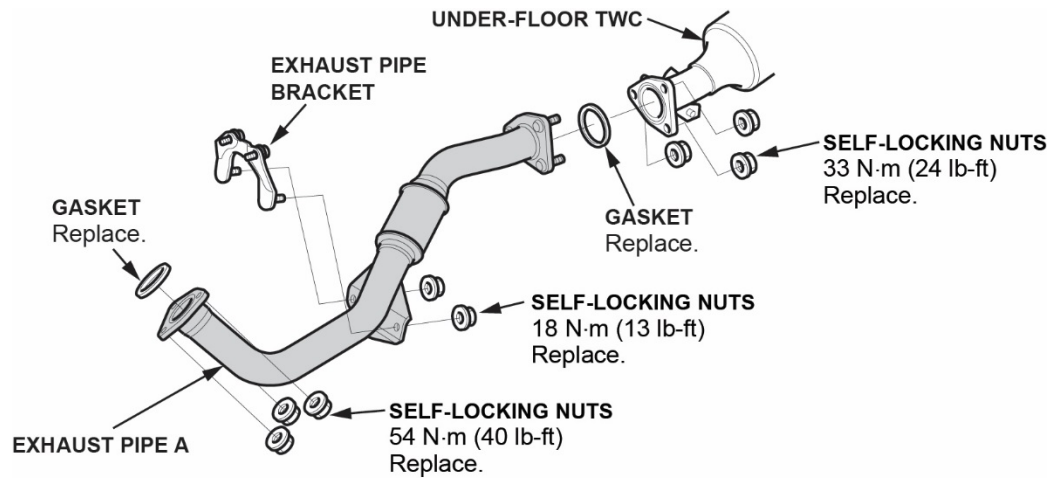
16. Install exhaust pipe A using new gaskets and lock nuts. Torque the self-locking nuts as shown.
