HYUNDAI NEW THINKING. NEW POSSIBILITIES. Technical Service Bulletin	GROUP CAMPAIGN	NUMBER 17-01-003-1
	DATE JANUARY 2017	MODEL VELOSTER (FS) SONATA HYBRID (YF HEV)
SUBJECT: CANISTER INSPECTION AND REPAIR - (SERVICE CAMPAIGN 948)

This TSB revises 17-01-003 to update the part order quantity information

This bulletin provides the service procedure to inspect vehicles for a potential crack found at the evaporative canister insert nuts:

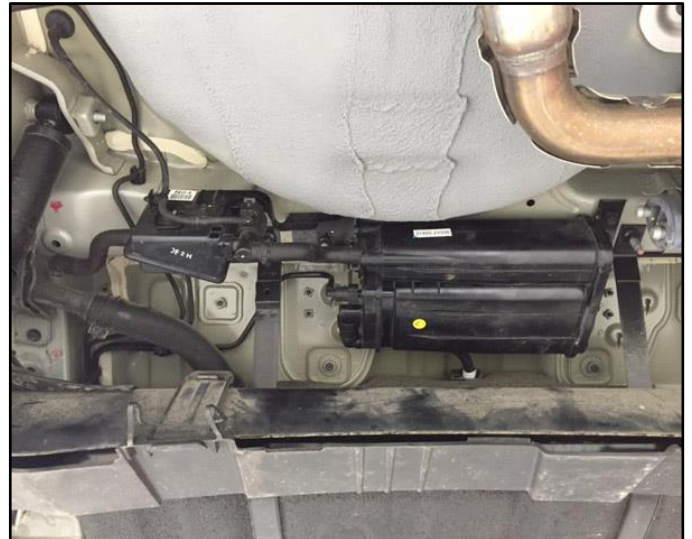
4. Reinstall all removed parts in reverse order of removal.

Tightening Torque

(Vehicle body side bolts):

21.6 ~ 32.4 Nm

(2.2 ~ 3.3 kgf.m, 15.9 ~ 23.9 lb-ft)

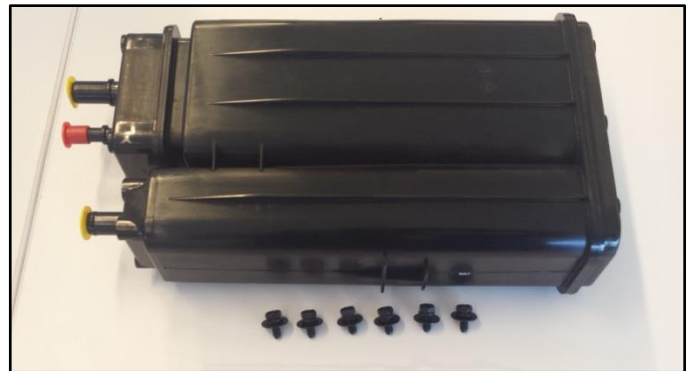
1. Replace the canister with correct Canister Kit and Bolts as shown in the Parts Information section. Install in reverse order of removal.

- Reuse the existing brackets from the vehicle.
- Be sure to transfer the protective metal shield from the old canister to the new canister.

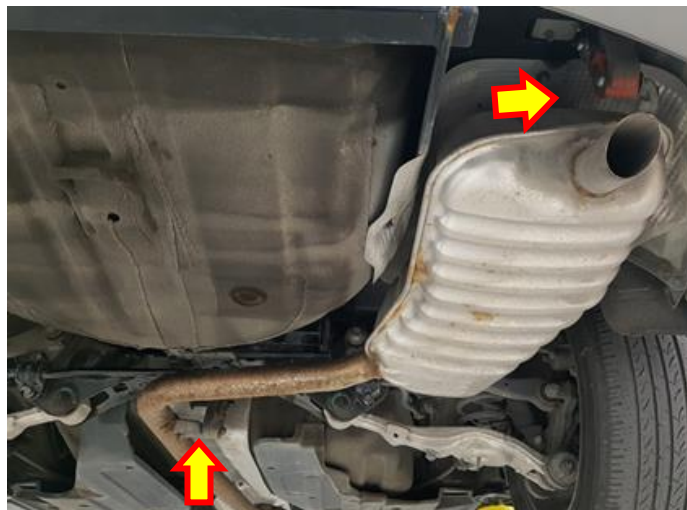
- i. Lift the vehicle on a hoist.
- ii. Disconnect the rear muffler from the 2 hangers as shown. Using a transmission jack, support the rear muffler and slowly lower to gain access to the canister assembly.

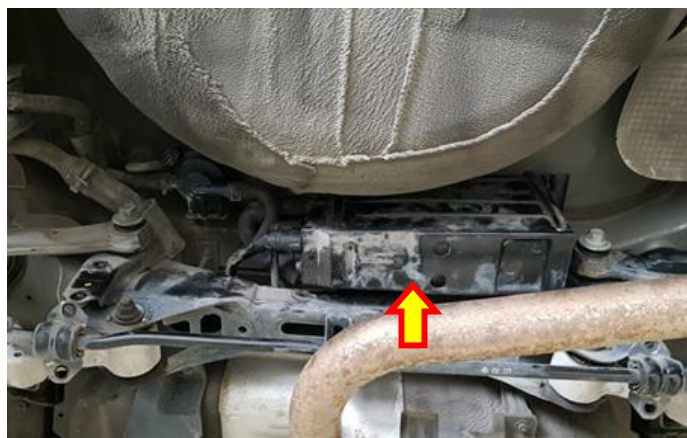
Remove the complete canister assembly with NVLD, brackets, and hose as shown.

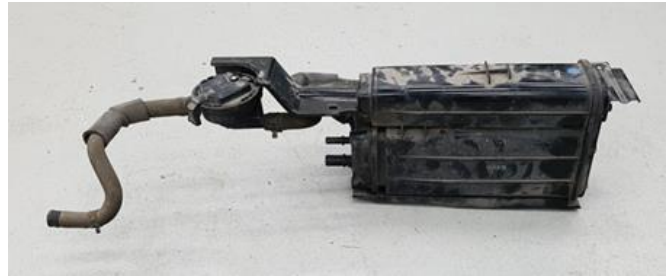
2011-2012MY YF HEV canister, NVLD, bracket and hose shown removed as a complete assembly from the vehicle.

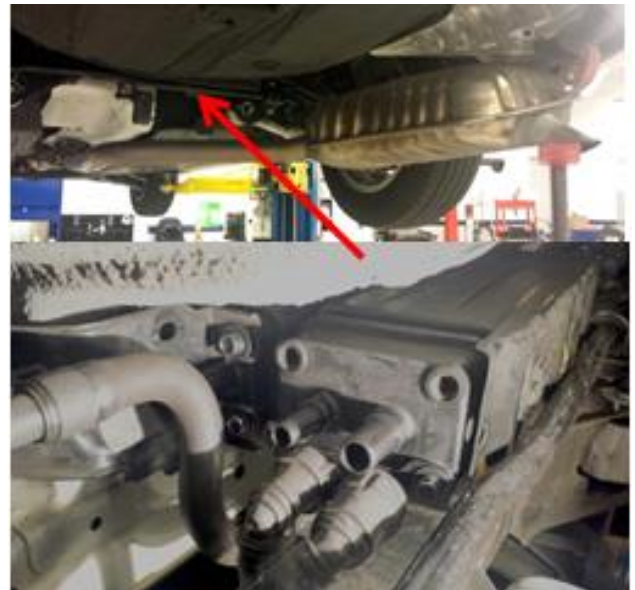
13-15MY vehicles have a different canister from 11-12MY vehicles. In 13-15MY, the complete canister assembly with NVLD, brackets and hose cannot be removed from the vehicle due to interferences at reinstallation of the canister.

Only the canister and its lower bracket as shown here can be removed from the vehicle for the inspection and repair procedures. The 4 bolts to the two upper brackets must be detached from the canister. The upper brackets are to be left in the vehicle.

The 2 Upper Brackets that were not removed with the Canister should be left in the vehicle. Attach them to the canister when the canister is installed back to the vehicle **but be sure to include the rubber washers.**

Applying a light coating of fast drying glue to rubber washers to hold them aligned with the canister will make it much less difficult to reinstall the canister back to the upper brackets in the car.

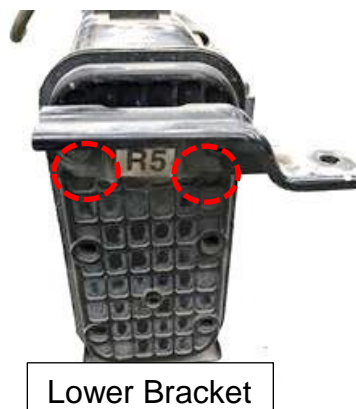
- With canister and its lower bracket removed from the car, remove the 2 mounting bolts from the canister lower bracket.

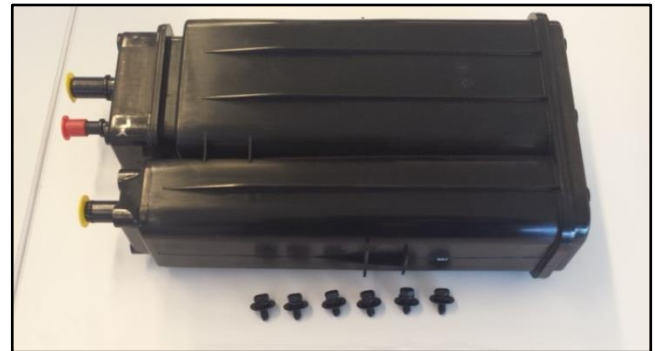
Replace the canister with correct Canister Kit Bolts and Nut as shown in the Parts Information section. Reuse the existing brackets from the vehicle.
