Technical Service Bulletin

GROUP	NUMBER
BODY ELECTRICAL	17-BE-001
DATE	MODEL(S)
JANUARY 2017	EQUUS (VI)

SUBJECT: DRIVER AND PASSENGER DOOR SWITCH MODULE REPLACEMENT

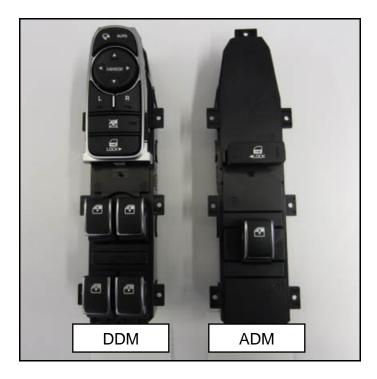
Description: On certain Equus vehicles the Blue Link remote services for door lock/unlock function is inoperative. The user is not able to lock or unlock the vehicle using Blue Link App or web portal.

This bulletin provides the procedure to replace the DDM (Driver Door Module) and ADM (Assisted Door Module) to correct the condition.

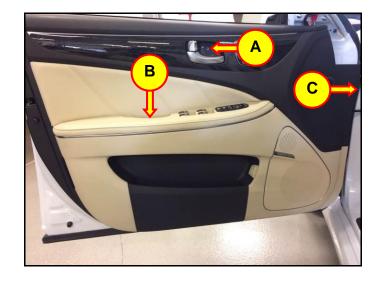
- 1. Remove 2 screws and one locking tab:
 - A. Screw at the door handle.
 - B. Screw in the door pocket handle.
 - C. Locking tab in the door jam.

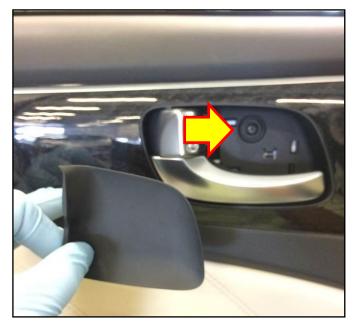
1A. Use a small flathead screwdriver, carefully pry and remove the door handle cover.

Use a Phillips screwdriver, and remove the screw.

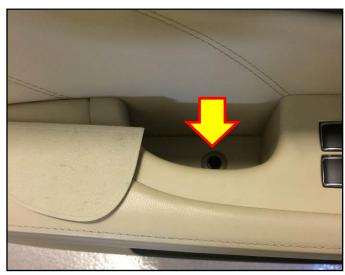
1B. Use a small flathead screwdriver, lift and remove the door pocket cover.

Use a Phillips screwdriver, and remove the screw.

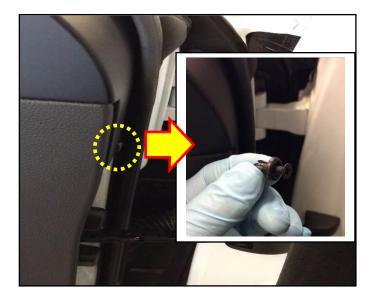
1C. Use a small and short Phillips screwdriver, remove the plastic screw and then pull the locking tab out.

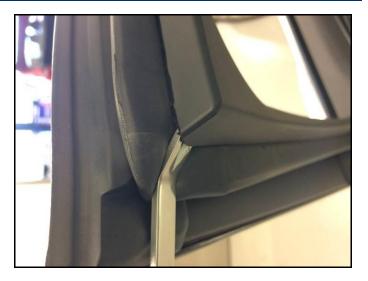
2. Use a panel removal tool to remove the top trim cover. Start with the top left corner.

Separate the top trim cover, disconnect the tweeter connector, and remove it from the door panel.

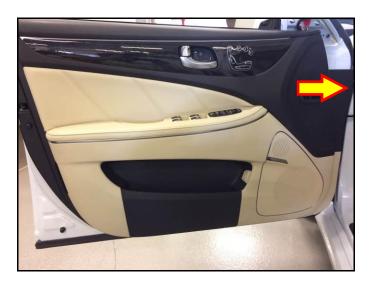
To remove the door panel, gently pull the door trim cover away from the door frame.
Start with the top right hand corner.

After pulling the door panel away from its frame, disconnect the two wire harness connectors and the door lock/unlock mechanism.

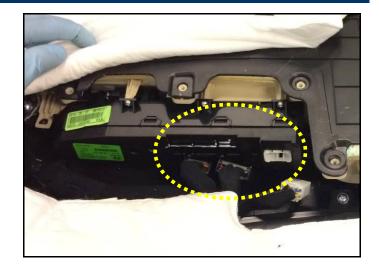
4. Place the door panel on a clean surface.

Disconnect the DDM connectors.

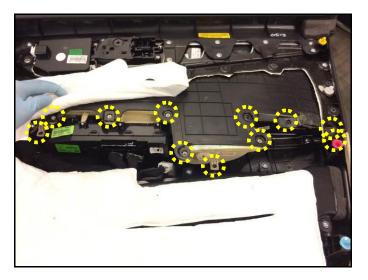
5. Use a Phillips screwdriver and remove the11 screws as shown on the right.

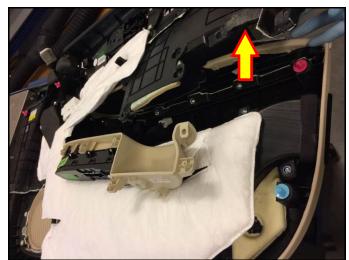
6. Separate the top half of the door panel from the bottom half and remove the DDM.
