ATS 170101 Version 3

## Driver's Seat-Back Bolster Looks Deformed

2017 CR-V

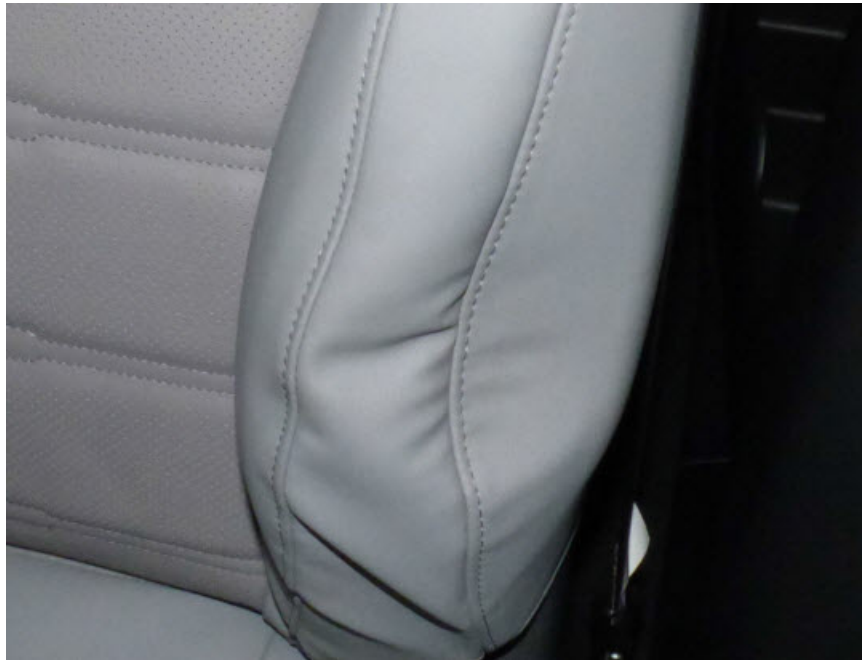
Does the driver's seat-back bolster look deformed? This can happen from rubbing against it when entering the vehicle. The seat foam folds under the frame, causing the seat cover material to collapse.

We're currently investigating this issue and are looking for a solution. In the meantime, remove the seat cover and massage the foam back into place. If the foam won't return to its original shape, then replace the seat foam.
