## **SuperSport “STD” Heat Guard Installation Sachs Shock Inspection**

Models: M.Y. 2017 and 2018 SuperSport STD version  
Service Bulletin SRV-TSB-17-007

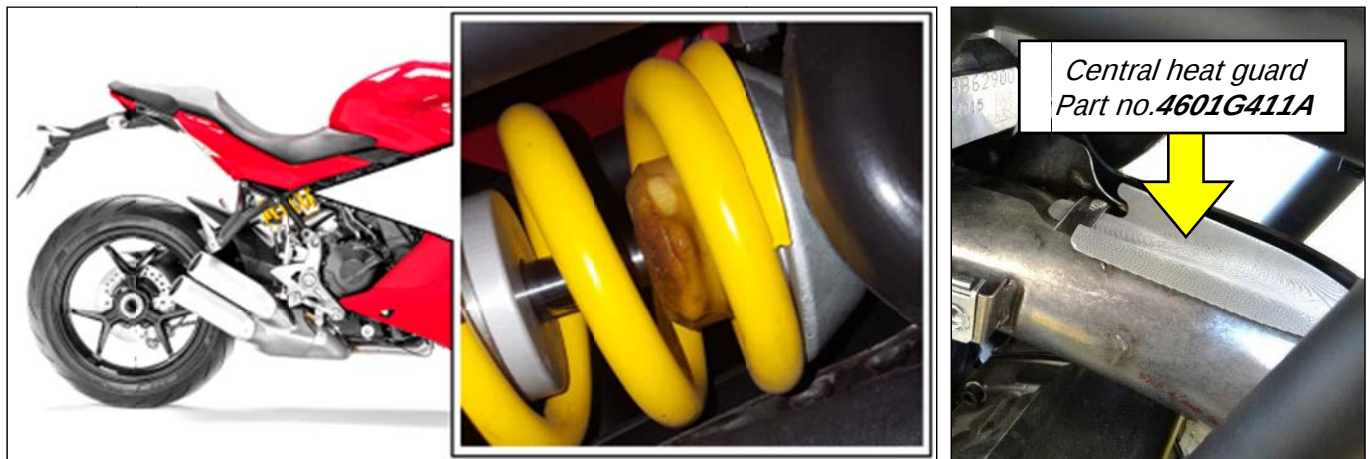
Ducati has received feedback regarding possible cosmetic damage to the Sachs rear shock absorber bottoming-stop cushion installed on STD versions of the SuperSport model. To prevent this damage, an additional central heat guard has been designed for installation on the vertical exhaust manifold. The new part no. is 4601G411A.

During installation of the central heat guard, it will be necessary to visually inspect the condition of the Sachs rear shock absorber bottoming-stop cushion. If evidence of cosmetic damage and deformation to the Sachs rear shock absorber bottoming-stop cushion is present, the rear shock absorber Part no.36521542A can be replaced. If this is the case, a clear picture of the damage must be attached to the warranty claim.
