66 Paint flakes off radiator grille or license plate holder

66 17 61 2038652/7 February 20, 2017. Supersedes Technical Service Bulletin Group 66 number 16-57 dated October 18, 2016 for reasons listed below.

Model(s)	Year	VIN Range	Vehicle-Specific Equipment
A4, A5, A5 cabriolet, S5 cabriolet, Q5	2013 - 2016	All	Not Applicable

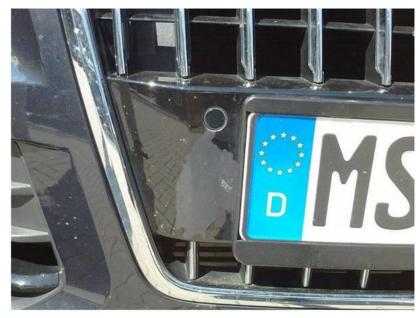
The paint is flaking off of the radiator grille or front license plate holder (Figure 1).

Figure 1. Example of flaked-off paint.

The surfaces of these components were too smooth (due to high-gloss polishing tools), which led to weak adhesion of the paint during production. Only components with color index T94 are affected.

Replace the components according to the instructions in ElsaPro at *Repair Manual* >> *Body* >> *Body* Exterior >> 66 Exterior Equipment >> Radiator Grille/Front Trim.
