Subject: SQUEAK NOISE FROM FRONT BRAKES AND/OR GROOVE MARKS ON FRONT DISC PLATE	Bulletin No.: 04-002/17
	Last Issued: 08/11/2017

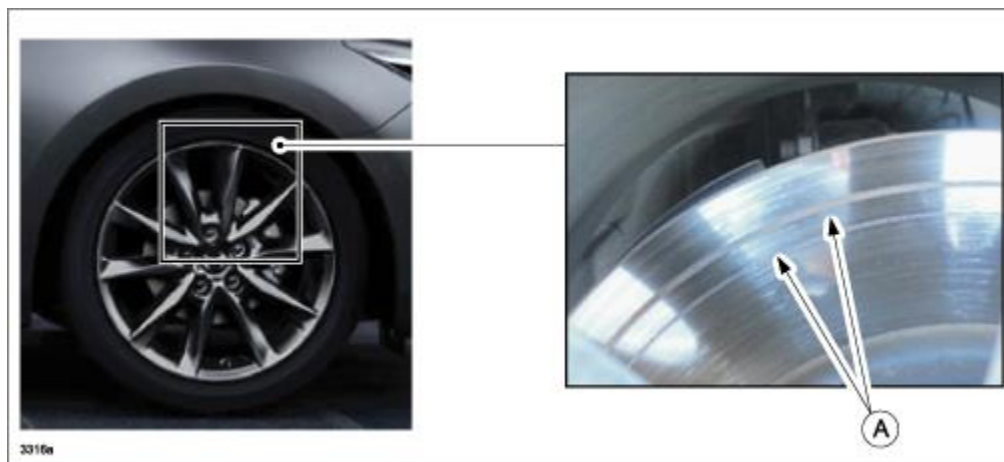
Some vehicles may exhibit a squeak noise when applying the brakes and/or groove marks (A) on the front disc plates. This is caused by abrasive metal from the front disc plate sticking to the brake pad, which damages the disc plate over time. To correct the problem, a modified brake pad is being used.

Customers having this concern should have their vehicle repaired using the following repair procedure.

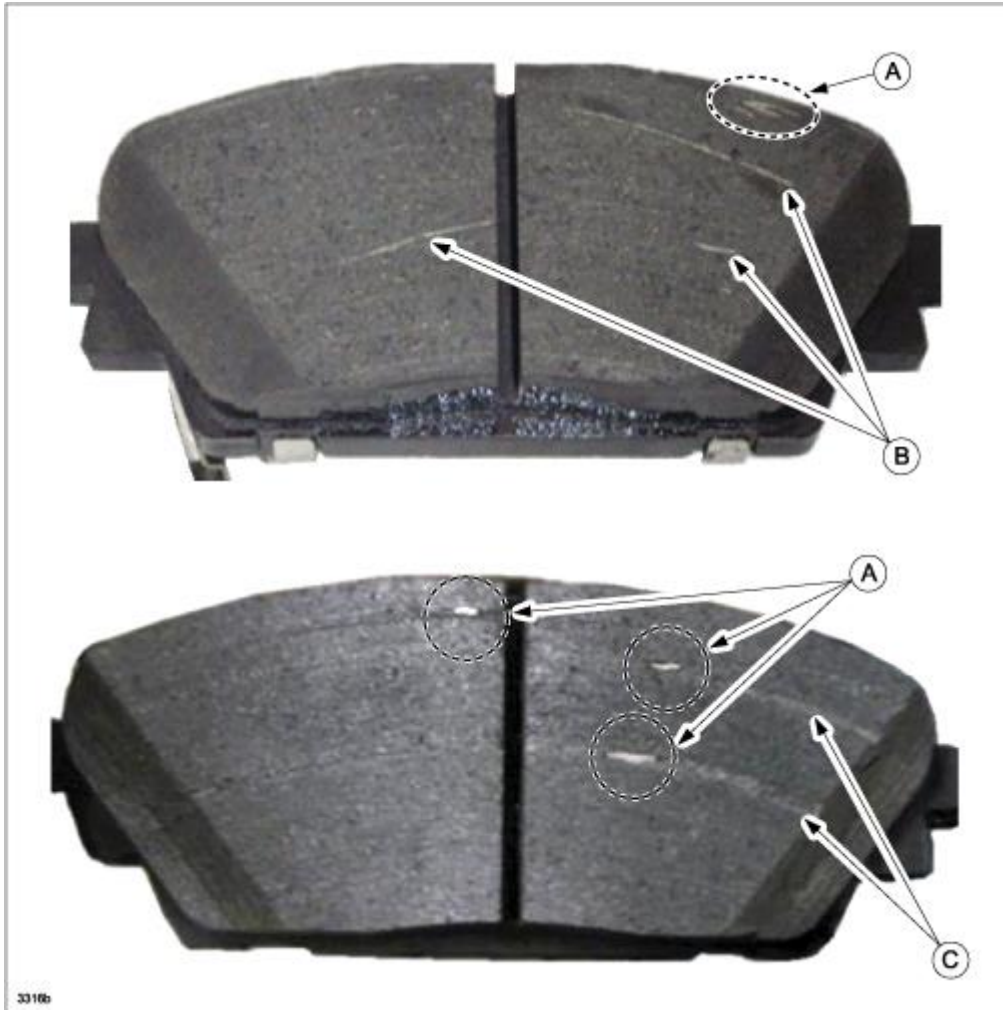
Visually inspect the front brake pads surface for pieces of metal.

- If metal pieces (silver or white in color) are found in a cluster (A) or line form (B) on the surface or there is groove damage (C), replace the front brake pads with a modified service set.

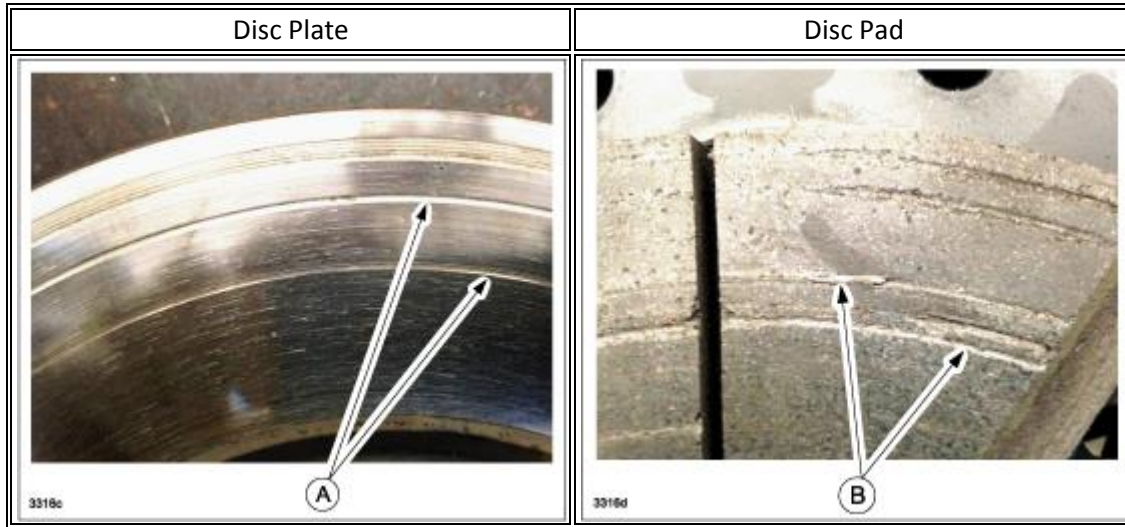
Visually inspect the surface of the disc plate(s) for damage.

- If groove damage is found on a disc plate (A) and brake pad (B), replace the front brake pads with a modified service set and **ONLY** the damaged disc plate(s).

NOTE: Metal may have dropped off the brake pad, and groove damage will be found on the brake pad in the same position as damage on the disc plate.
