Special Bulletin

SP16-311G

DIRECT LIGHT COVER LENS SECUREMENT

Prevost vehicles

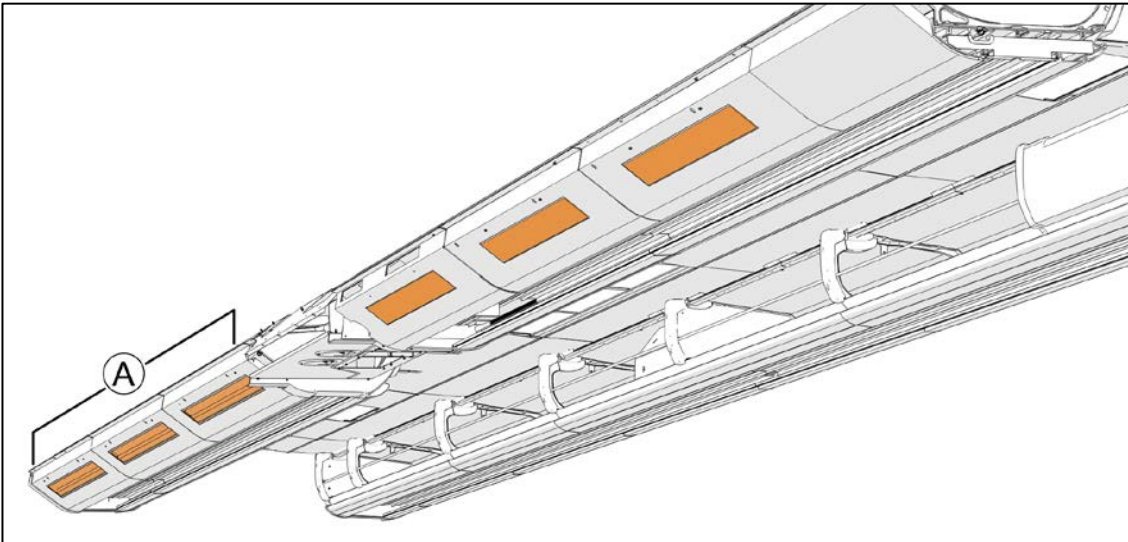
Figure 1: Curb side lenses. "A" 4ft lenses: follow instructions

3. Refer to Figure 1 and Figure 2. If lens is longer type "A" it needs to have the "U" shape edge on the bottom of the opening and the rolled edge at the top

9. Refer to Figure 1 and Figure 2. Type "A" lenses are longer and need an additional clip along the outer edge (window side) at mid length (24" from front edge of lens)

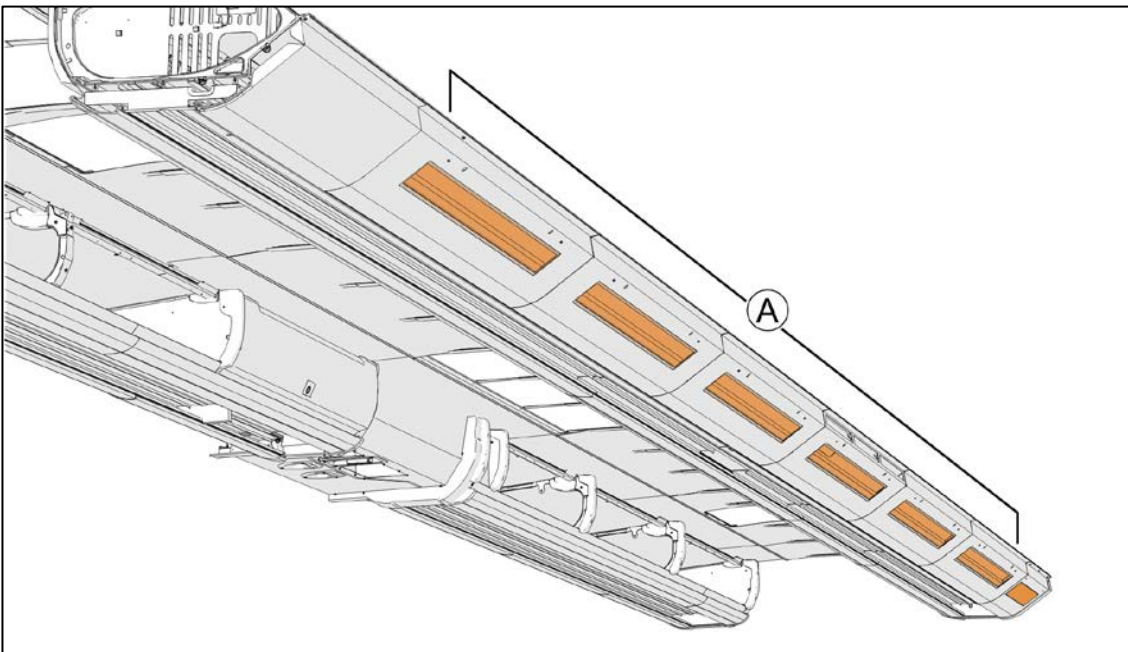
Figure 2: road side lenses. Longer lenses are "A". Three(3) Z-clips required

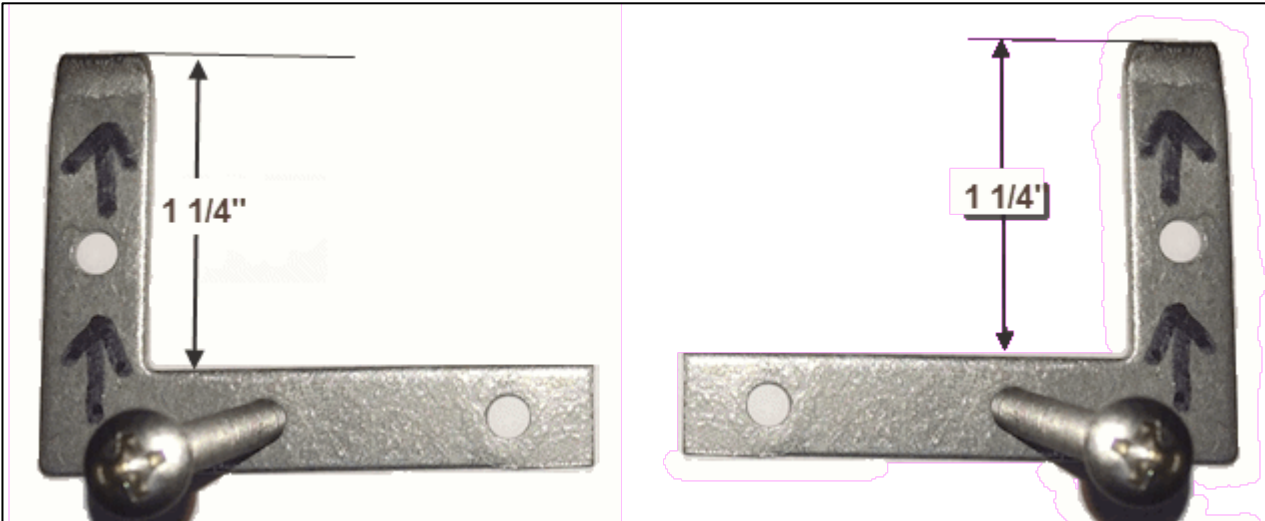
Figure 3: Simple Templates

1. Before starting any work, protect the passenger seats under the lens by installing a clean drape to collect debris from drilling and bulletin activities.
2. Fabricate a set of two simple templates (Figure 3) to locate the Z-supports 1 1/4" from the edge of the lens. (Figure 4)

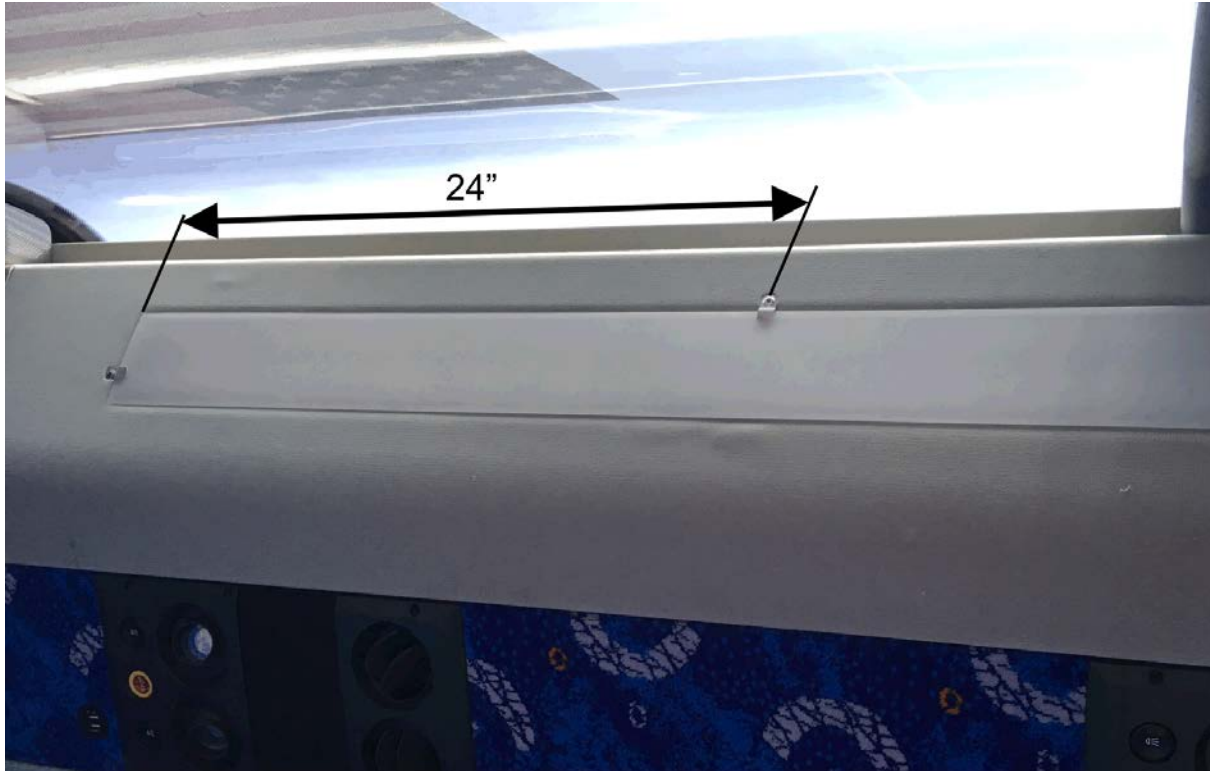
Figure 6: 3rd clip on type "A" lens

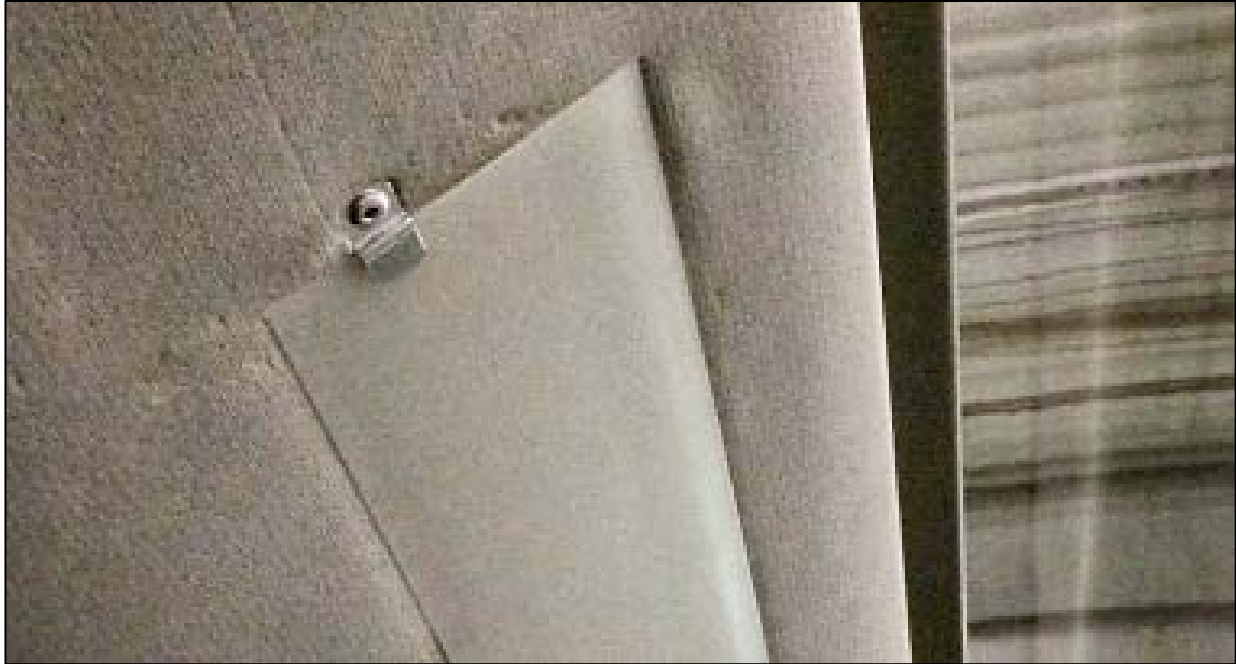
Figure 8: Finished result

13. Remove protective drape from the seats and inspect for any un-collected drill material. Clean as necessary.
14. Ensure the seats are clean of any sharp drill material.
