September 22, 2017

06543 Version 2

## Warranty Extension: MDX Transmission Chirps During 3-4 Shift, Poor Shift Quality, or Engine Overheats Because of Defective ATF Warmer

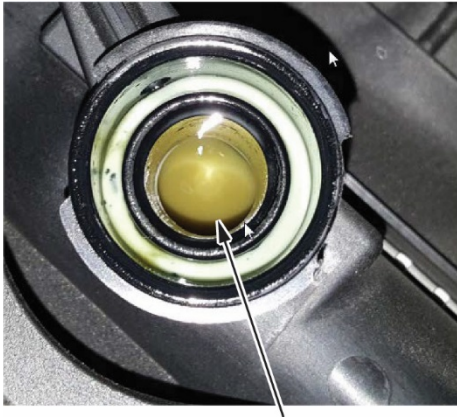
**ATF IN THE COOLING SYSTEM**

Remove the radiator cap and inspect for ATF in the coolant. If there is coolant contamination, the coolant will look brown.

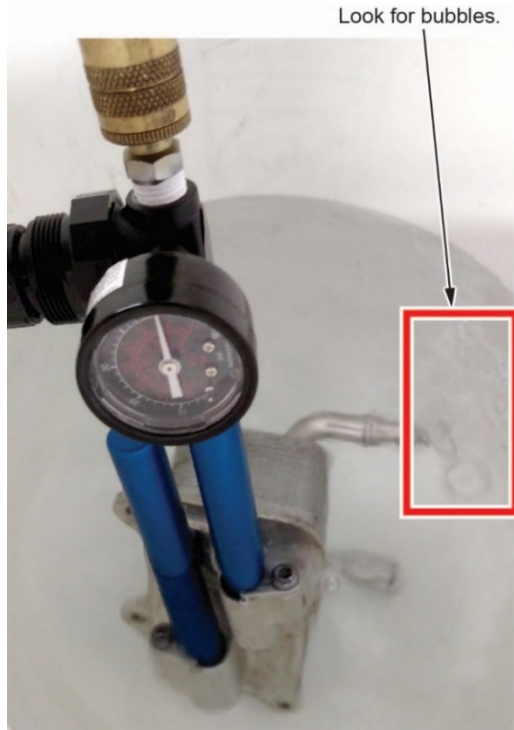
14. Check the transmission warmer for leaks by submerging the warmer completely under the water and watching for bubbles.

NOTE: Some bubbles are normal when the transmission warmer is first submerged and will come to a stop. If there is a leak, there will be a steady stream of bubbles coming from the transmission warmer.

- **If there are no bubbles** coming from the warmer, the 9-speed transmission warmer is OK. **Go to step 15 to install the original warmer** with new O-rings and Jiffy-Tite fittings (if equipped with an accessory cooler.) Submit a claim for the warmer inspection only, then continue with normal troubleshooting to resolve the original client complaint.
- **If there are bubbles**, take photos (see Photos) and check to see if the vehicle also overheated by checking the client responses on the RO.
  - If the transmission warmer leaks, but the vehicle did not overheat, go to [REPAIR PROCEDURE A](#).
  - If the transmission warmer leaks, and the vehicle did overheat, go to [REPAIR PROCEDURE B](#).

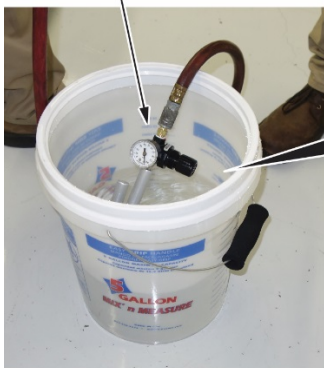
ATF WARMER PRESSURE TEST

If there are bubbles because of a leaking transmission warmer, take photos of the bubbles during the pressure test, the transmission warmer serial number, and the VIN.

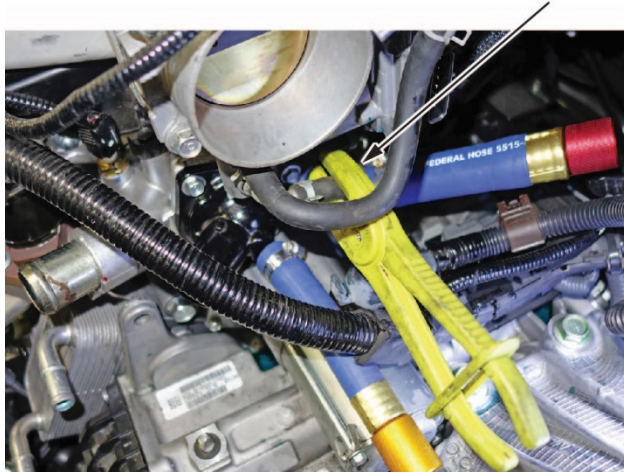
10. Using commercially-available clamps, clamp the throttle body coolant lines as shown.

Clamp both of the throttle body coolant lines.

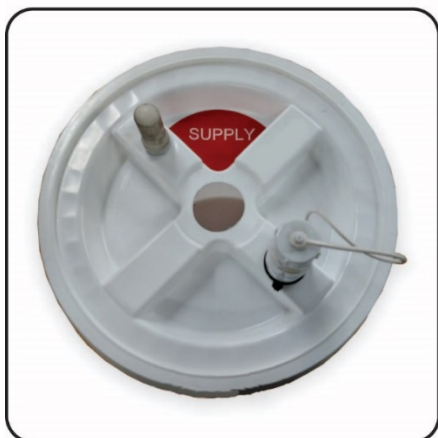
11. From the bucket marked SUPPLY, remove the lid and install the large (1.5 in.) return hose with the T-fitting through the hole in the lid as shown.

ENGINE RETURN HOSE

T-FITTING

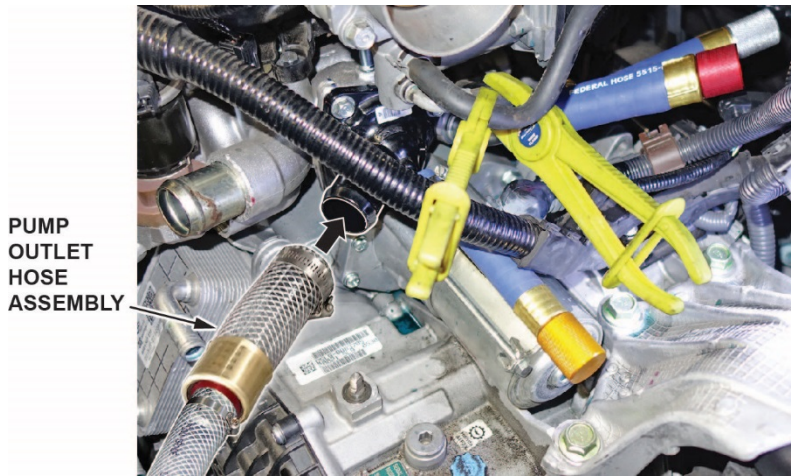
13. Install the pump outlet hose onto the thermostat housing.

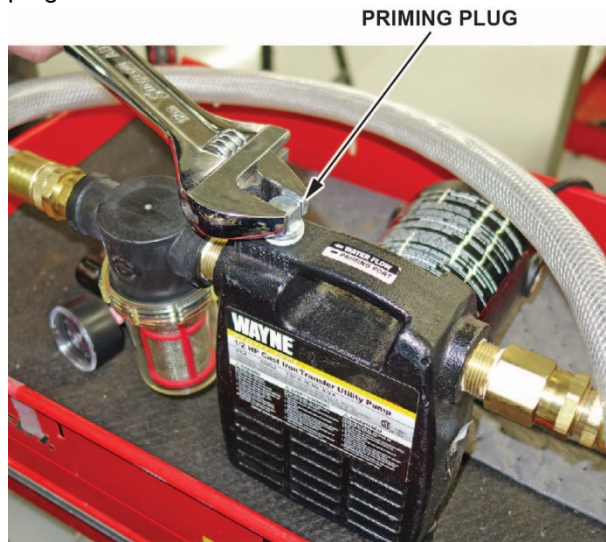
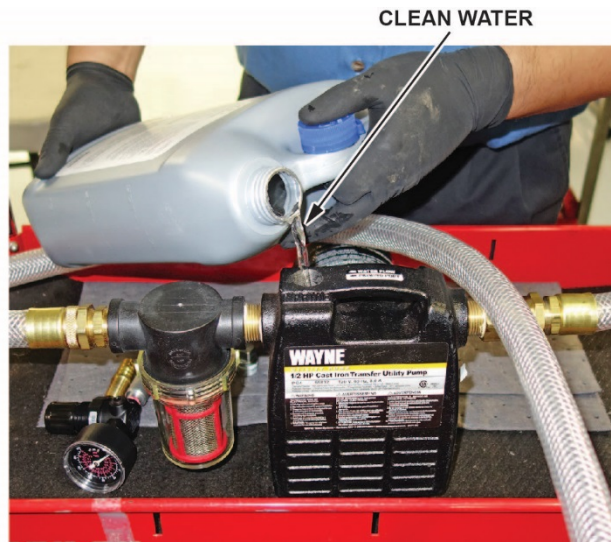
16. Turn on the pump, and let it run for 10 minutes.

NOTE: If this is the first time using the pump, remove the priming plug, fill the pump with clean water, then install the plug.

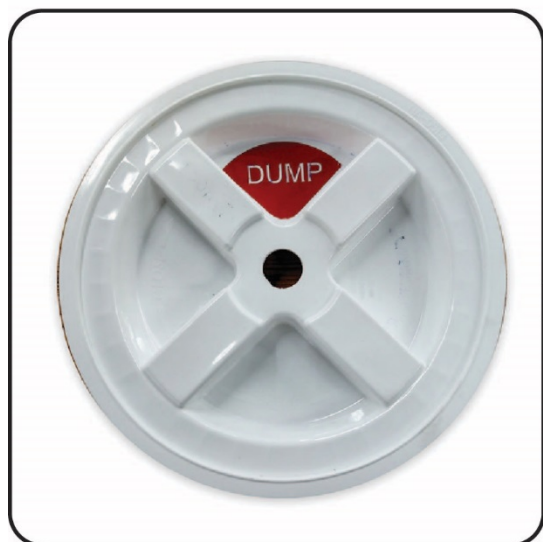
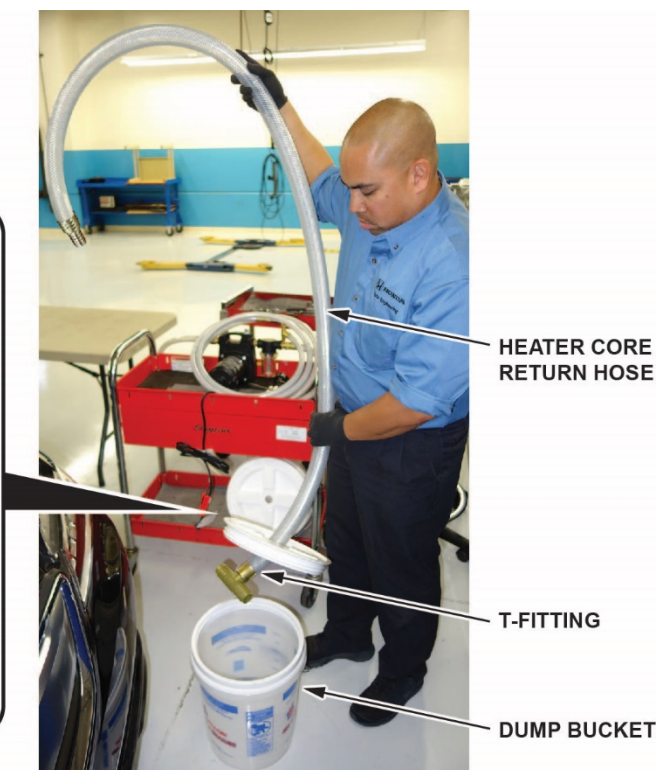
23. Install the heater core return hose through the DUMP bucket lid.
