Bulletin Type.....: Field Fix (M)
Bulletin No.....: TS-M124
Bulletin Name.....: T-bolt clamp replacement
Bulletin Ref No.....: 700003234
PQR No.....: 500000006103
Release Date.....: 11.09.2017
Expiry Date.....: 11.09.2018
Vehicle Model.....: TS45
Fiat Rate Code.....: TSM124
Flat Rate Time.....: 50'

Subject: T-bolt clamp replacement

Summary : This technical service bulletin gives the instruction about how to replace the T-bolt clamp for TS 45 vehicles

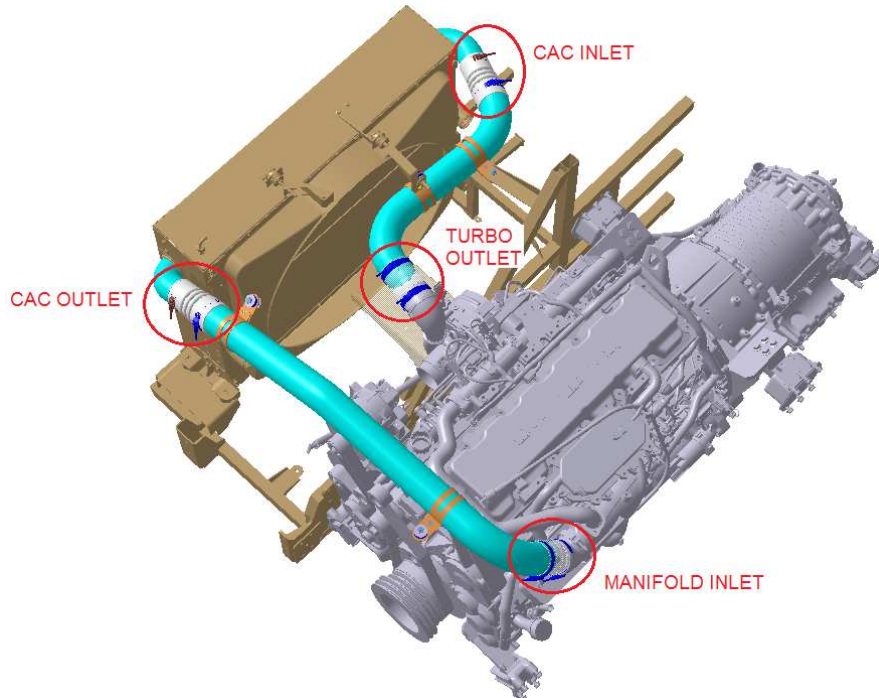
Figure-1

- 1- Location of the clamps to be replaced, see in. (see. **Figure-1**).
