Temperature Sensor Connector in Replacement IMA Battery Now Different

2005–07 Accord Hybrid

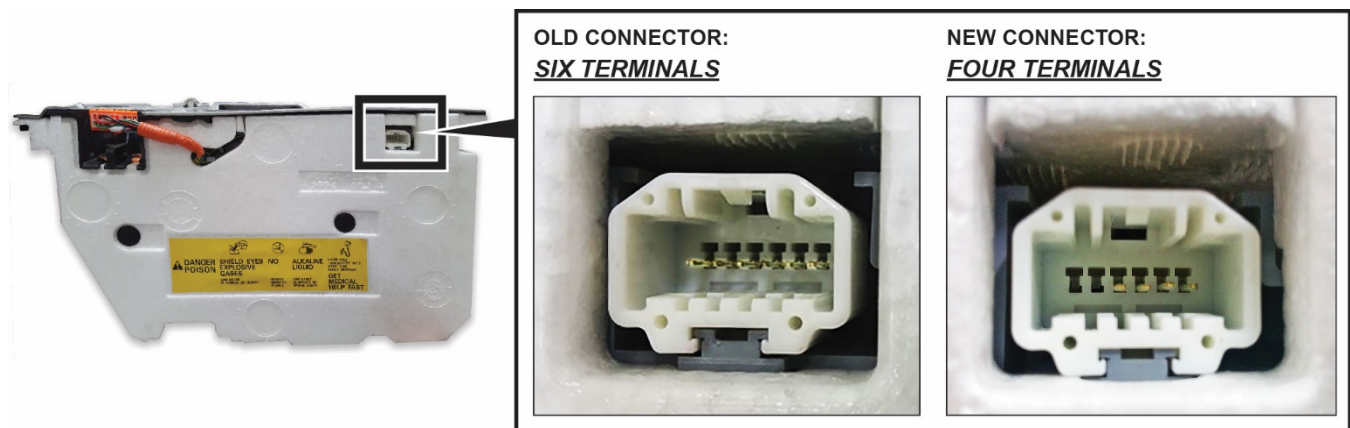
If you're replacing the IMA battery, be aware the 6-pin temperature sensor connector in the replacement battery is different than before. It now uses just **four** of the terminals instead of all six.

But don't worry; this won't cause any problems. Just install the IMA battery like you normally would, and update the software if needed.
